Ross & Partners

Consulting Civil and Structural Engineers

Basement Impact Assessment
for
New Subterranean Development
at
25 John's Mews
London
WC1N 2N

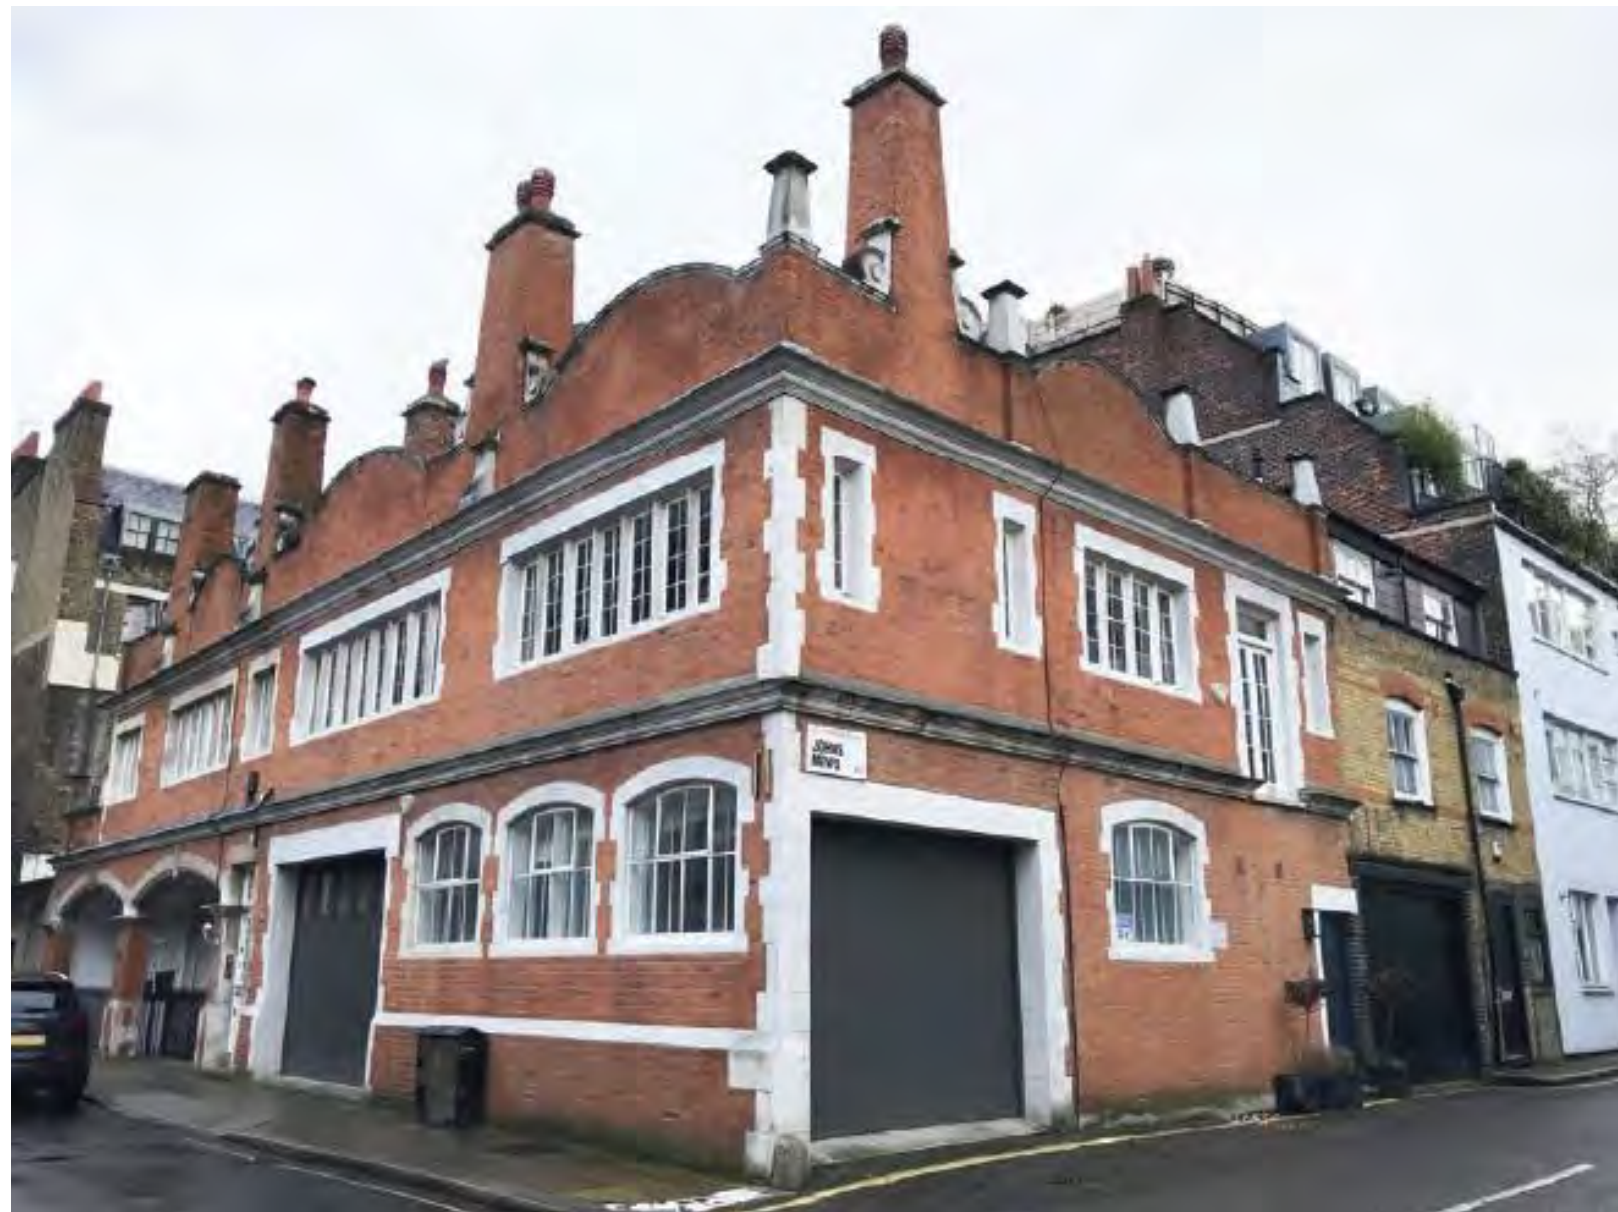
Street View of 25 John's Mews

- 1.1 The site location is 25 John's Mews, London WC1N 2NS. The building is located on the corner of John's Mews and Northington Street within the Bloomsbury Conservation Area. The building comprises of a two-storey red brick with stone features. It is understood the building was constructed c.1903. It is an end of terraced mews house with accommodation arranged over ground, first and second floors with a pitched roof over. There is a part basement area which is thought to be part of an historic vehicular ramp that has been partly sealed. The existing walls extend to circa 3m below street level which may anecdotally suggest this part of the building may also have a full basement.
- 1.2 The existing property is shown in the photograph below.

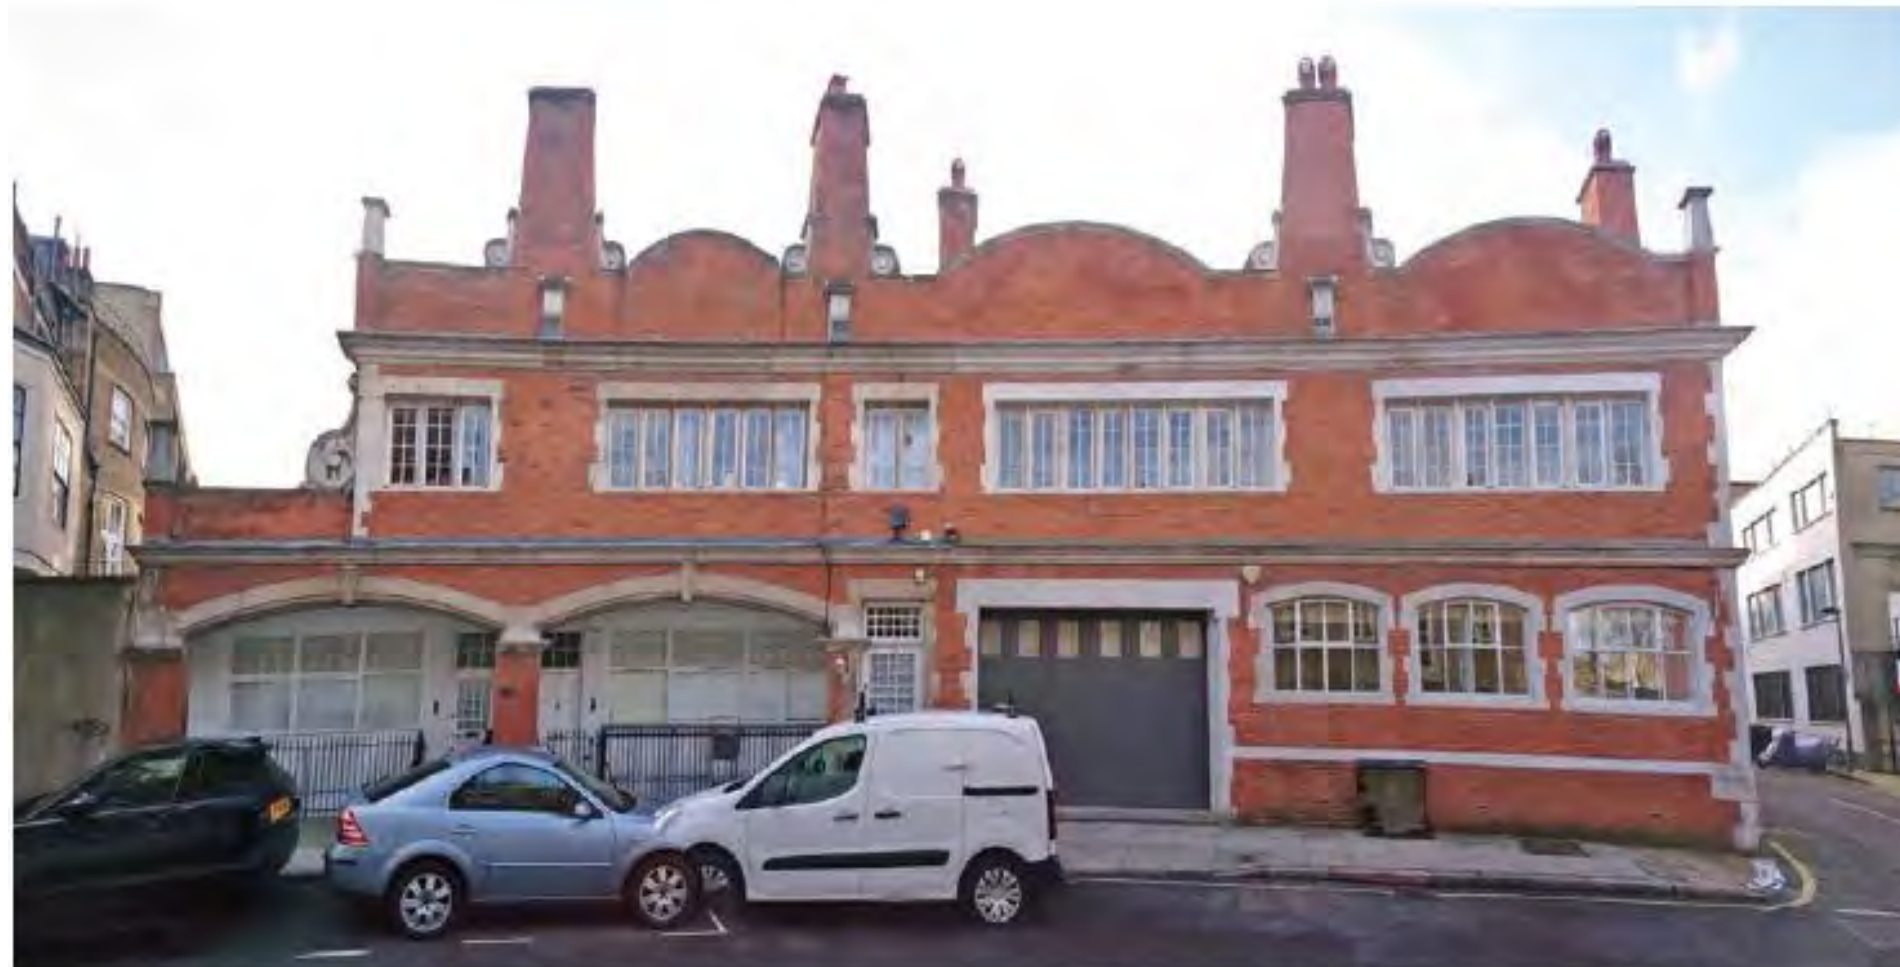
Site photo along Northington Street - Both addresses sit within the same building as constructed by the Finch Brewery.

- 1.3 The photograph below illustrates the Northington Street Elevation. The property is divided into two sections: 25 John's Mews and 13 Northington Street. Within 25 John's Mews accommodation is arranged over ground and first floors as a single dwelling house for the client Mr Colin Fraser. The adjacent 13 Northington Street was converted into two maisonettes in 1995. Interestingly this part of the building has basement accommodation. It is believed the basement is part of the original construction.
- 1.4 25 John's Mews has an existing ramped area that extends to below ground level. It is considered this ramp may have historically provided access into the existing adjacent basement. At present it is used for storage.

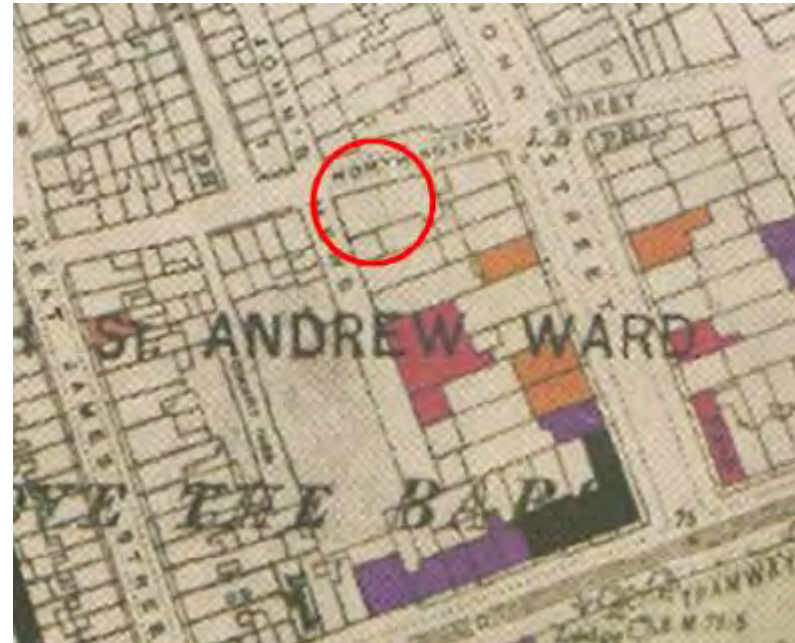
- 3.1.1 With reference to historic maps the site was an open bowling green from 1720 until during most of the Eighteenth Century and was developed as a single building between 1755 and 1792. The building was used as both a stable and coach building workshop and at some time became a garage. The garage was known to have a basement in 1982 and 1995 (ref SI Report) which was subdivided and converted to residential use circa 1995.
- 3.1.2 There are no recorded WW2 bomb strikes at the site. The nearest recorded strike hit Cockpit Yard. It is reasonable to regard the ground beneath the property as free from any WW2 ordinance. The plan on the right shows recorded strikes in the vicinity of John's Mews.

Black	total destruction
Purple	damaged beyond repair
Dark Red	seriously damaged; doubtful if repairable
Light Red	seriously damaged but repairable at cost
Orange	general blast damage – not structural
Yellow	blast damage, minor in nature
Light blue	clearance areas

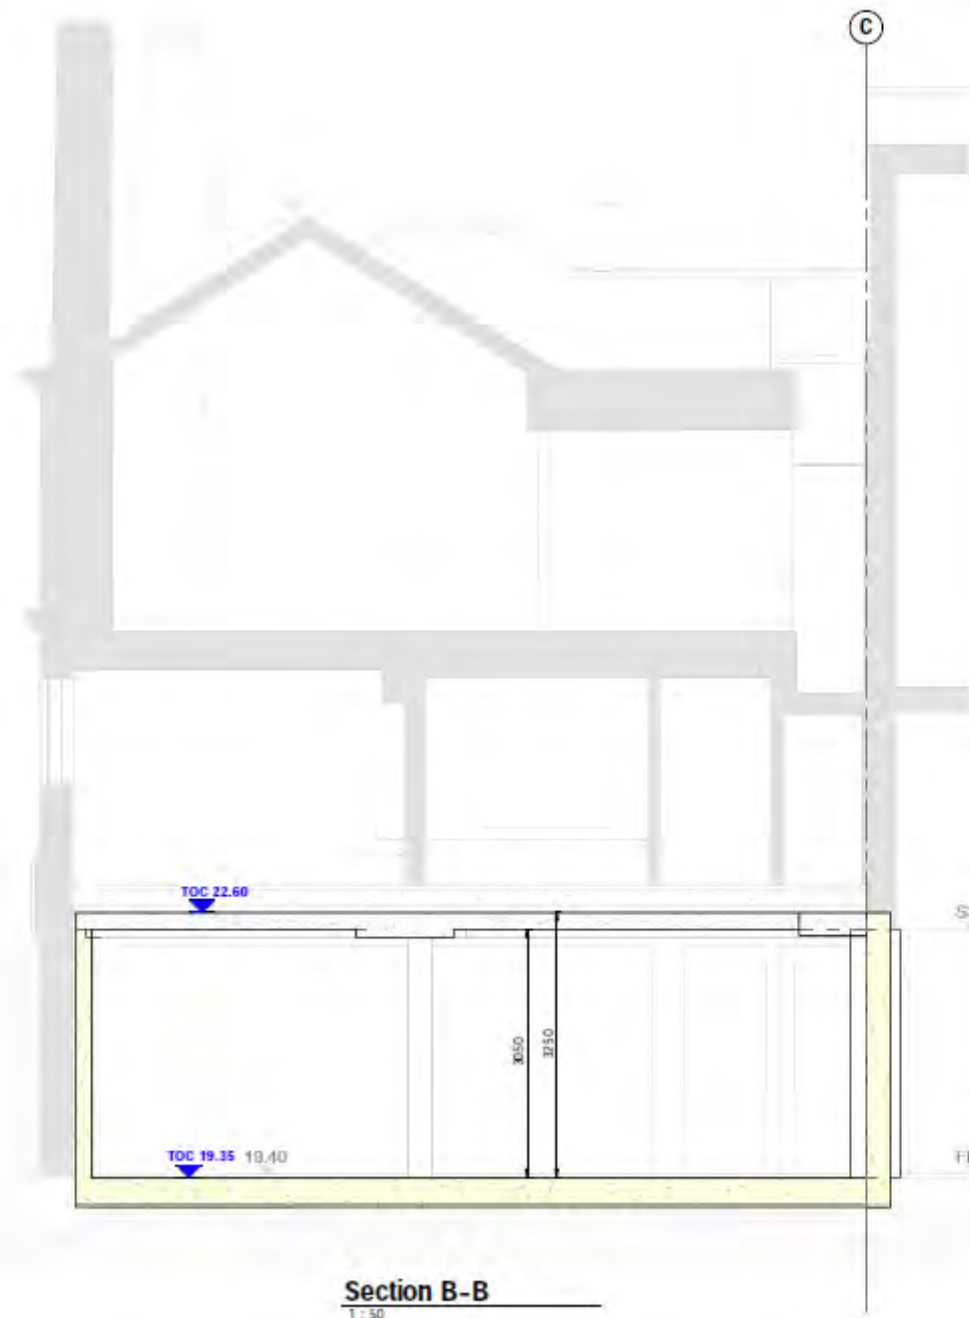
Stage 1 Backpropping

- Strip out all existing ground floor fixtures and fittings back to bare structure.
- Erect Mabey Mass 25 temporary props and spreader beams to underside of first floor beams. Prop windows and arches.
- Back prop first floor slab with Titan Props

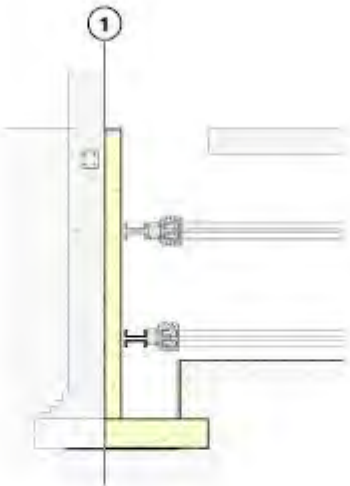
Section AA - Stage 6
1:50

Stage 6
Reduce ground levels in horizontal layers to approximately 1/3 of the total height and install second layer of props.

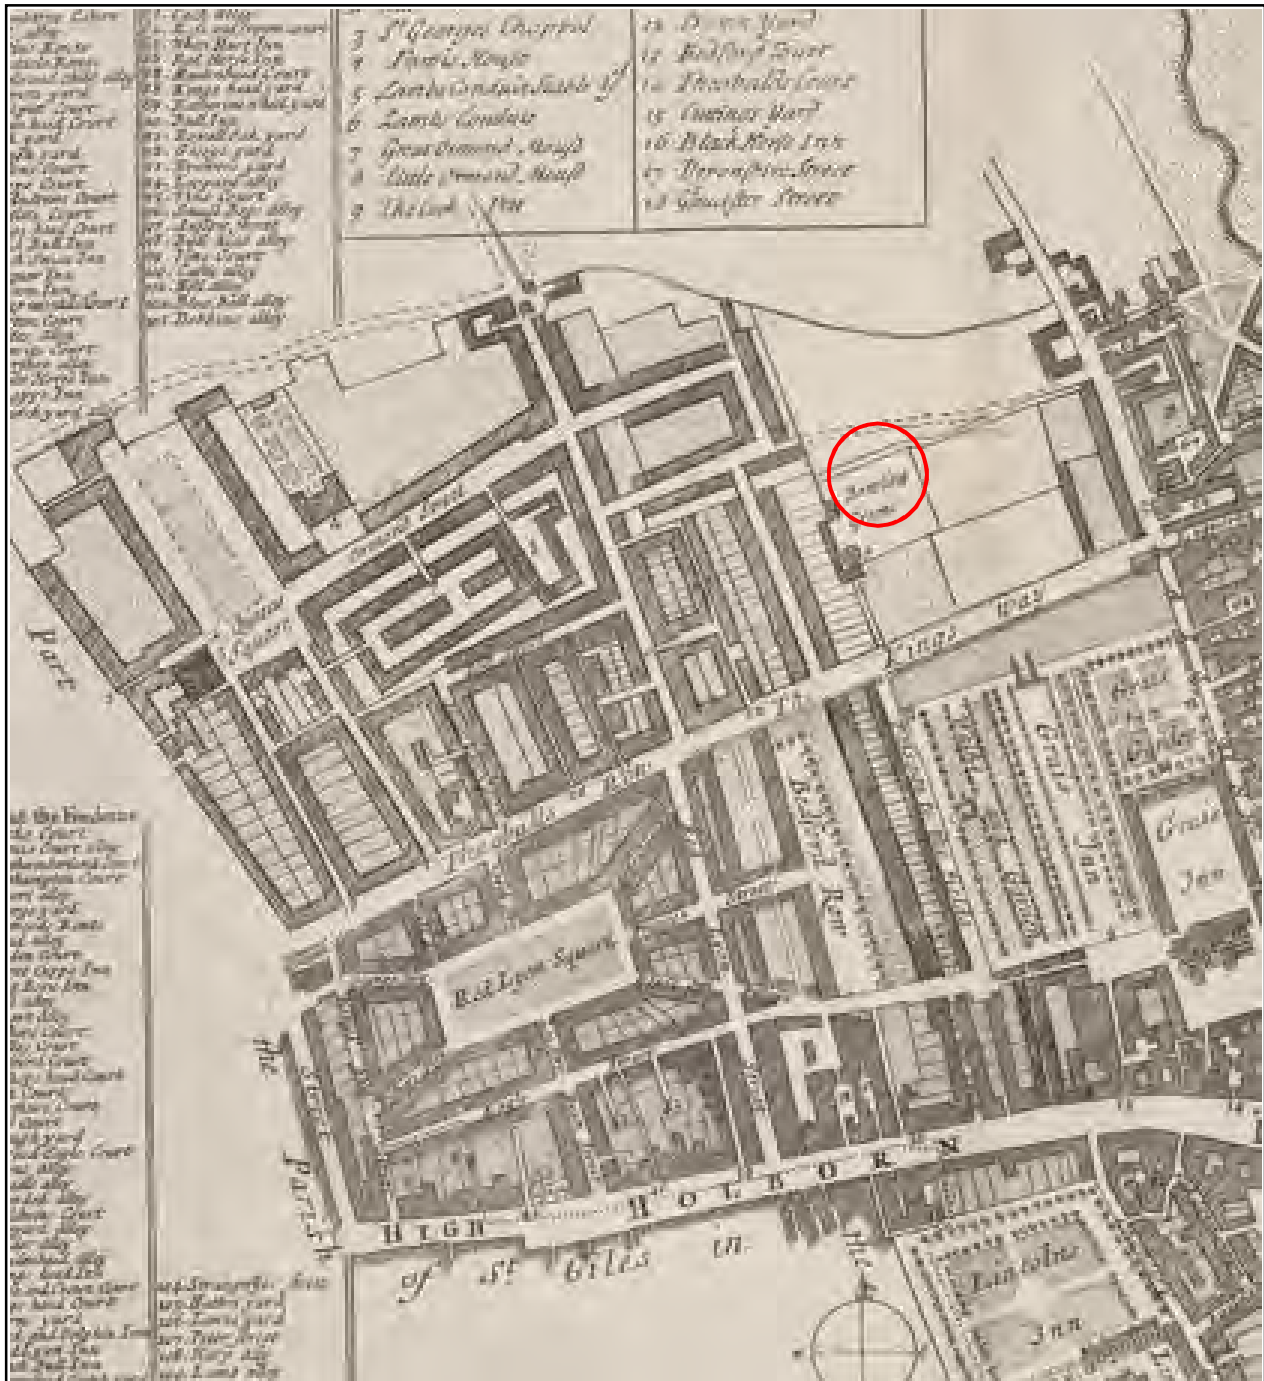
Figure A

Reproduced from the 1720 Stow's 'Survey of the Cities of London & Westminster'
Not to scale

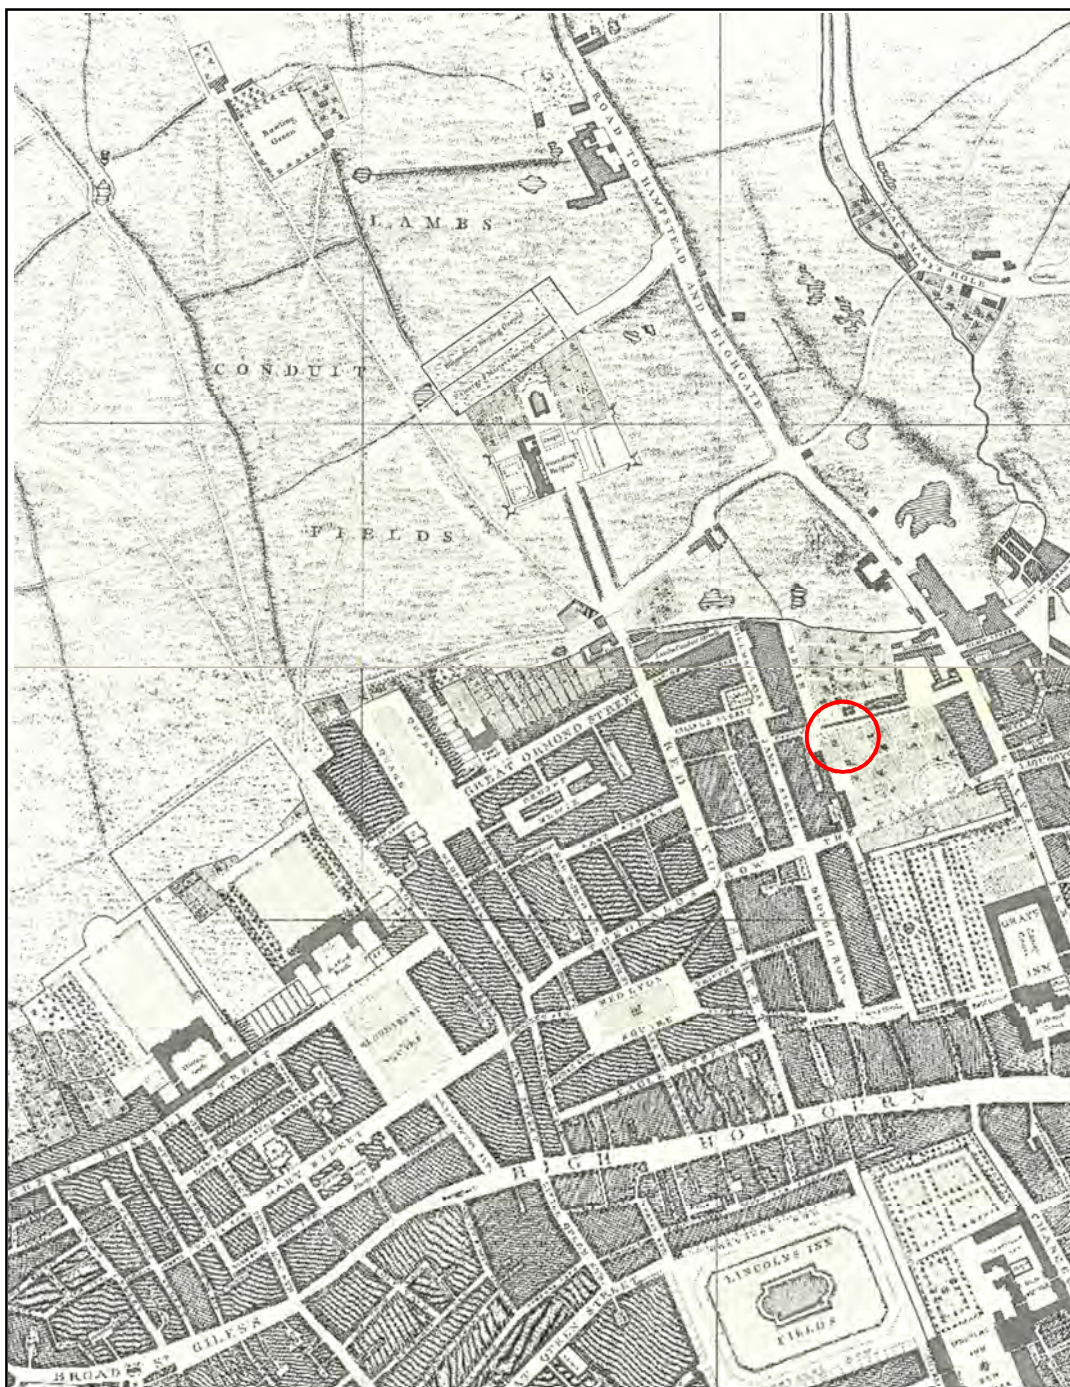
Figure B

Reproduced from the 1747 John Rocque's Plan of the Cities of London and Westminster and Borough of Southwark
Not to scale

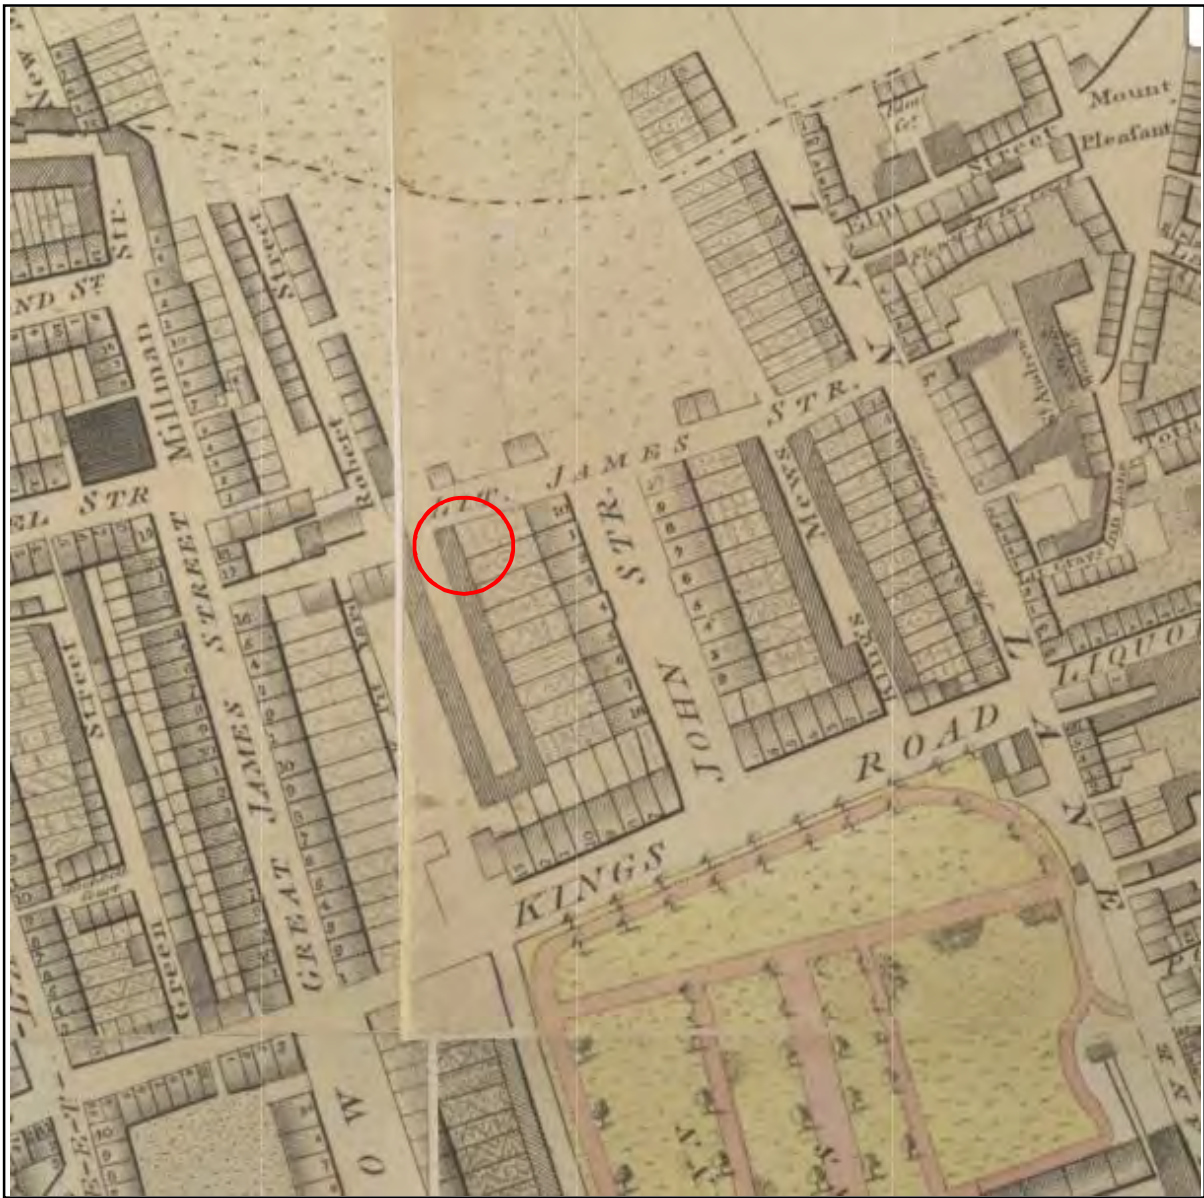
Figure D

Reproduced from the 1792 1st Edition Richard Horwood's Plan of London
Not to scale

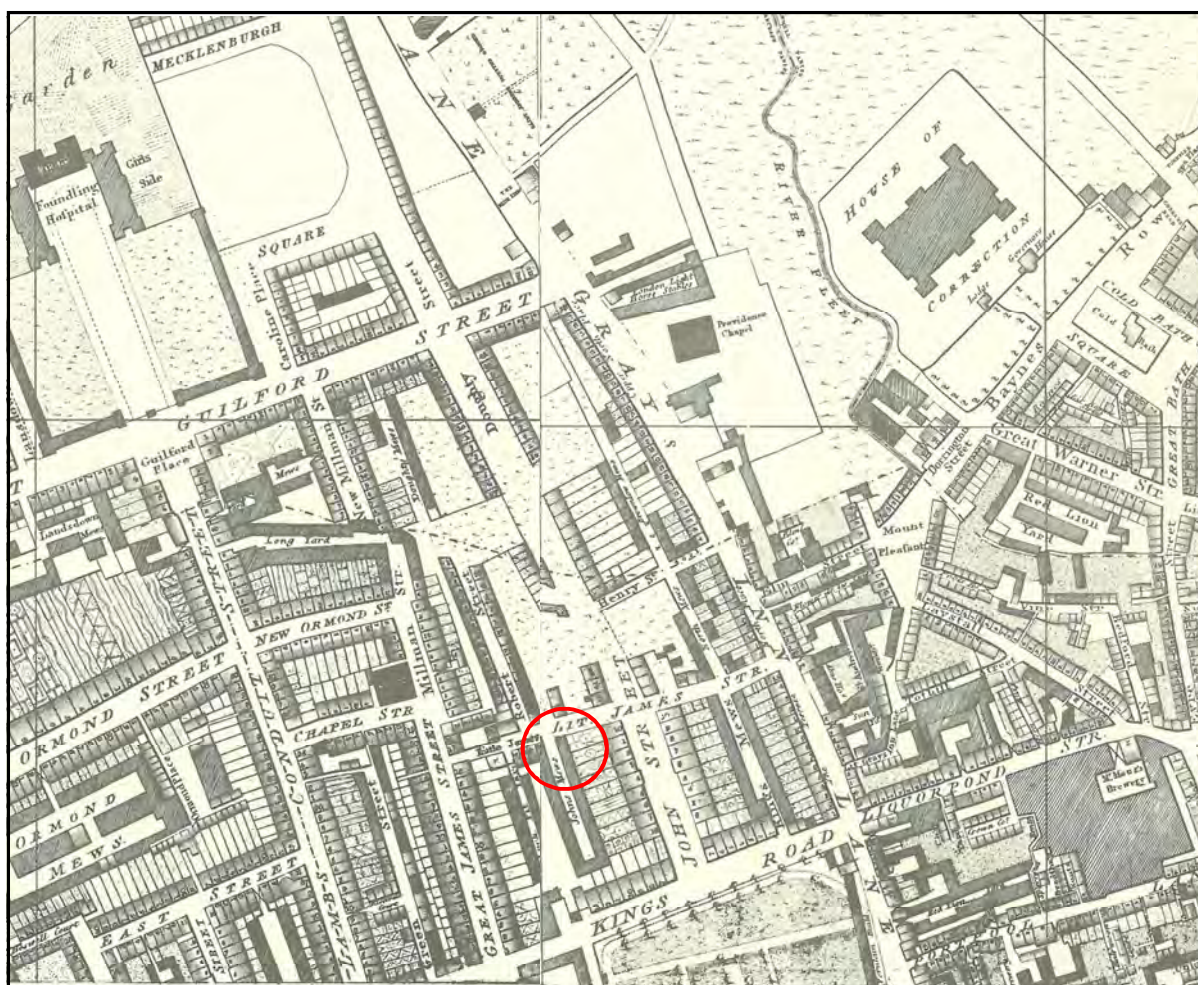
Figure E

Reproduced from the 1813 3rd Edition Richard Horwood's Plan of London
Not to scale

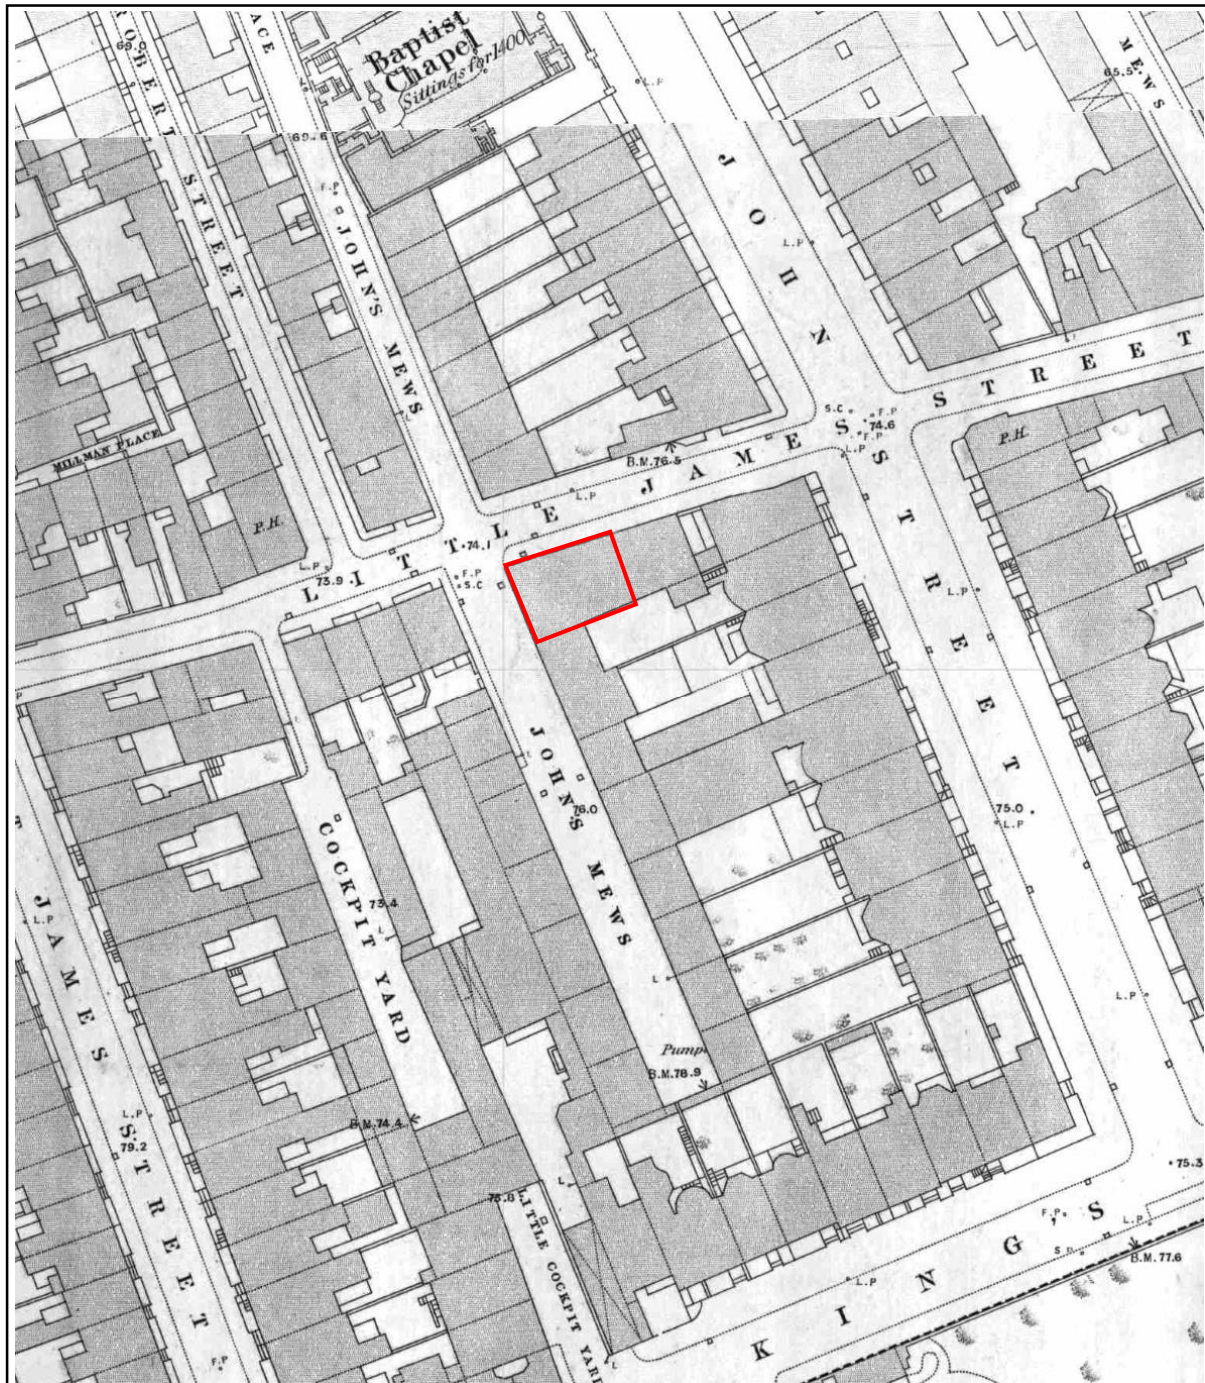
Figure H

Reproduced from the 1874-75 edition Ordnance Survey Town Plans at 1:1056 scale with the permission of the Controller of Her Majesty's Stationery Office, © Crown Copyright. All rights reserved. Licence number AL100005523

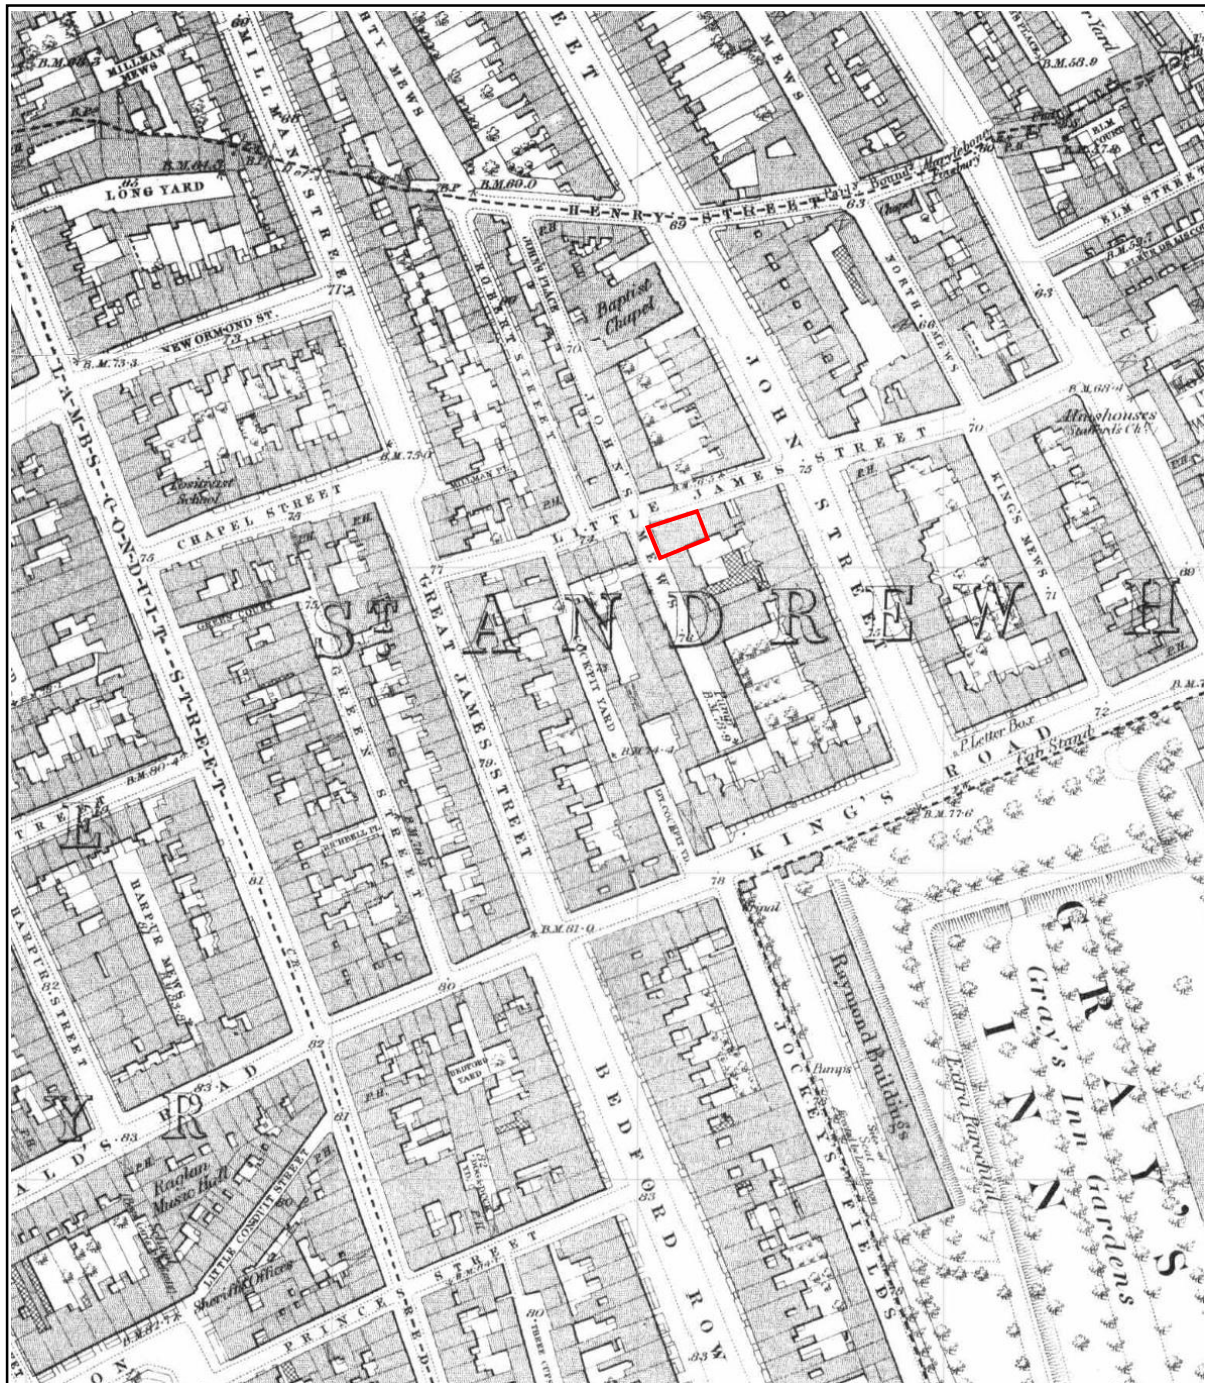
Figure I

Reproduced from the 1877-78 edition Ordnance Survey sheets London XXVI & XXXV at 1:2500 scale with the permission of the Controller of Her Majesty's Stationery Office, © Crown Copyright. All rights reserved. Licence number AL100005523
