Bat Roost Potential Survey Report

3 – 6 Spring Place, Kentish Town

Presented to **SEGRO PLC**

Delta-Simons Project No. 20-1101.01

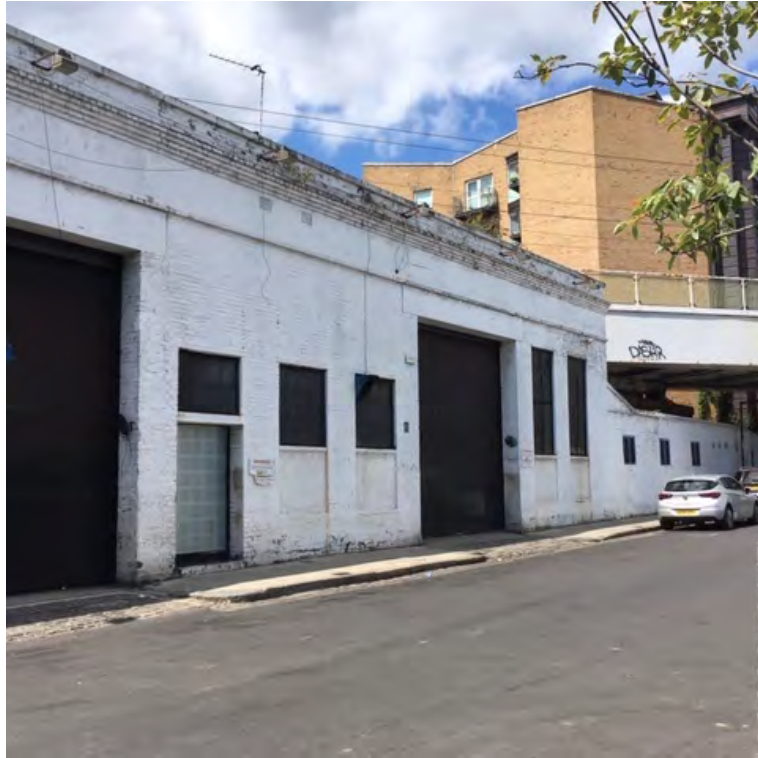
The Site comprised a single building. Externally the building was brick-built with a multiple hipped metal sheet roof (Appendix C - Photograph 1). The Overground Line spanned the centre of the building, north to south, with the associated section of building built into the railway arches. External lighting (Photograph 2) was present on the north-eastern aspect of the building, which bordered Spring Place, whilst much of the remaining boundaries adjoined neighbouring buildings, with the southern extent bordering Grafton Road.

Photograph 1 – External view of B1

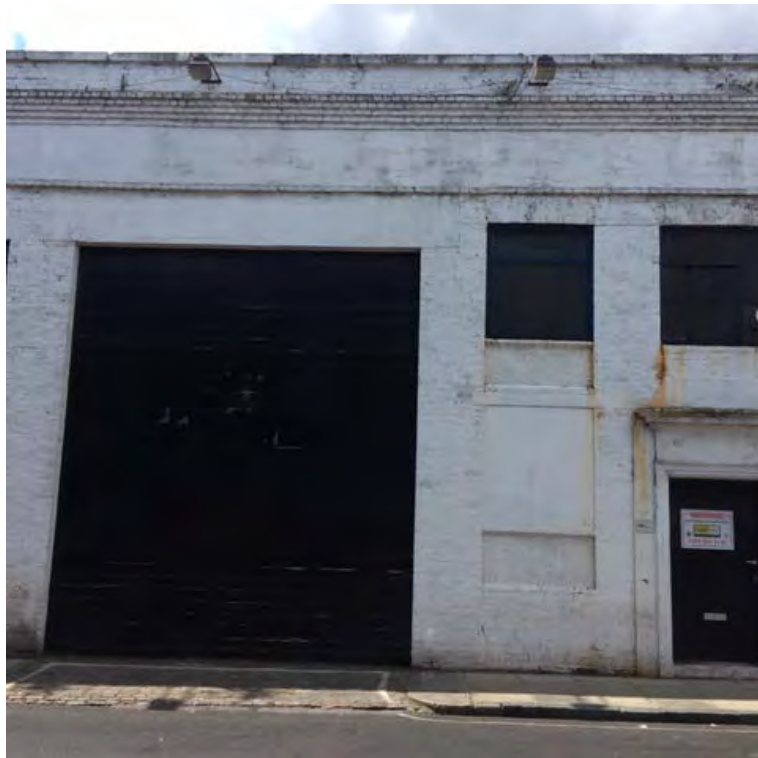
Photograph 2 – Lighting on north-eastern aspect of B1

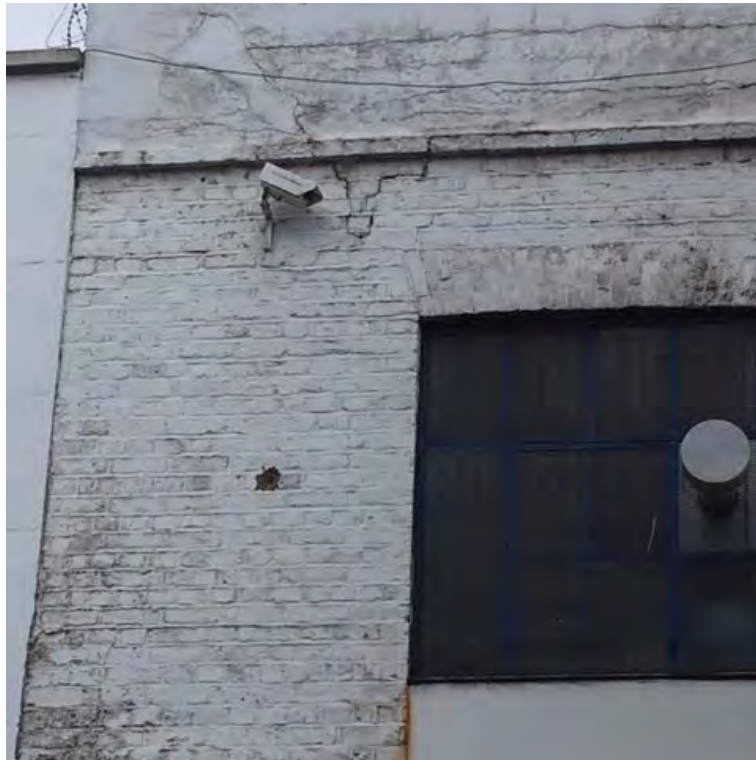
Externally, no potential bat roost features were identified. There were superficial cracks in the brickwork on north-eastern aspect of the building (Photograph 3) as well as superficial damage to the bricks themselves, but overall, the brickwork was intact and well-sealed. The building featured gaps around one of the roller doors (Photograph 4) which may allow access into the internal areas for bats or birds. There was also a crack in the brickwork surrounding another of the doors, but the crack did not appear to lead to a suitable crevice. An airbrick was present on the eastern aspect of the building, but it was considered unlikely that it would be used by bats.

Photograph 3 – Superficial cracks in brickwork

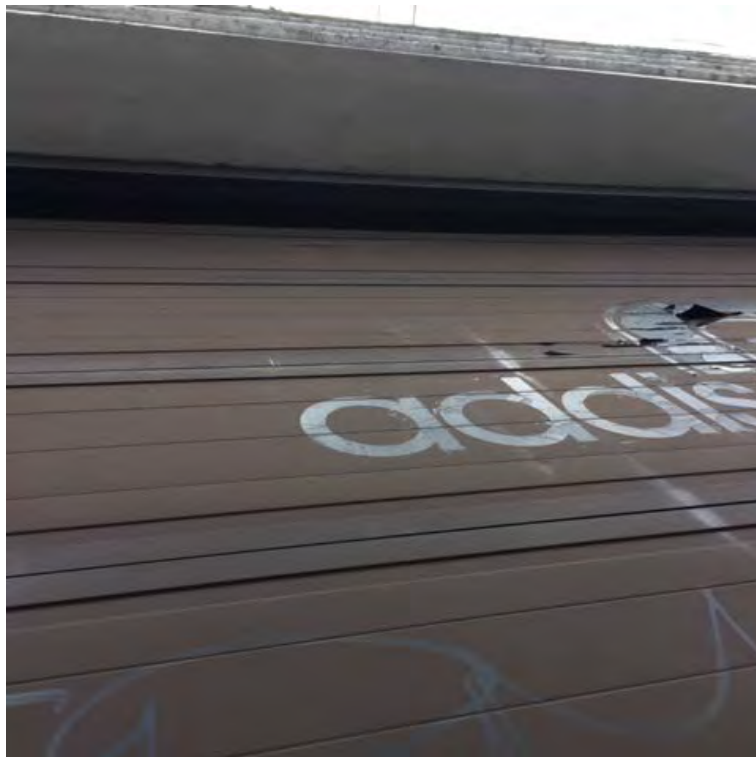
Photograph 4 – Gaps under roller door

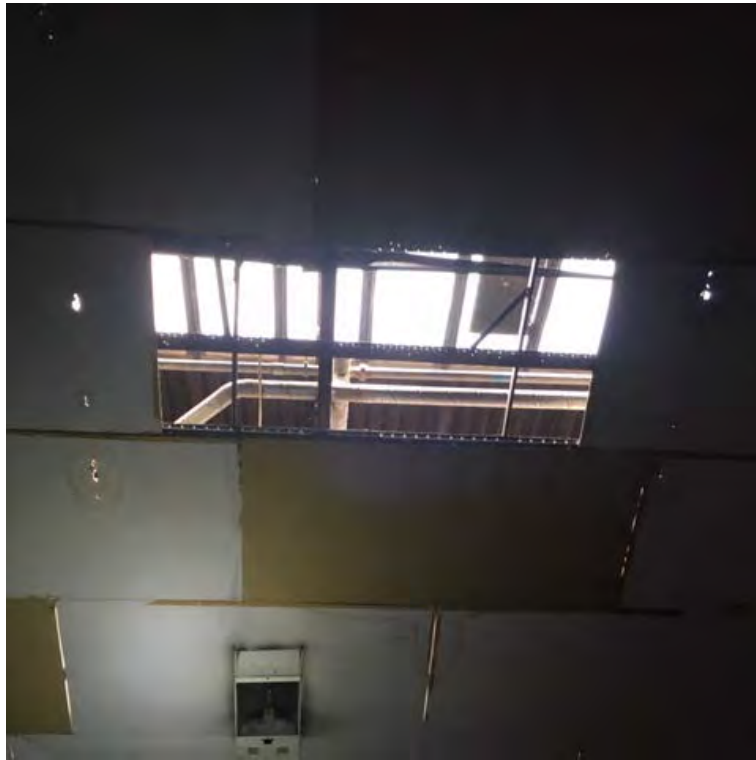
Whilst the roof could not be seen externally, during the internal inspection it was viewed from below through holes in the internal ceilings (Photograph 5). It appeared to be constructed of metal sheeting with plastic panel sky lights. An overlapping piece of sheeting could be seen at the ridge (Photograph 6), but it was considered unlikely to provide suitable climatic conditions for roosting bats.

Photograph 5 – Holes in ceiling showing skylight and roof structure

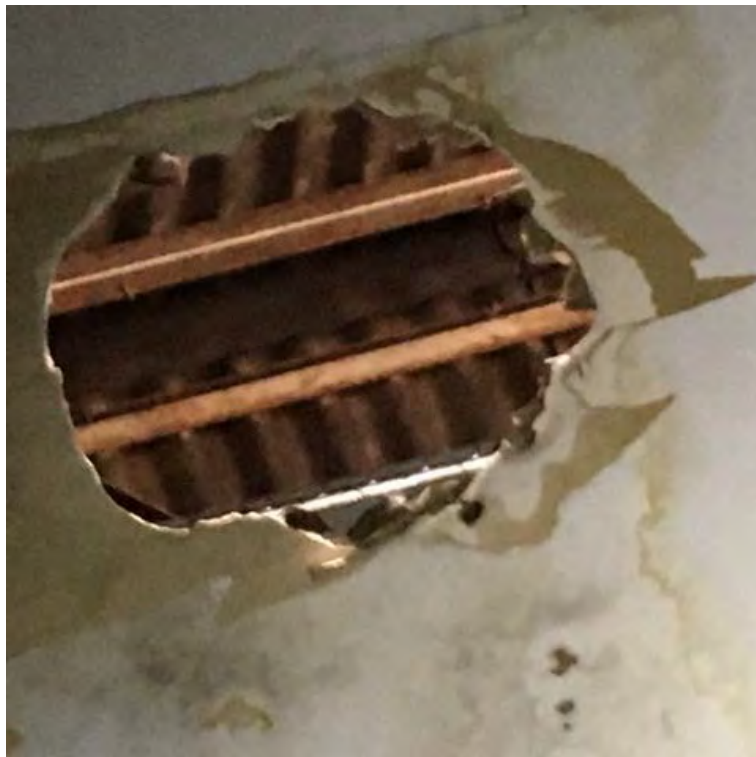
Photograph 6 – Holes in ceiling showing overlapping metal sheeting

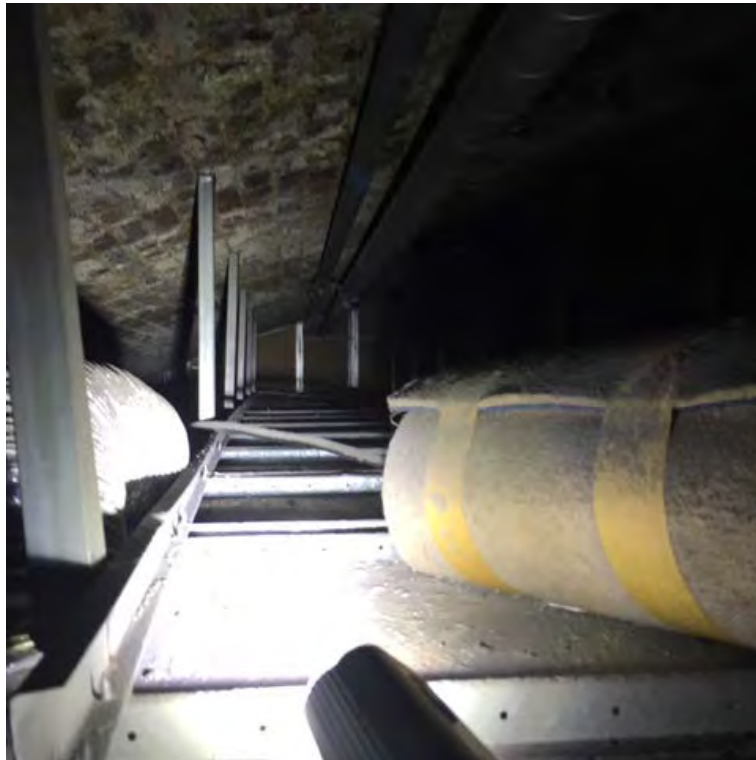
In the north-western building elevation was a void leading under the railway line. The brickwork in the railway's arches appeared to be intact with no holes or crevices that could be utilised by bats (Photograph 7), there was a small door leading to another area beneath the line. This was nailed shut and could not be accessed at the time of the survey, however, no potential bat access points were identified. The vibration and noise from the railway line are considered to deter roosting bats from these areas.

Photograph 7 – Intact brickwork in railway arches
