Regent's Canal Wall Survey

1 St Mark's Crescent London NW1 7TS

Jonathan Freegard Architects

Introduction

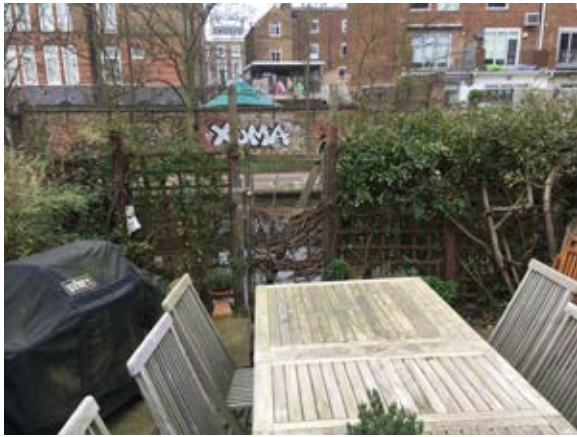
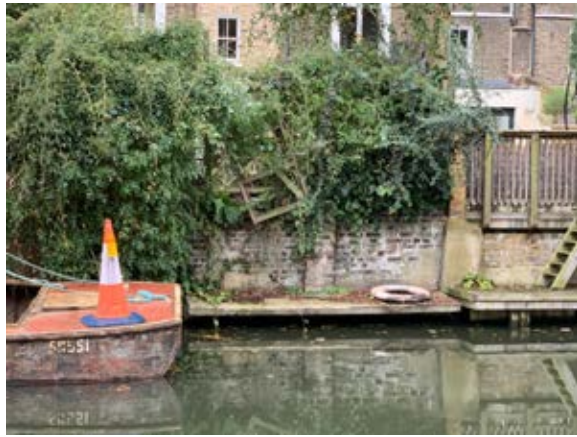
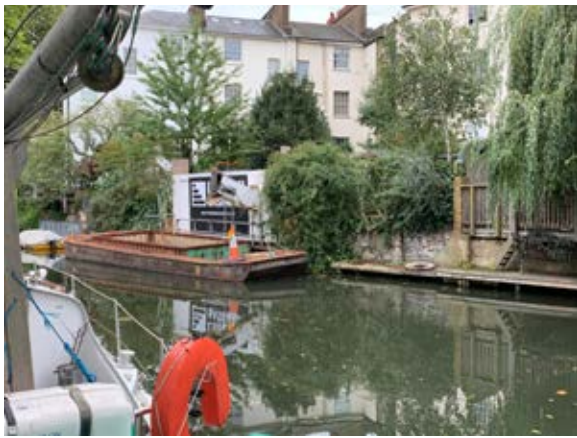
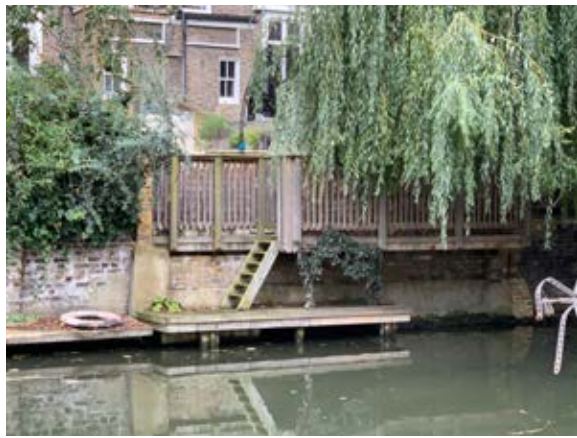
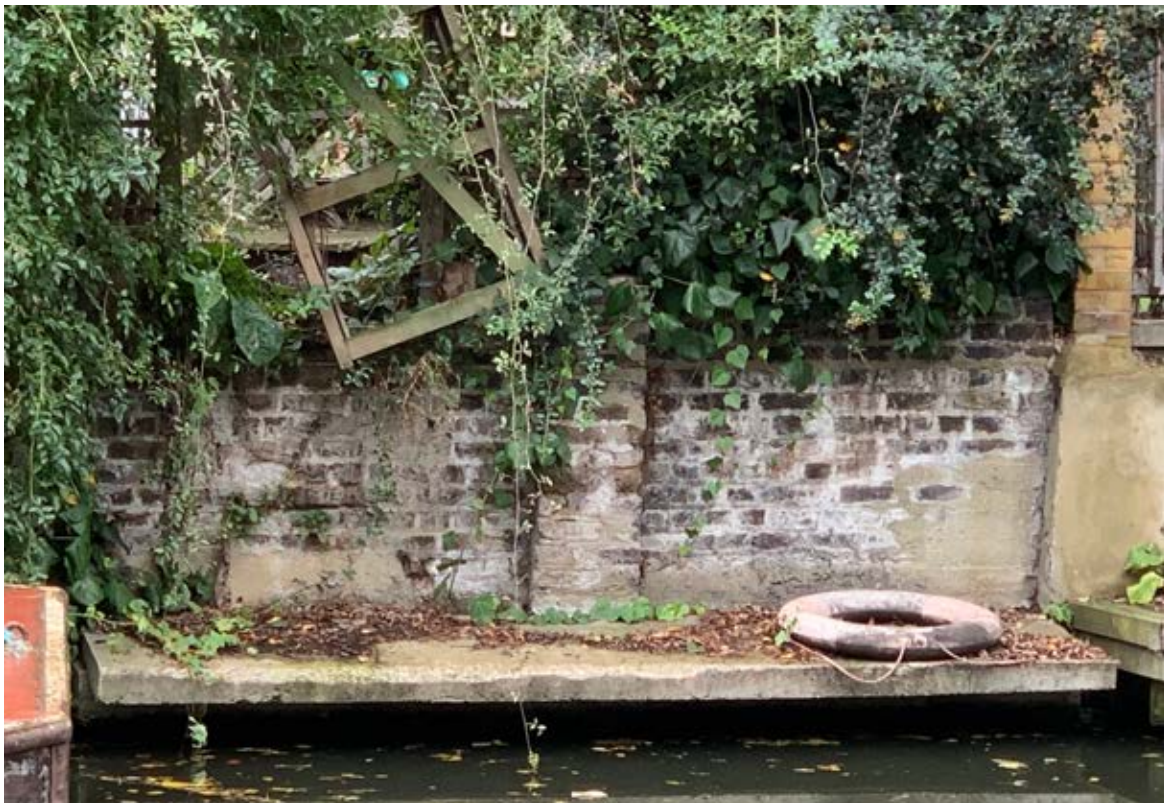
Canal Wall Photos

The canal wall is a 225mm – 750mm thick battered retaining brick wall. The width reaches 750mm thick at a depth of 1650mm with a three piers on the Canal side 340mm wide and projecting 110mm from the point just above water level where the wall steps. A trial pit carried out on 4/12/2019 showed the profile of the wall and is recorded with photos and an excavation log at the end of this survey report. There is a projecting 150mm thick concrete slab 300mm above water level forming a jetty. This slab was built pre-WWII and has rotated slightly over the last 80 years or so under its own weight. The jetty it forms matches the width of those at the properties on either side that are constructed of timber. The brickwork below the water line is firm and undisturbed by the slight rotation of the wall above.

It is proposed first to strengthen the wall from the rear garden side with a 250mm thick concrete retaining wall behind it, all hidden below ground level. This retaining wall will be secured from rotation by a 1m toe projecting beneath the garden and also by two transverse concrete walls containing in-set steps. This will spread the load over a greater width than at present thus reducing any load on the old brickwork beneath. The cantilevered slab (jetty) will then, subject to any necessary consents by The Canal and River Trust, be re-formed anchored to the concrete retaining wall and the facing brickwork towards the Canal rebuilt in the existing or matching reclaimed buff-coloured London stock bricks with the central pier retained as a feature. The slab and steps will be faced with yorkstone paving stones on the both the landing treads and step risers.
