## BRE Global Test Report

**Ad-hoc fire resistance** test following the procedures and criteria of EN1363-1:2012 on two Wates fire cavity barriers (Burnham Profile) installed within a 200mm-deep cast concrete floor.

**Report Number:** P115309-1000 Issue: 1

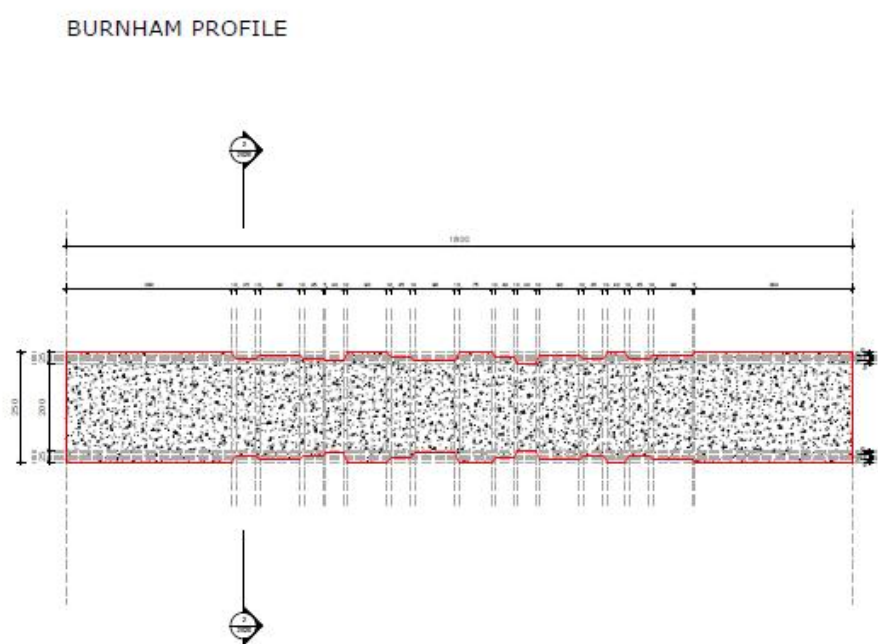
**Figure 1:** Test construction details – as supplied by the sponsor.

Two cast concrete slabs nominally 763mm x 1800mm x 200mm-thick and a third concrete slab nominally 250mm x 1800mm x 300mm-thick incorporating two fully formed 25mm deep Burnham profiles in the longitudinal edge, referenced in this report as Seal A and Seal B.

The seal was delivered to BRE for test, fully formed off site by the sponsor, comprising of Mineral wool RWA-45 packed 25mm deep and sealed with 10mm Firepro non-intumescent mastic (P12/391) with one layer of 12mm Cement board fixed to the outer face.

The seal was delivered to BRE for test, fully formed off site by the sponsor, comprising of Sika Monotop 610 Primer (C42/321). Profile infilled with Sika Monotop Microconcrete (C4/322) with one layer of 12mm Cement board fixed to the outer face. A bead of FirePro Fire resistant silicone sealant was gunned on the top of the cement board.

FirePro Fire resistant silicone sealant was gunned on one side face of one of the 763mm x 1800mm x 200mm-thick concrete slabs and placed in the test frame, the 200mm x 1800mm x 300mm-thick profiled slab was pressed against it. The remaining 763mm x 1800mm x 200mm-thick concrete slab had a layer of FirePro Fire resistant silicone sealant gunned on one side face and placed in the test frame against the other edge of the profiled slab.

Strips of 180mm-thick Rockwool Rainscreen Duo slab were positioned on the outer edges of the cement boards and fixed with SFS-Intec Mids-s Insulation fastener with stainless steel plate washer (H92/777).

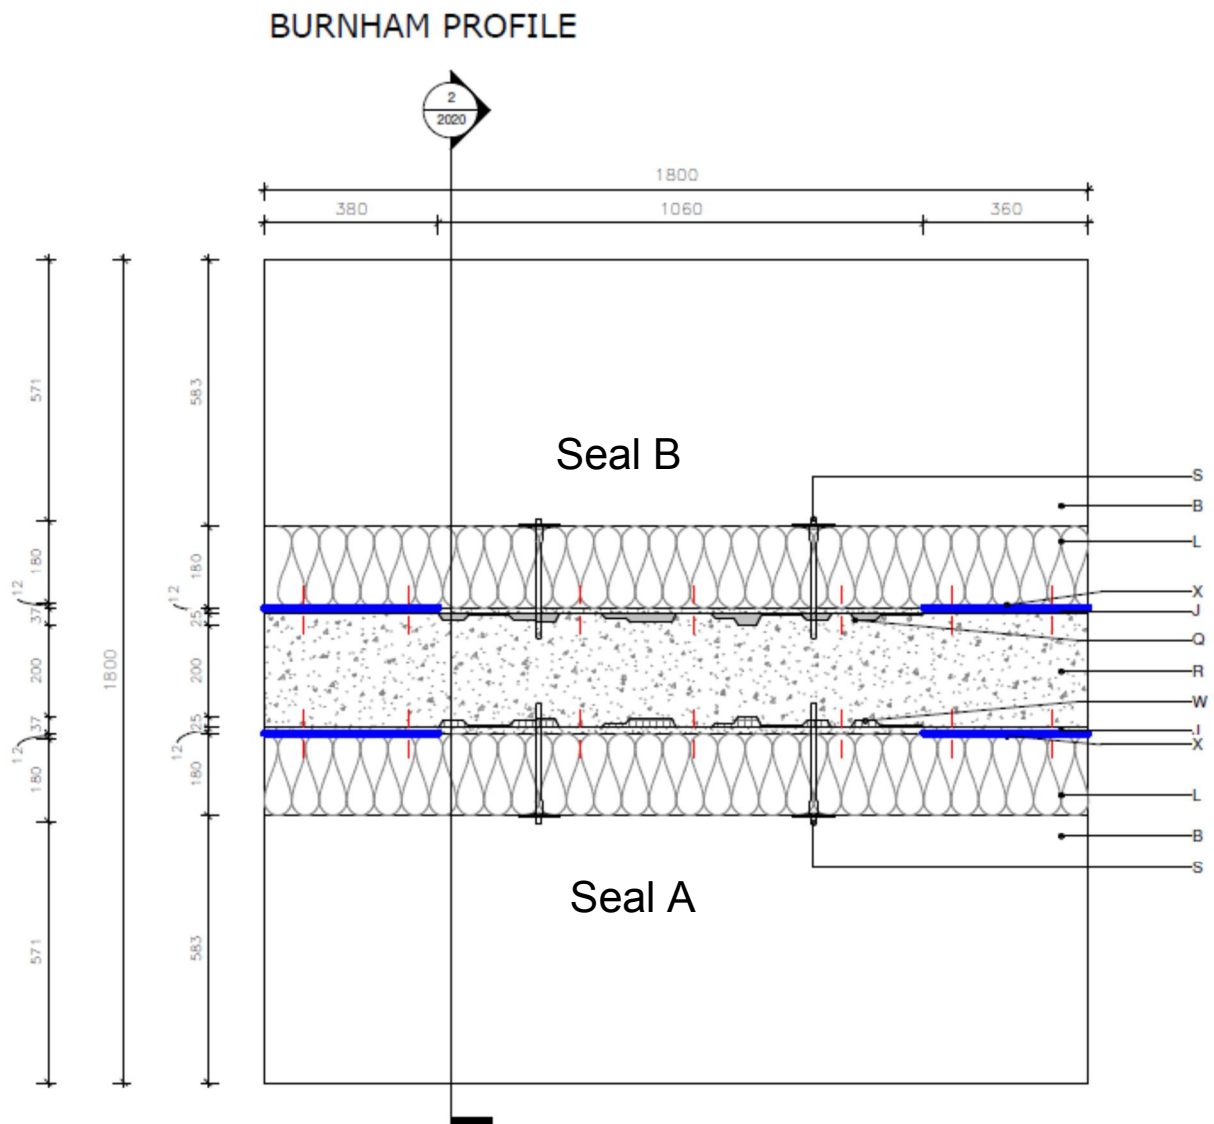
**Figure 2:** Test construction details– as supplied by the sponsor.

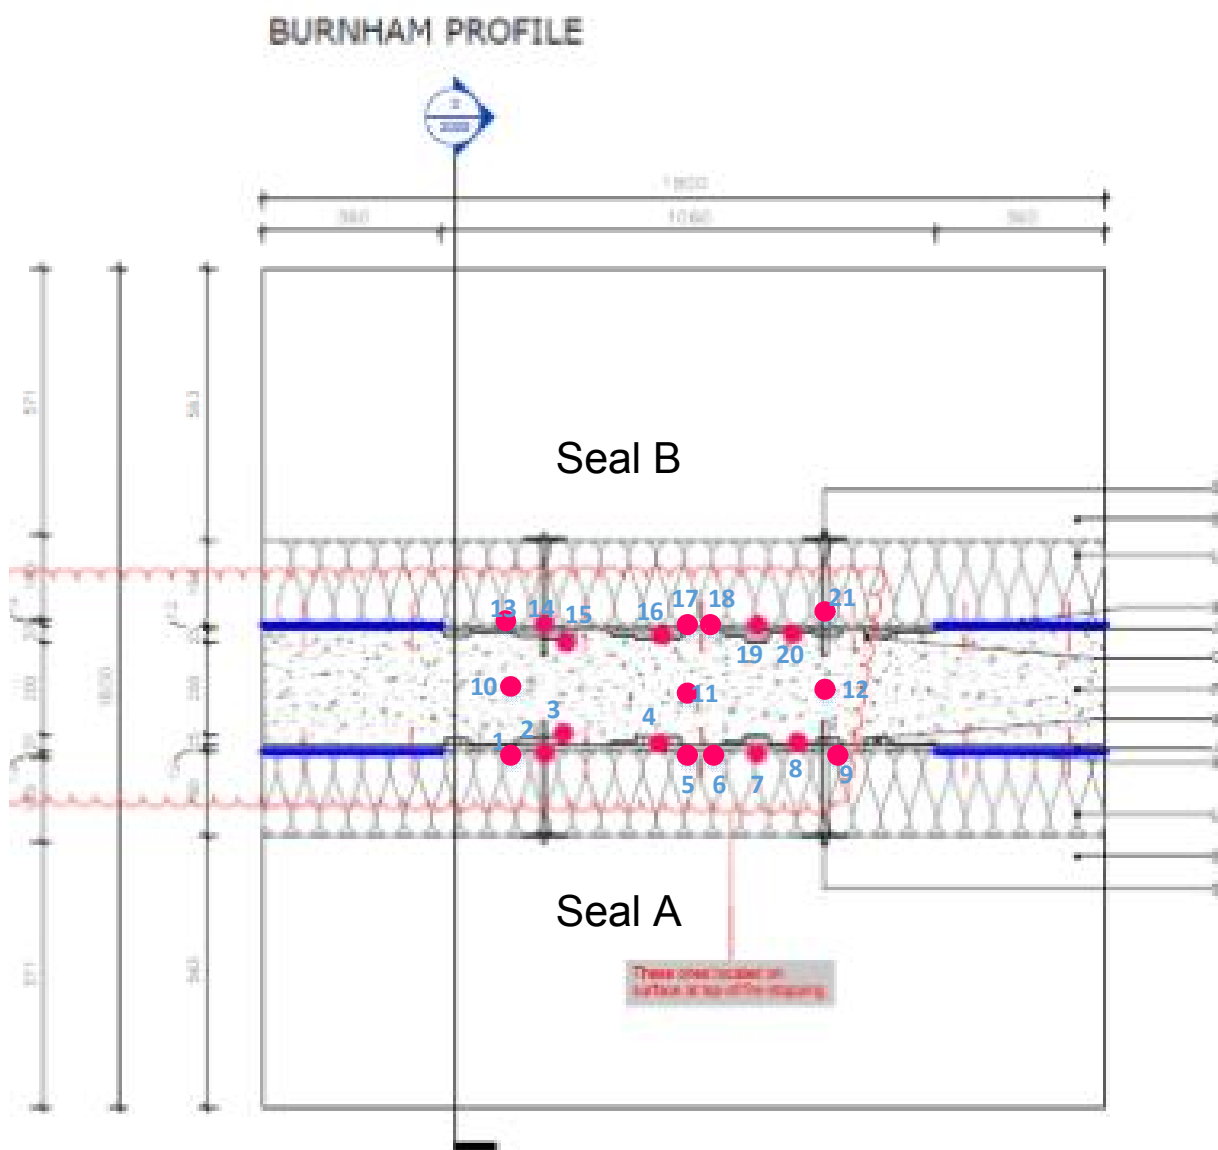
**Figure 4:** Sketch drawing showing nominal thermocouple locations.

**Note:** TCS 1,5,6,9,13,17,18,21 were located on the side faces of the Rockwool.

Twenty-one K-type thermocouples each covered with an insulating pad were fixed to the non-fireside face of the specimen to measure its temperature continuously during the test. Their locations are shown in Figures.

- Seal A = 85.1°C (recorded by thermocouple t/c2 after 121 minutes)
- Seal B = 93.7°C (recorded by thermocouple t/c21 after 50 minutes)

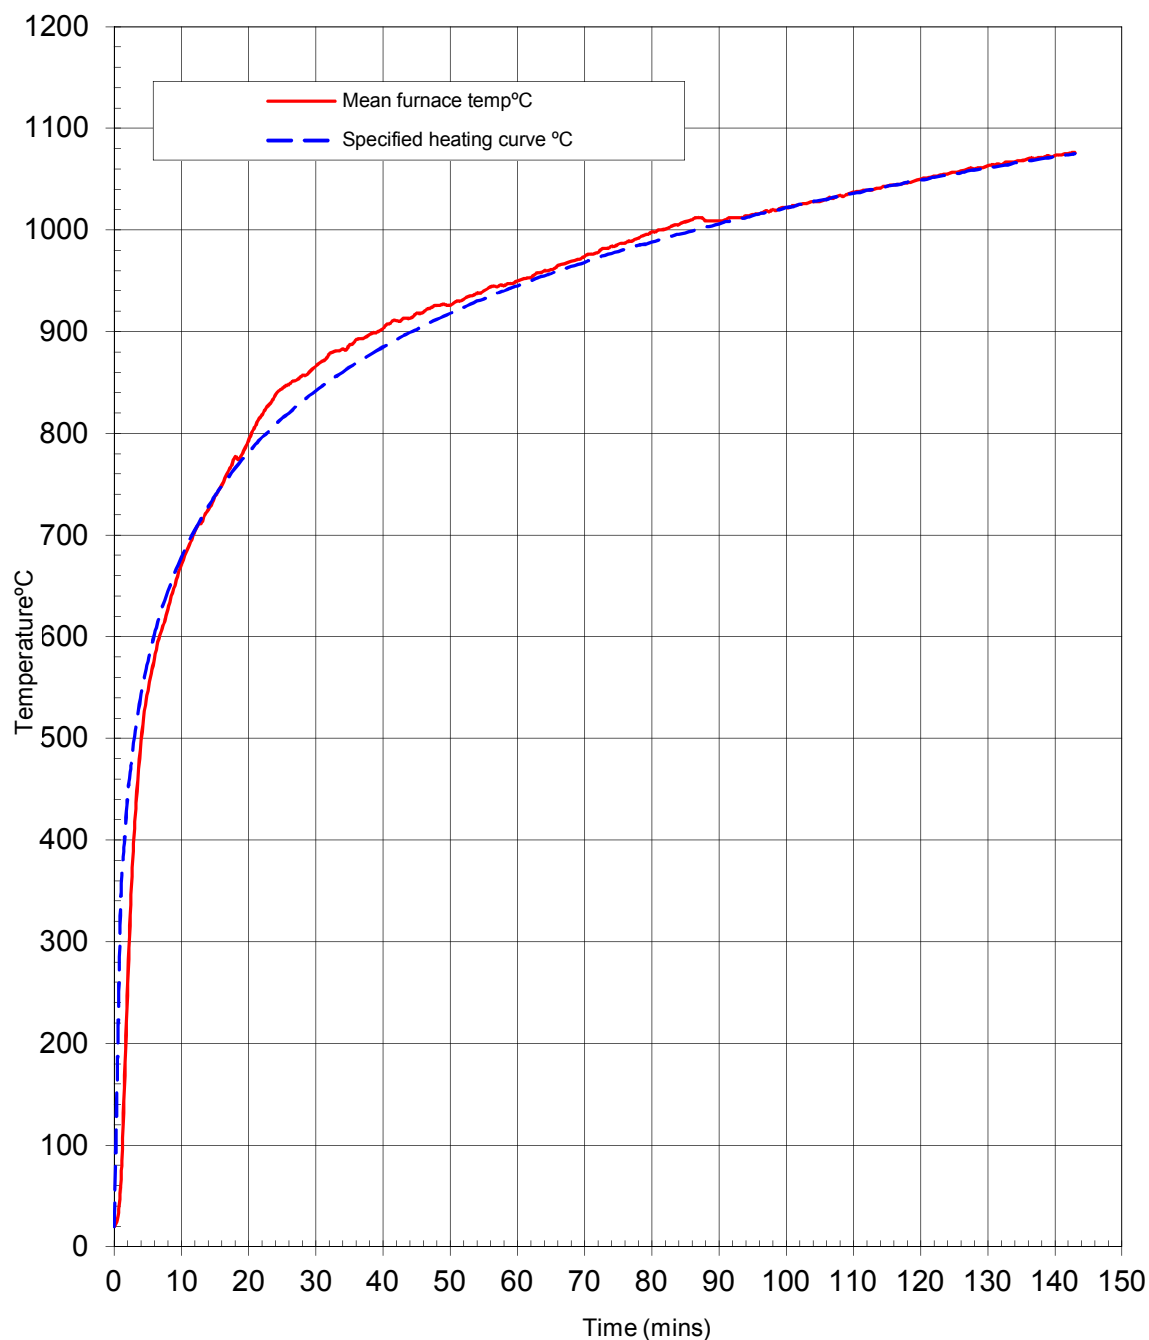
**Graph 1:** Mean Furnace Temperature with the specified furnace curve for comparison

The furnace temperature was measured by means of four chromel / alumel plate thermometers, positioned symmetrically in the furnace with their measuring junctions nominally 100mm below the soffit of the concrete floor. The furnace was controlled so that the mean temperature followed the time/temperature heating curve specified in EN 1363-1: 2012<sup>1</sup>.

The actual mean furnace temperature is plotted against time in the Graphs together with the specified curve for comparison.

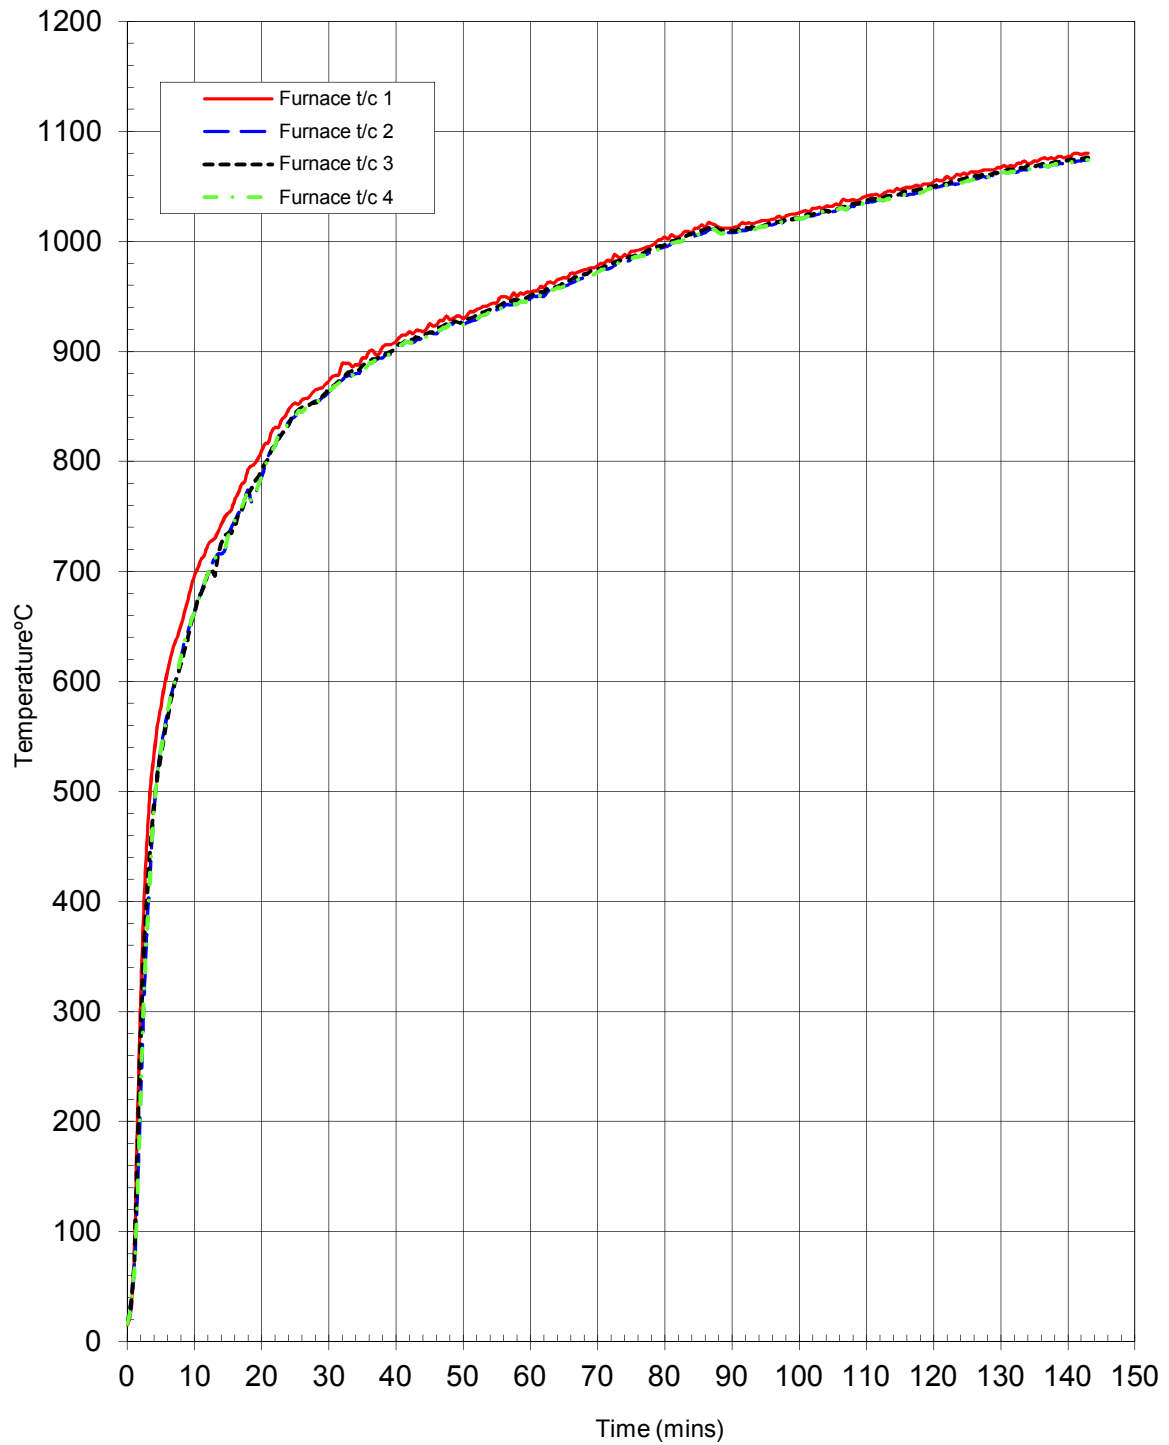
**Graph 2:** Individual furnace thermocouple temperatures.

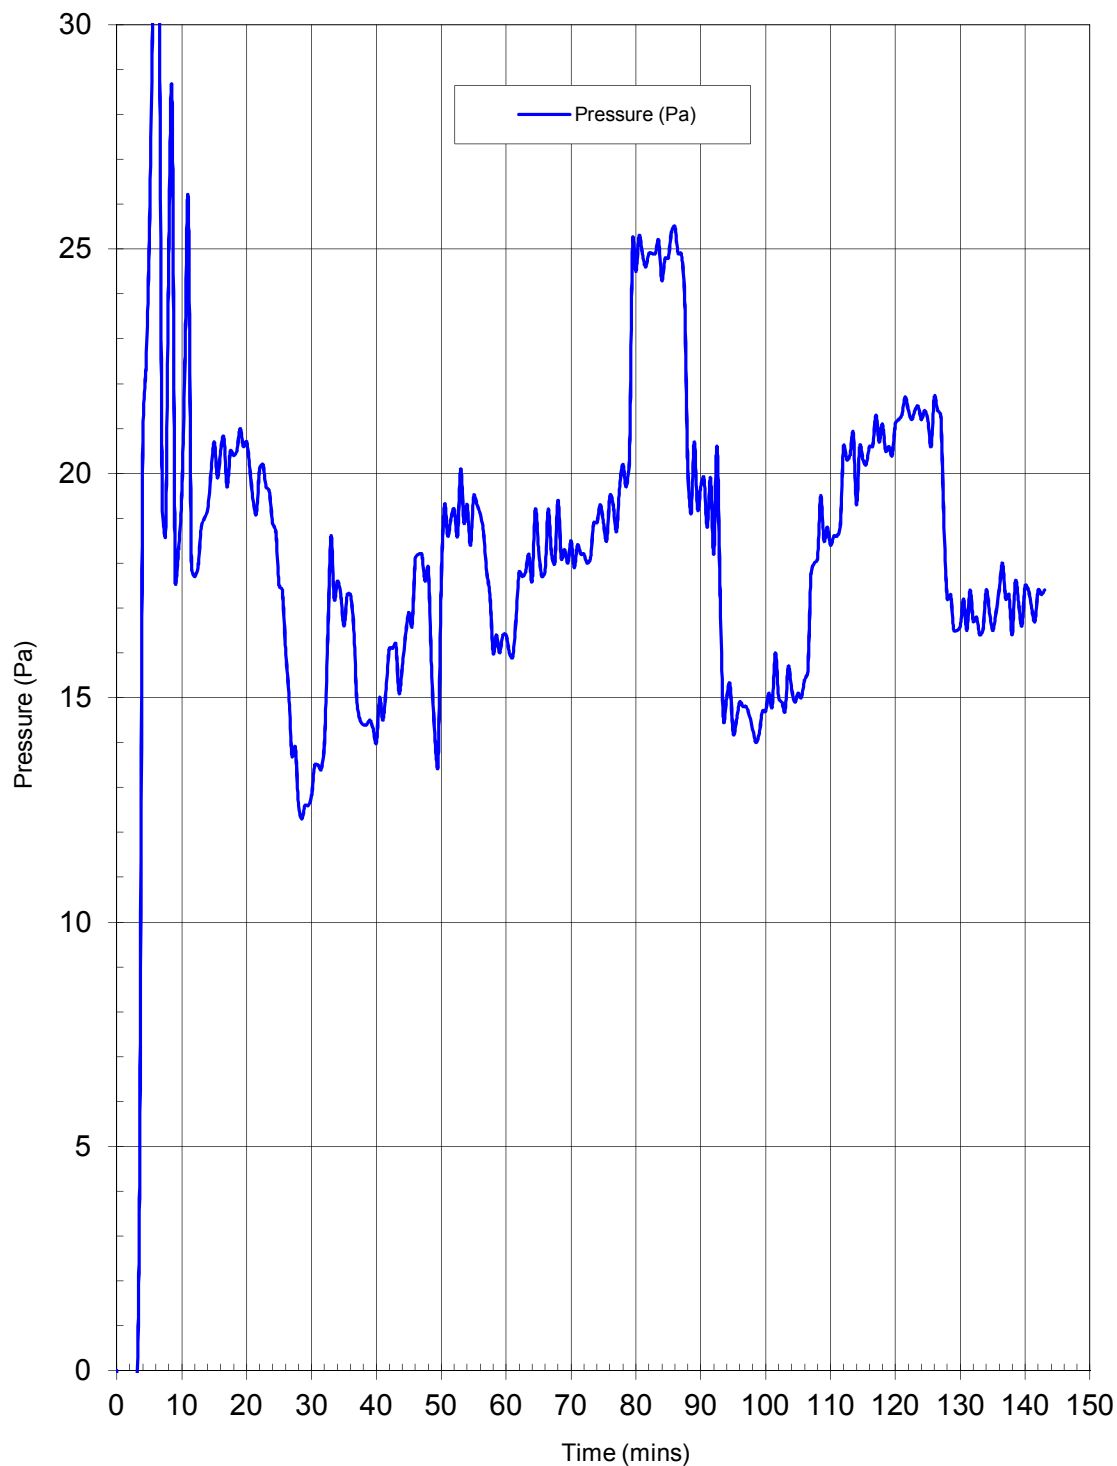
**Graph 3:** Furnace pressure

A pressure sensing head was positioned similarly to the furnace thermocouples. The furnace was controlled to maintain a pressure of 20Pa ± 2Pa above that in the laboratory 100mm below the floor.

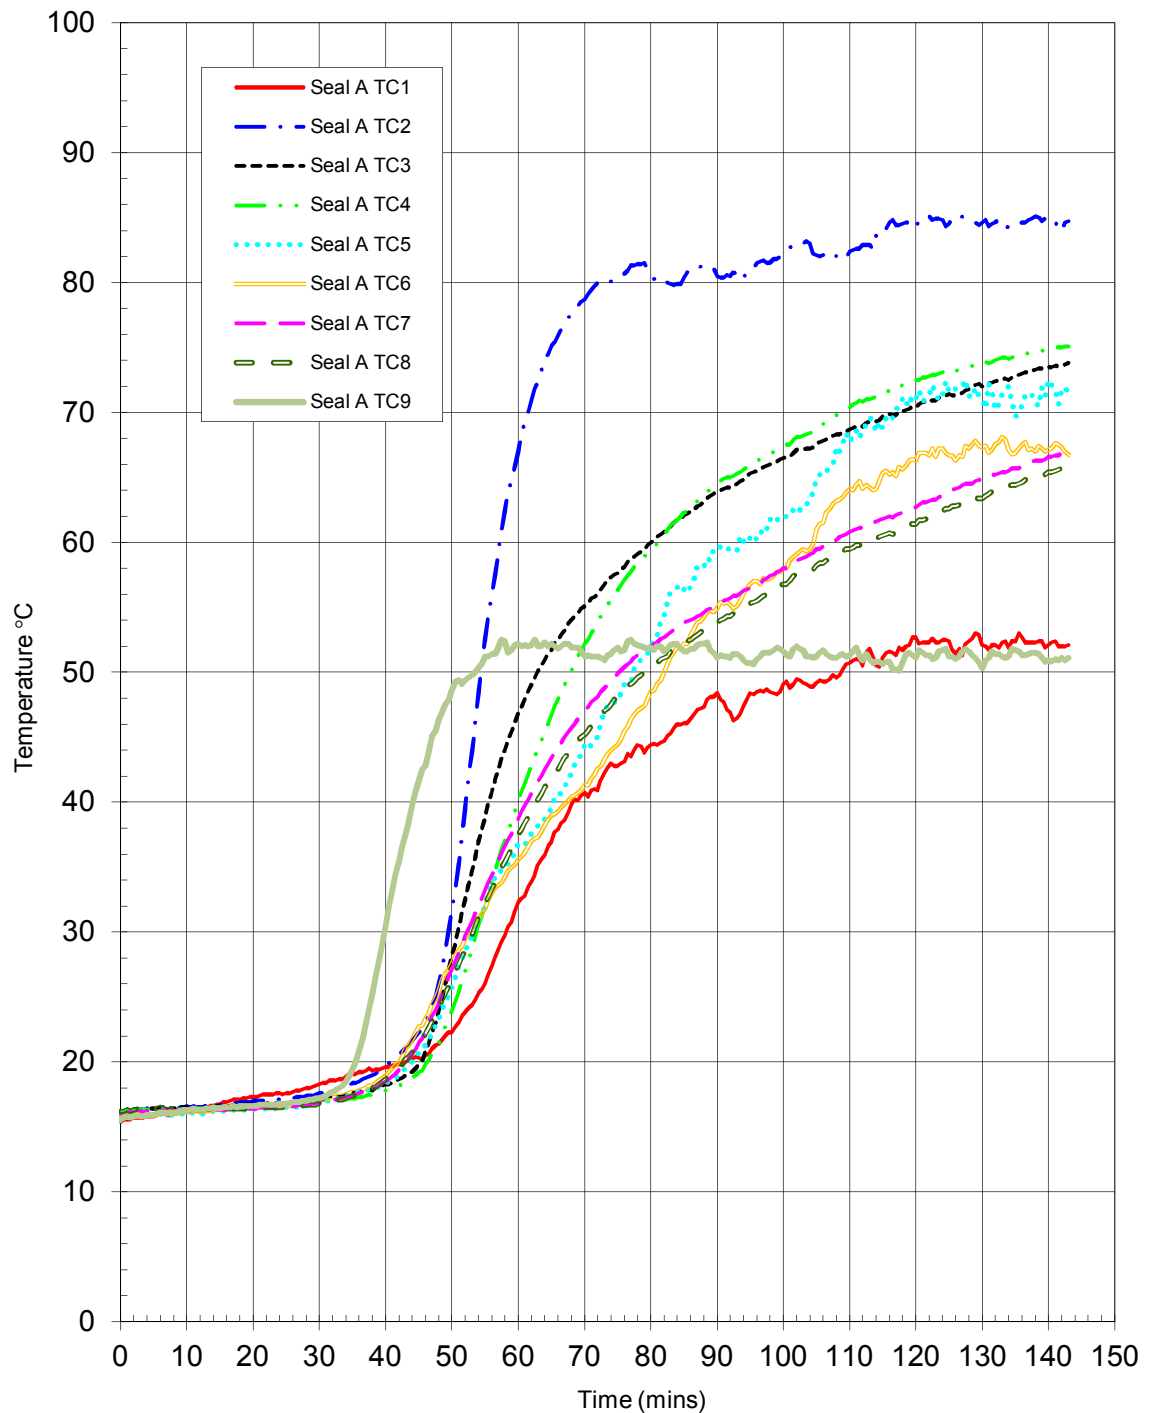
**Graph 4:** Temperature recorded by thermocouples 1 to 9 on Seal A.

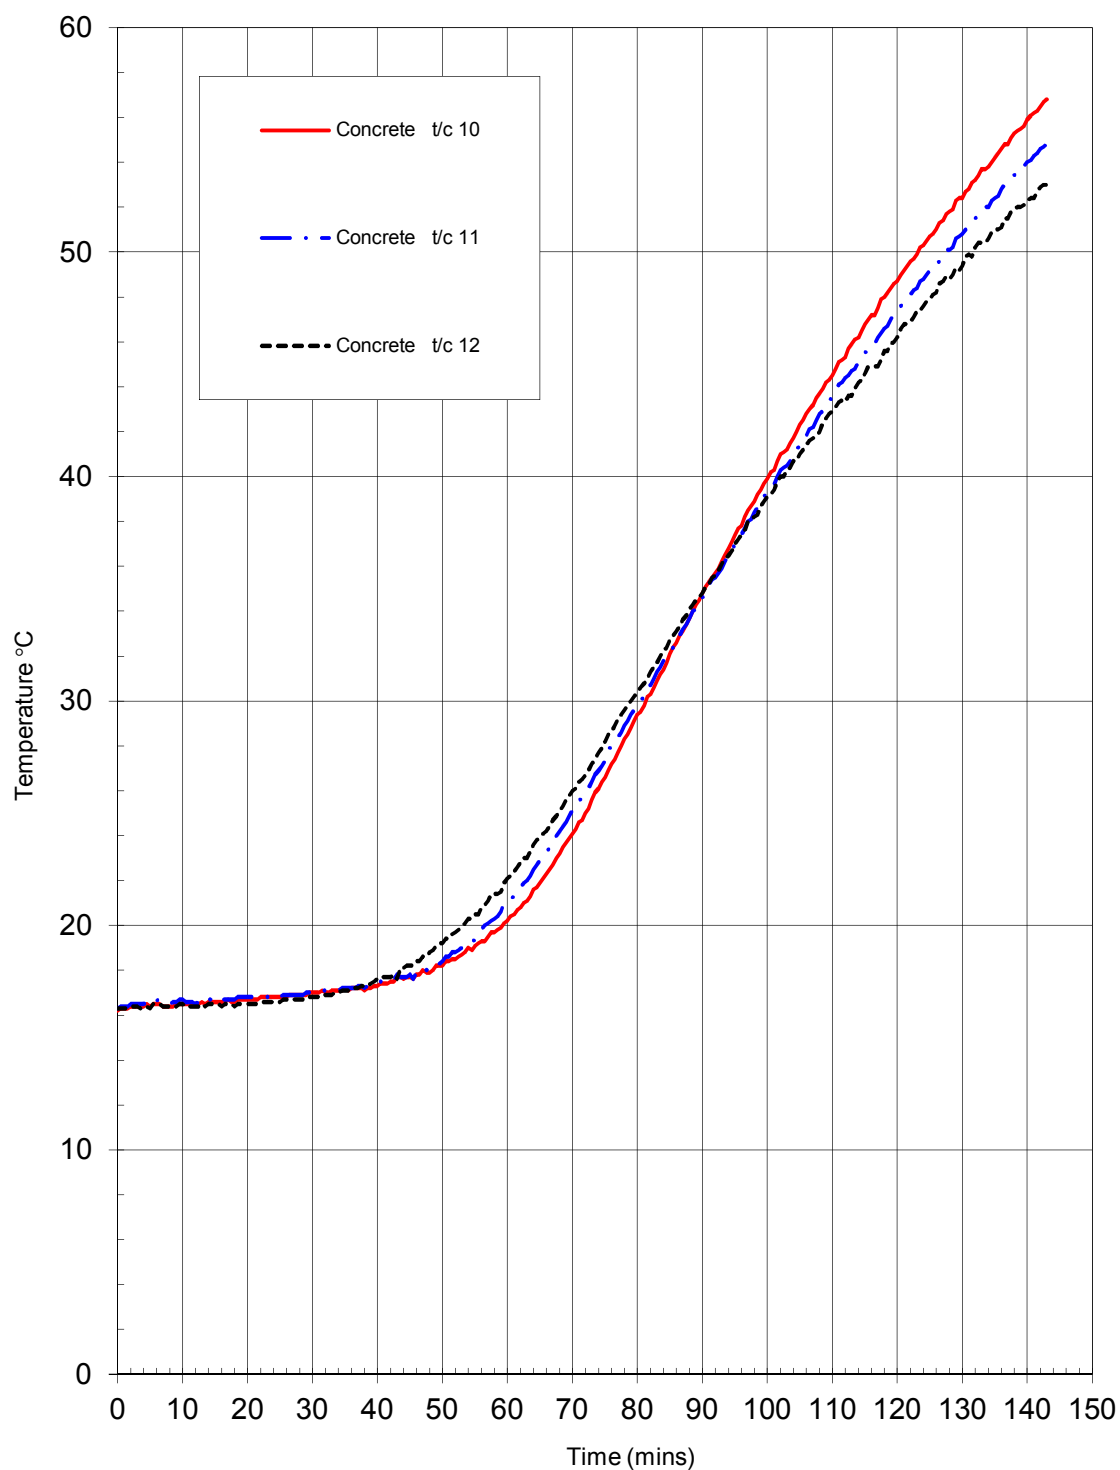
**Graph 5:** Temperature recorded by thermocouples 10 to 12 on the concrete.

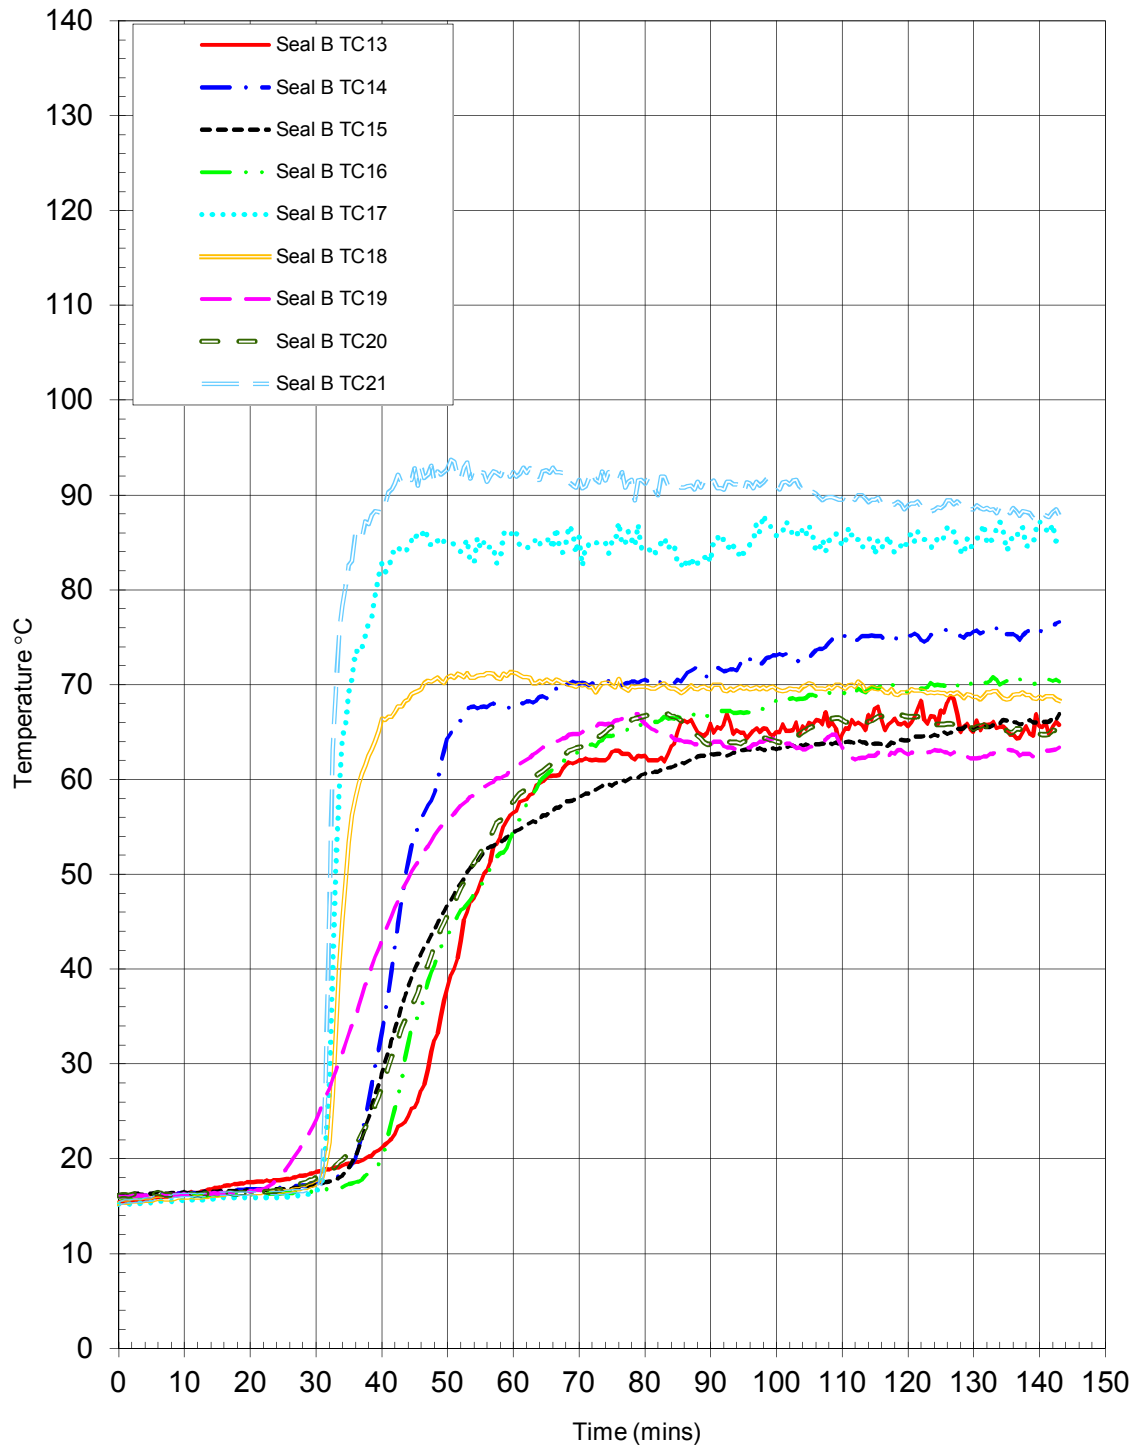
**Graph 6:** Temperature recorded by thermocouples 13 to 21 on Seal B.

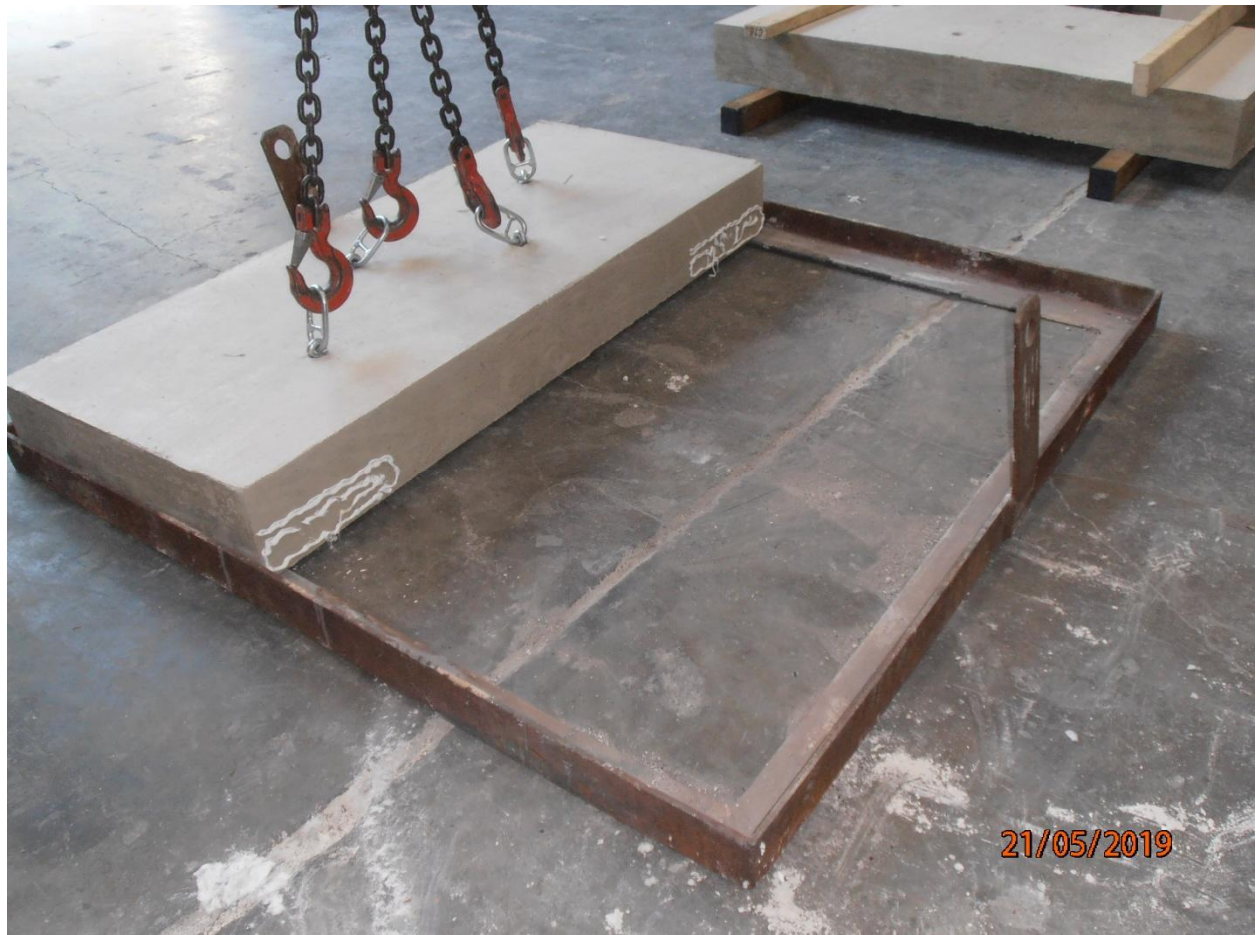
**Photograph 1:** Installation of specimen into test frame.

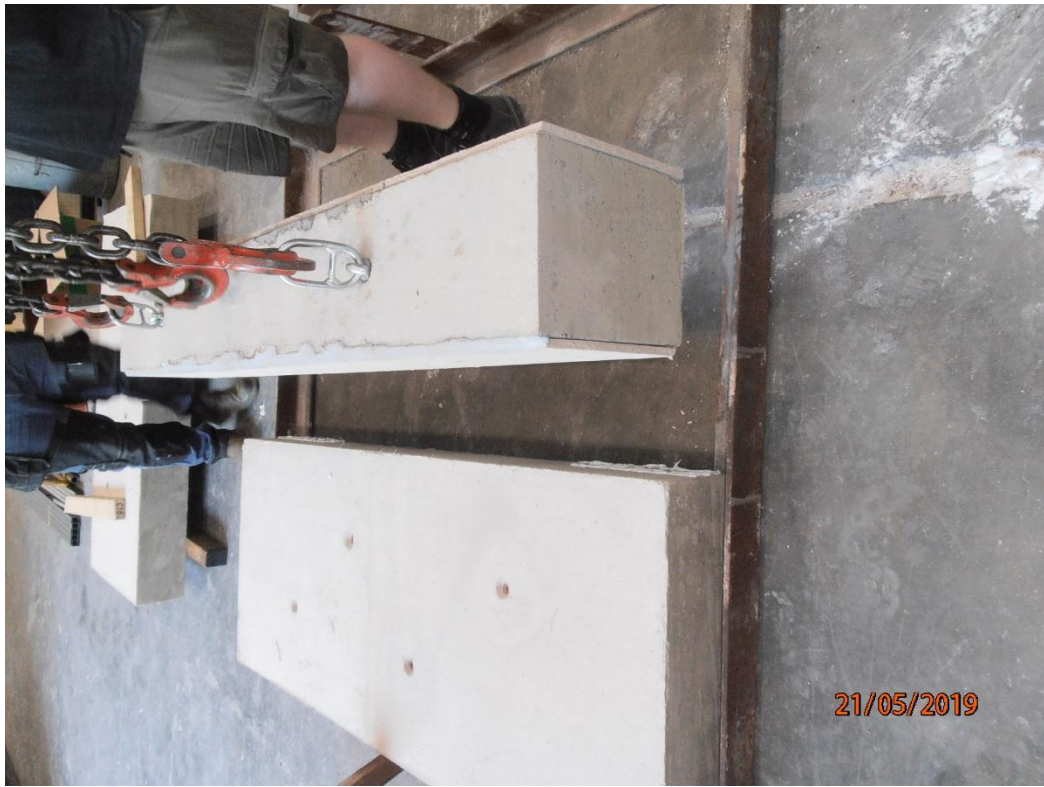
**Photograph 2:** Installation of test specimen into test frame.

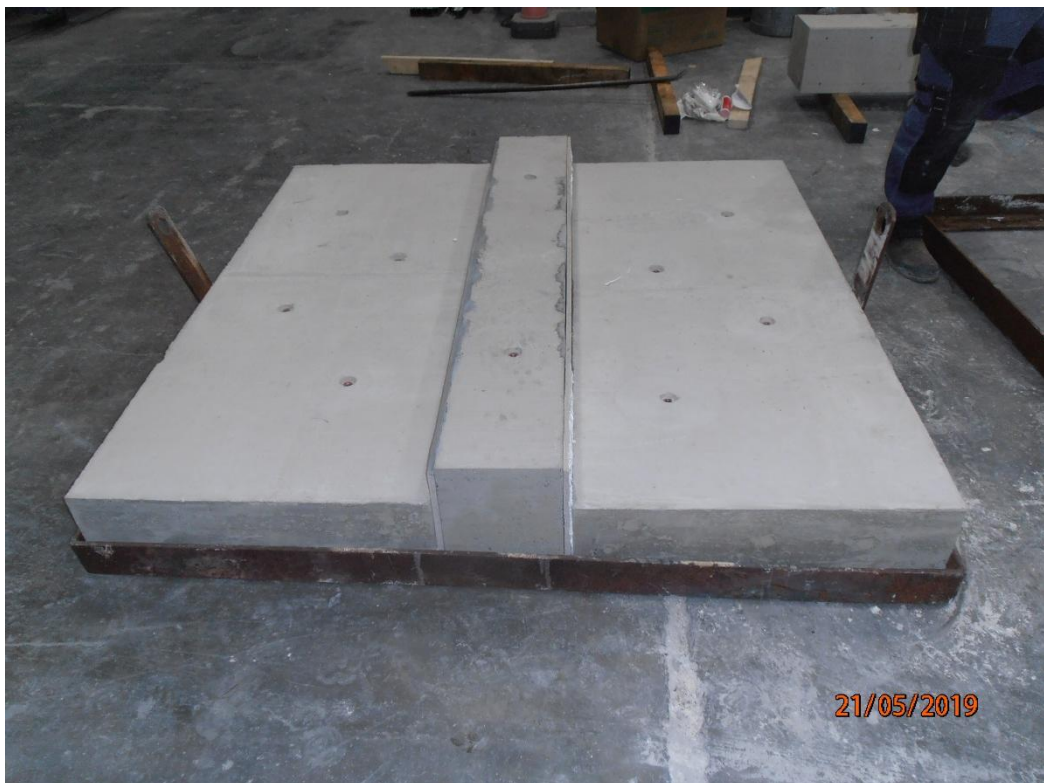
**Photograph 3:** Installation of test specimen into test frame.

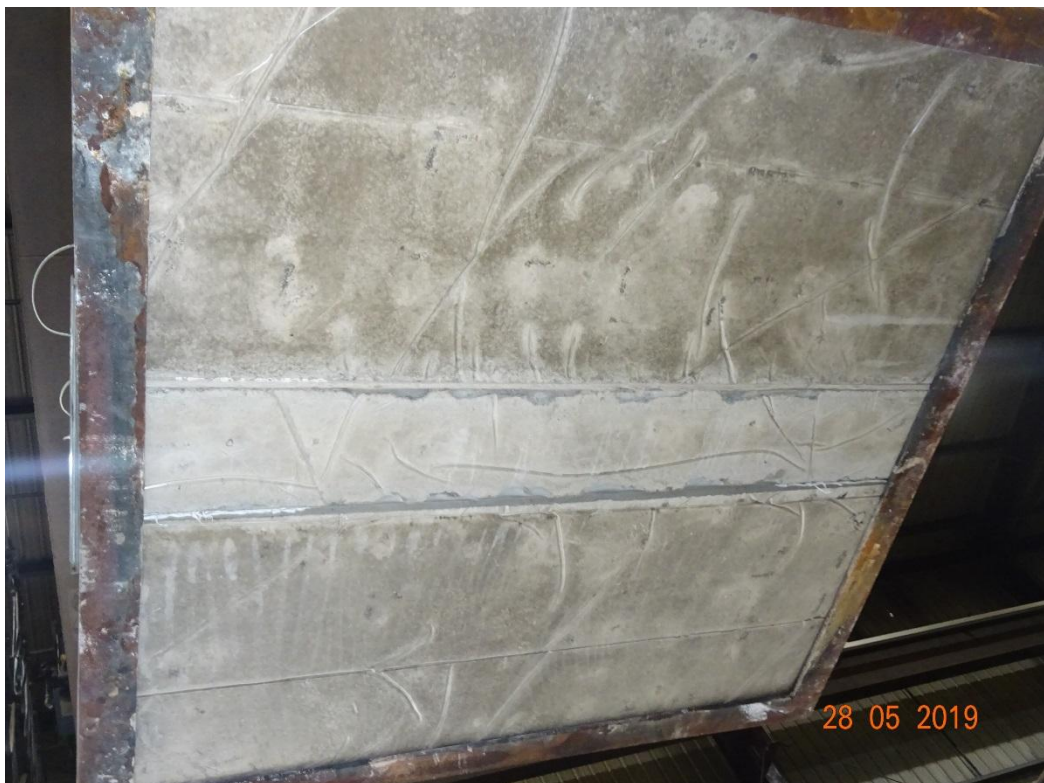
**Photograph 5:** Exposed face (fireside) face before test.

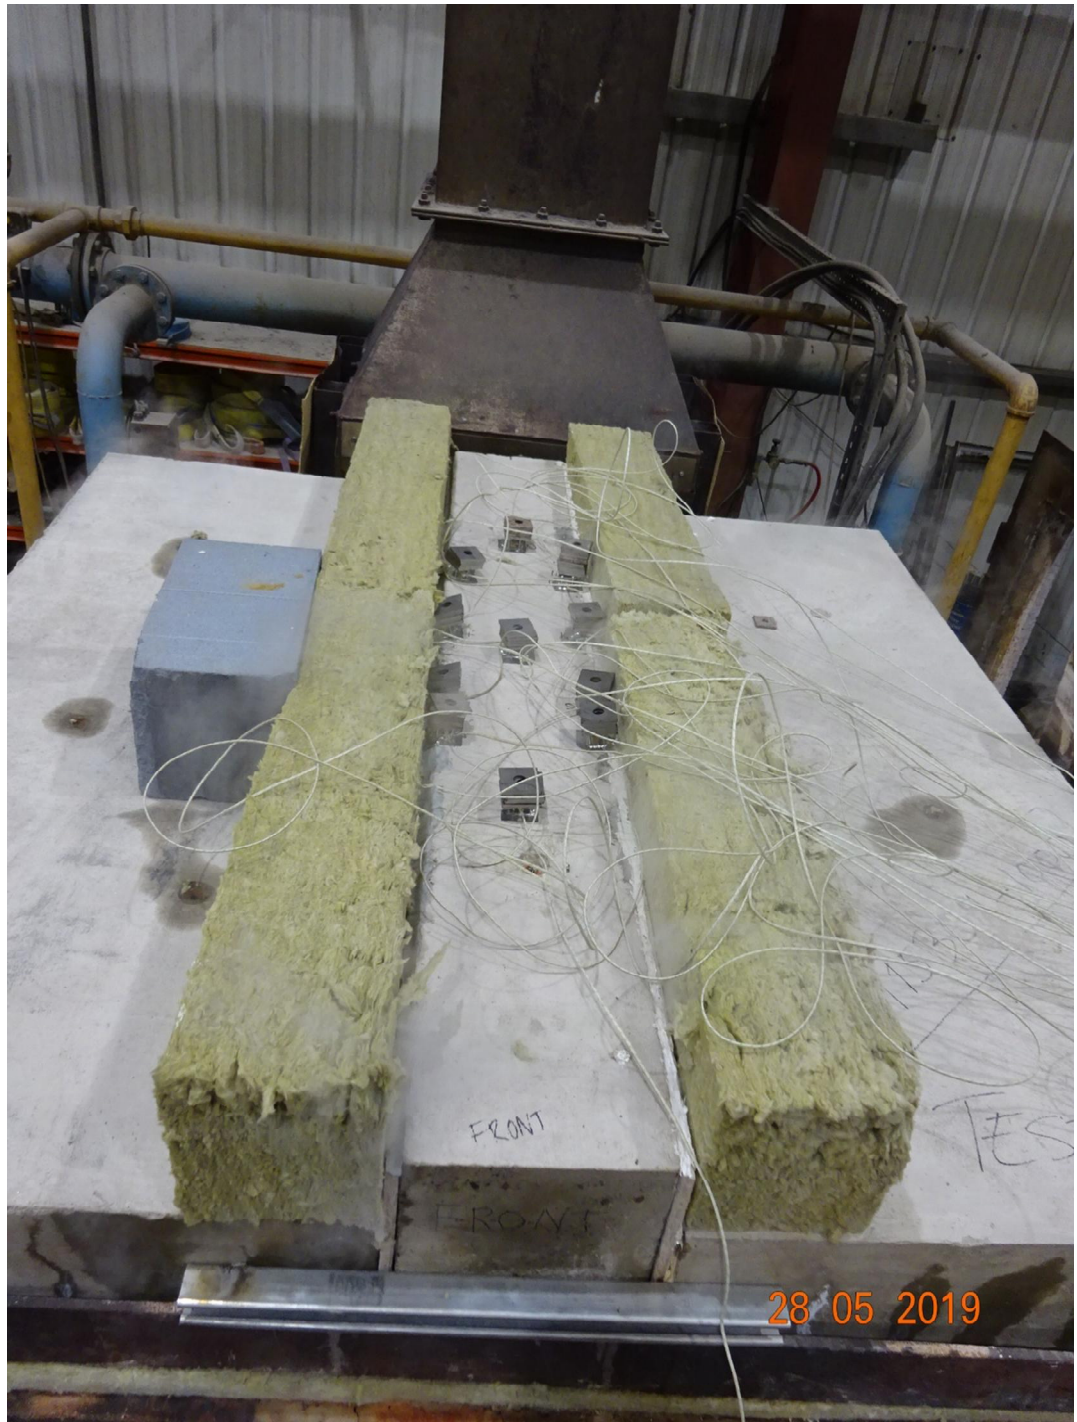
**Photograph 6:** Unexposed face (non-fireside) face after 60minutes from the start of the test.

Time mins:secs	Observation
0:00	Test started.
9:23	Exposed: Concrete spalling, Unexposed: Smoke issuing from beneath Rockwool.
17:13	Exposed: Seal A- intumescent forming, causing uneven texture.
34:45	Exposed: Both seals bubbling texture
53:20	Unexposed: Smoke issuing from top edge of seal B.
88:24	Exposed: Concrete fallen away around seals, no visible change to seals Unexposed: Smoke from seals
118:10	Unexposed: Slight discolouration around seal B Smoking from multiple places.
142:00	Test terminated at sponsors request.

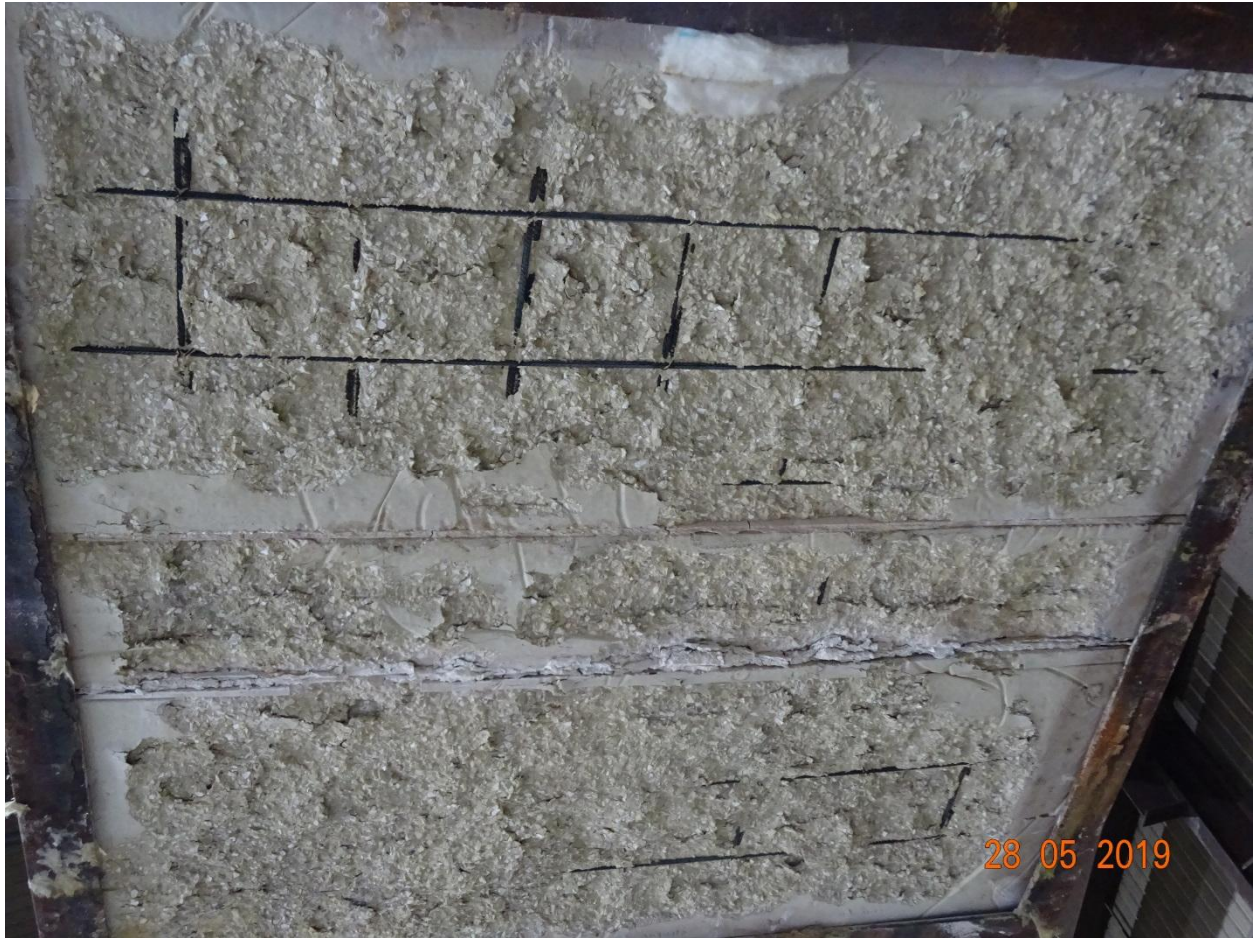
**Photograph 7:** Exposed face (fireside) face after test.

The construction after test is shown in Photographs.
