# THE BRITISH MUSEUM

## THE SOUTH COLONNADE

### TYMPANUM OF THE CENTRAL PEDIMENT

Proposed Scope of Works for essential conservation cleaning

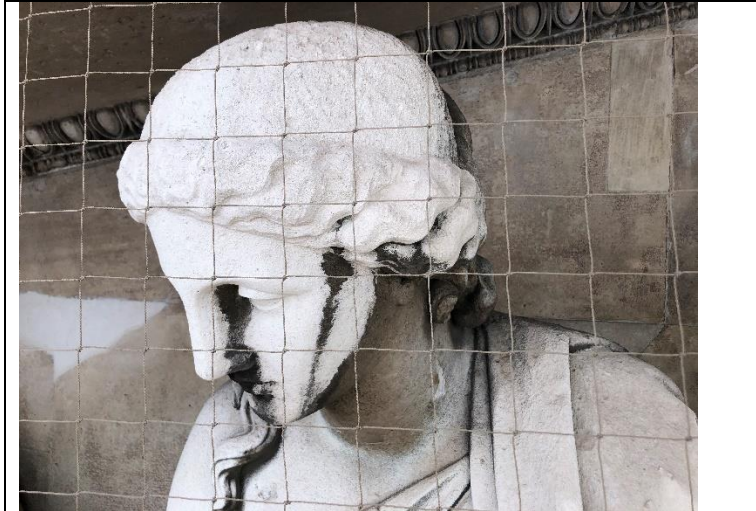
*Figure 5: detail showing gypsum crust formed on statue*

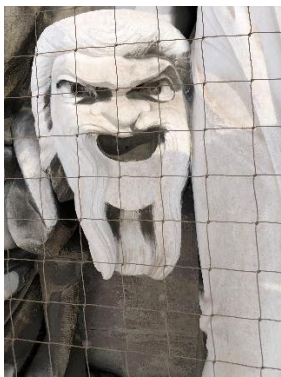
*Figure 6 photos showing gypsum crusts*

The laser cleaning of gypsum crusts

- **Use of small hand held conservation laser to clean under infrared light which will enable the crusts to lose cohesion and then fall away or can be removed by a brush**

Carbon encrustation can cause significant damage to stone. The removal is desirable both in terms of aesthetics but also by not removing the crusts the stone will be further damaged over time.
