PM<sub>10</sub> Monitoring Report (September 2020)

Highgate Newtown Community Centre

Project no.	Project	
9556.S	Highgate Newtown Community Centre

Report No.	Written By:	Checked by:	Authorised by:	Date
9556 PM10 Report (September 2020)	J. Mills	R. Boakes	N. Jenkins	13/10/2020

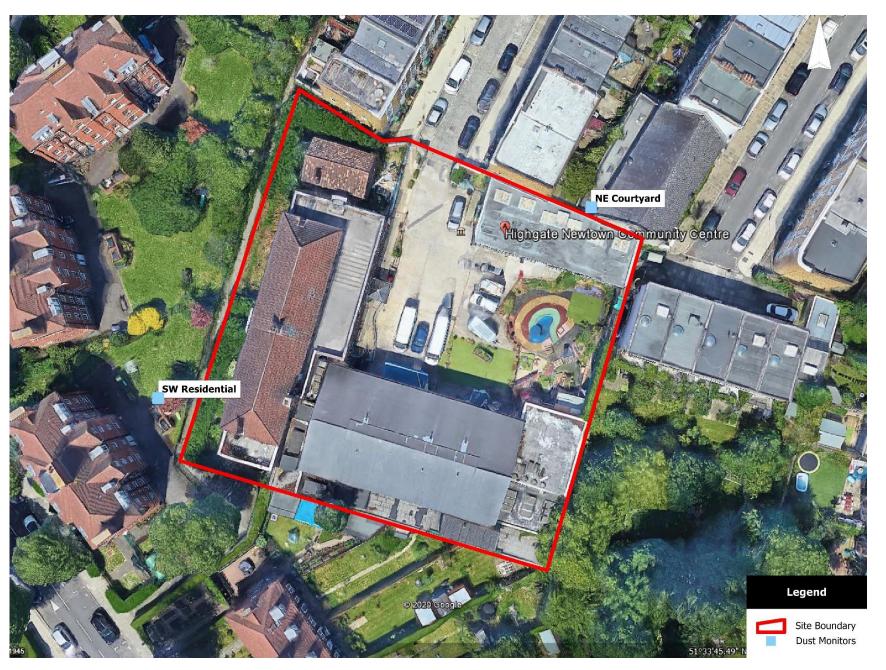
Figure 1: Map of monitoring locations

1.9 An updated map of the dust monitoring locations is provided in Figure 1, with new photographs of the units installed on site provided in Figures 2 and 3.

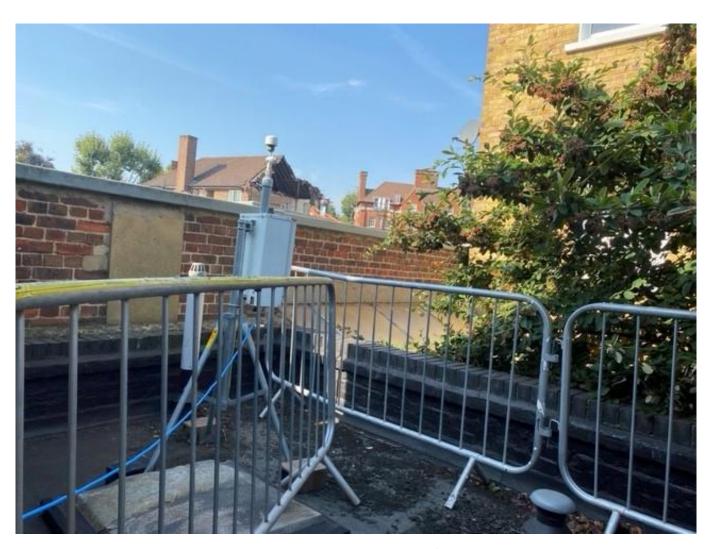
Figure 3: Monitor 2 – NE Courtyard

<sup>\*</sup> On the 25<sup>th</sup> August, Monitor 2 was relocated and allocated a different power source, as the wall the unit fixed to was to be demolished.

Note: This monitor was moved on 25<sup>th</sup> August 2020.

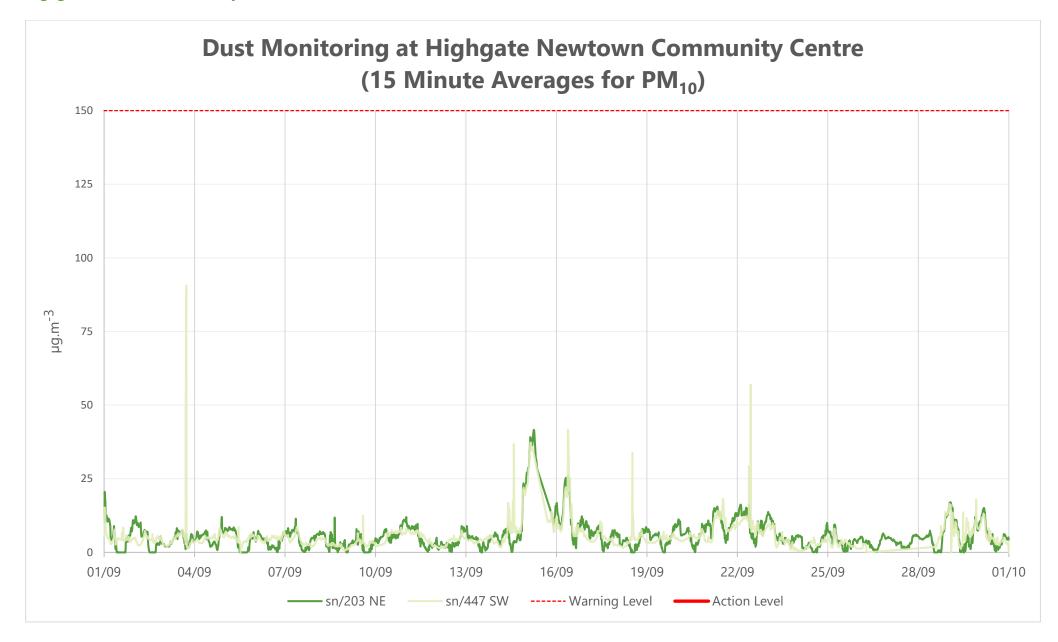
Graph 1: 15-minute mean time-series

- 2.4 Graph 1 provides the 15-minute average  $PM_{10}$  time-series for the monitoring period. It shows that there were no exceedances of the 15-minute 'Warning' level or the 15-minute 'Action' trigger level at either Monitor 1 or Monitor 2. Overall, there is good agreement in the trend lines for both monitors which suggest that there are few significant localised dust sources in close proximity to either monitor.
- 2.5 Graph 2 provides the 1-hour average PM<sub>10</sub> time-series for the monitoring period. It shows that there are no exceedances of the 'Action' trigger level and there is good agreement in the trend line for both monitors. A brief localised dust source was present at Monitor 1 between 16:16 and 17:16 on September 3<sup>rd</sup>.

- 2.6 There were no exceedances of the 15-minute 'Warning' level at Monitor 1 and also no exceedances of the 15-minute  $PM_{10}$  'Action' trigger levels at either monitor during the monitoring period.
- 2.7 Overall, there is good agreement in the trend line for both monitors and there were no exceedances of the 1-hour mean 'Action' trigger level during the monitoring period.
- 2.8 During this monitoring period, demolition works commenced on site. As such, the results presented for September 2020 relate to the first construction phase monitoring period.

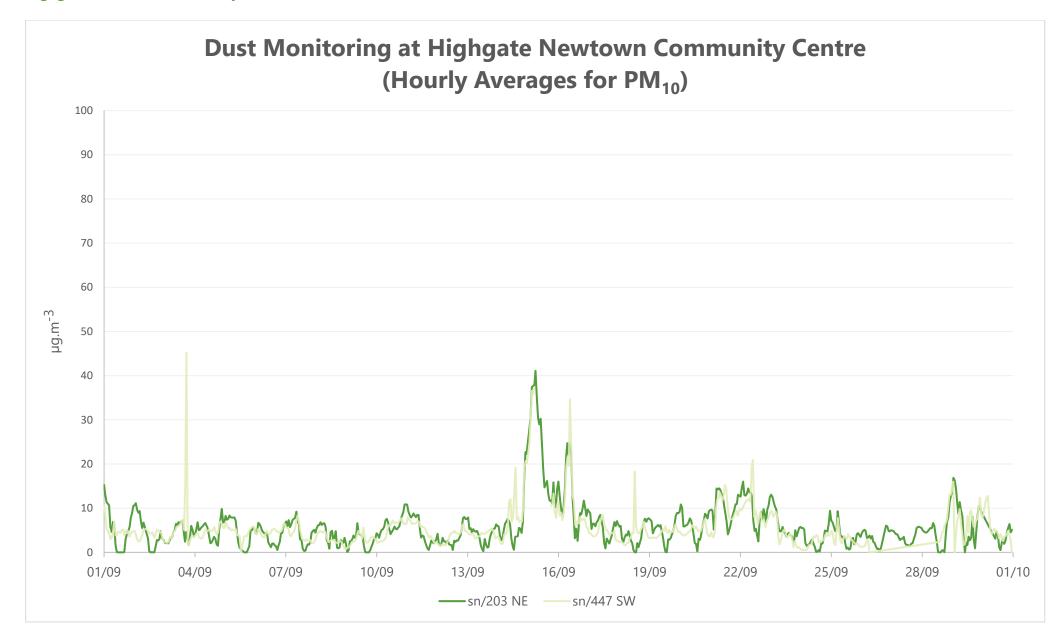
Graph 2: 1-hour mean time-series

1-Hour mean Trigger Level Exceedances	0	0	There were no exceedances of the 1-Hour mean trigger level at either monitor during
Exceedances			September 2020.
