GEOSHIELD Verification Report

GEOSHIELD

Godfrey Ltd - Kilburn High Road

254 Kilburn High Road

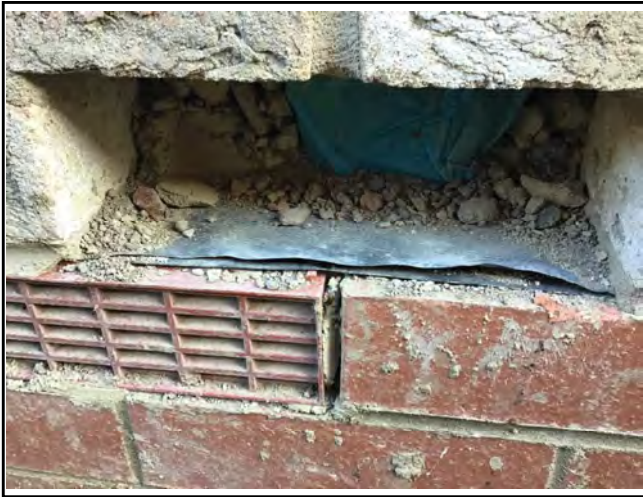
Good number of vents installed to score 1.5 points under BS8485:2019.

1. Telescopic vents installed beneath DPC Level.

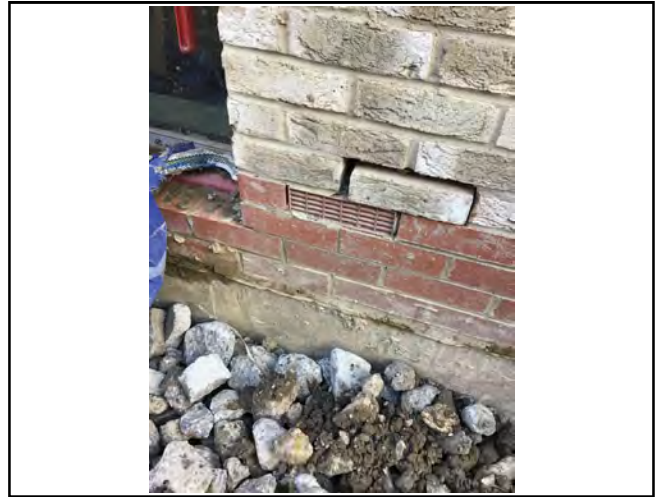
2. Telescopic vents installed beneath DPC Level.

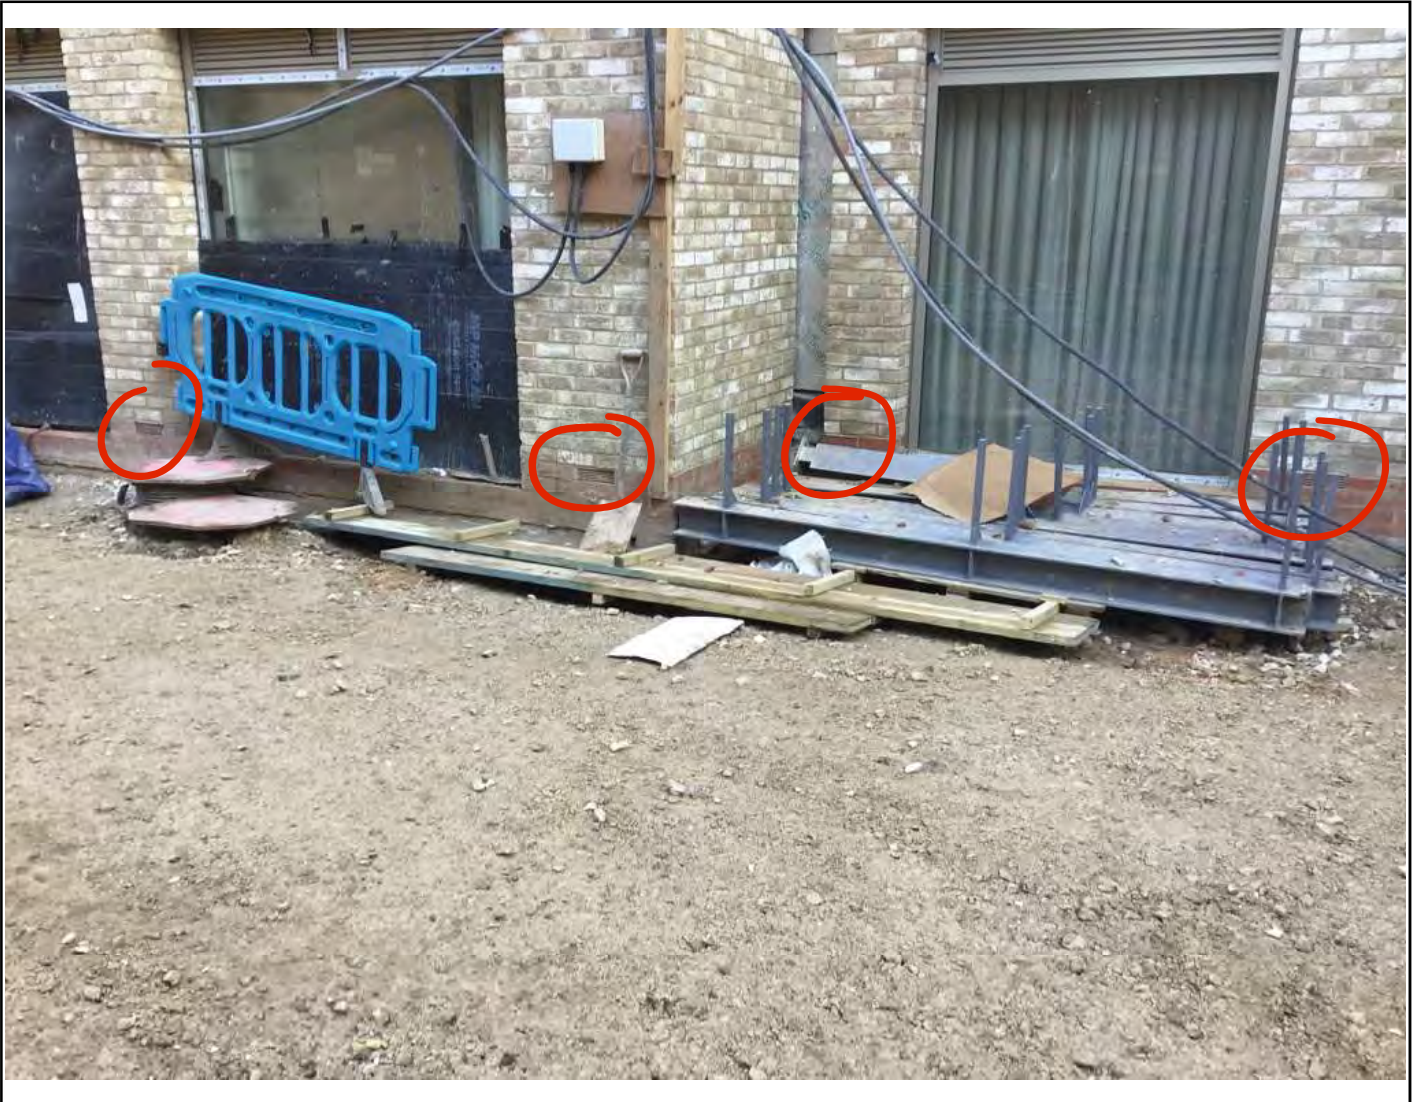
3. Good number of telescopic vents installed around entire perimeter.

Vents circled above. Spacings given allow for point score of 1.5 under BS8485:2019.

Contractor confirmed suspended raft foundation has been poured with waterproofed concrete. This gives a point score of 2 points for structural Barrier under BS8485:2019

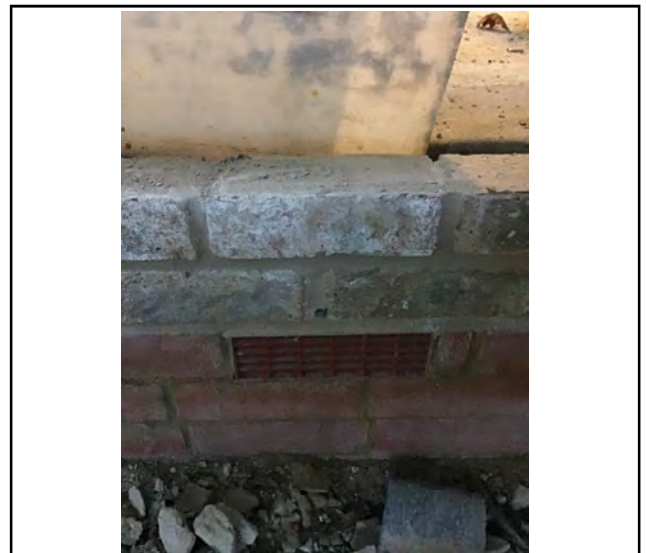
NOTES: Entire perimeter of the building checked to ensure

high number of telescopic vents installed throughout. Vents installed in between

all window and door thresholds and the rear of the property spacings at an average

of 1.5M.

1. Photo evidence of vents

2. Photo evidence of vents

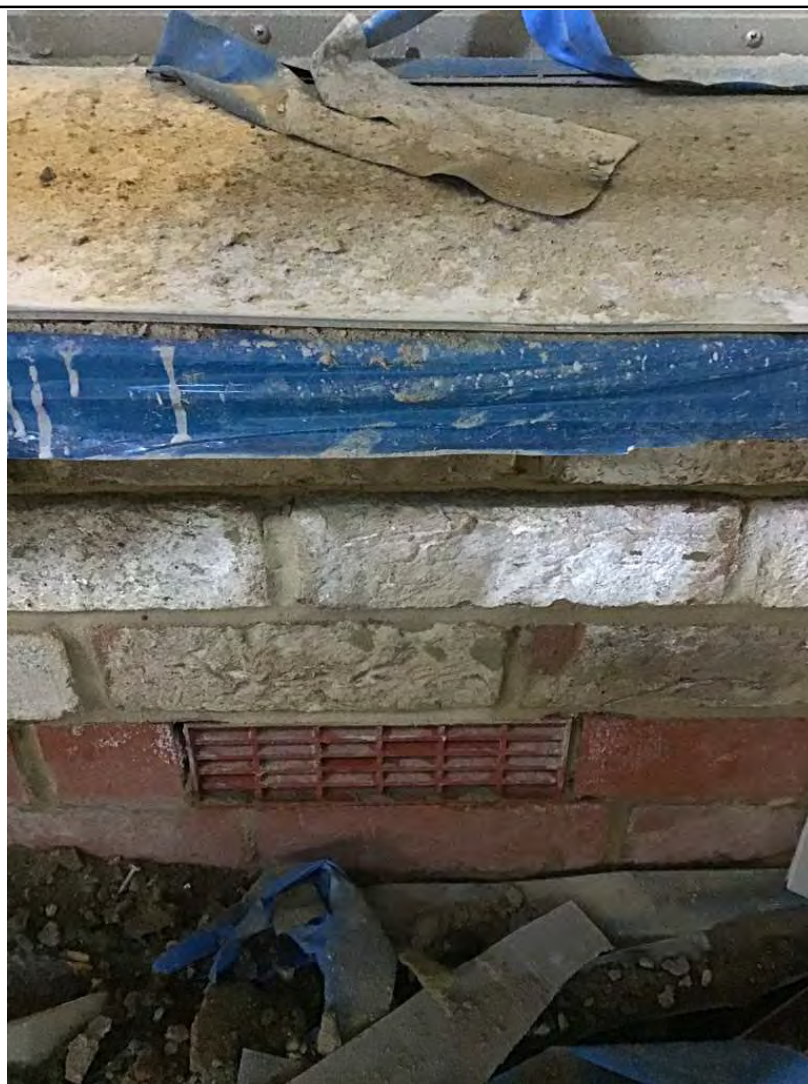
3. Photo evidence of vents

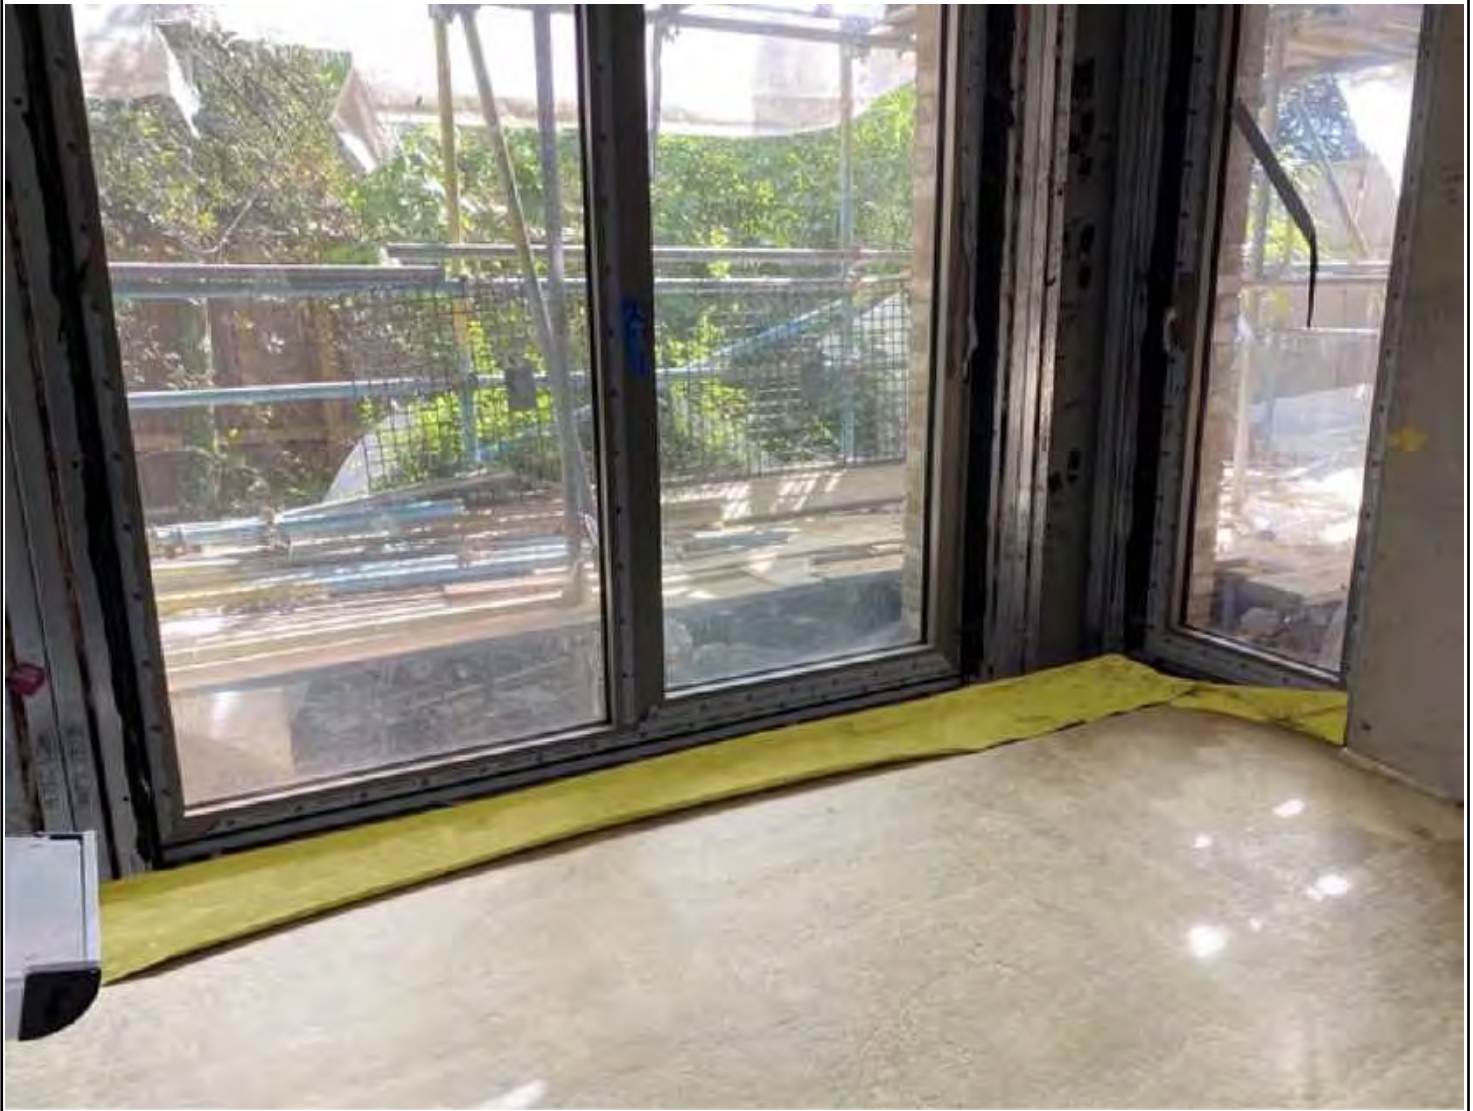
Above photo) this photo is an overview of an area where screed has been poured on top of the damp proof course, the dpc can be seen in the photo.

Sufficient evidence has been supplied to confirm a the Visqueen Low Permeability

Membrane has been installed as the required DPM.

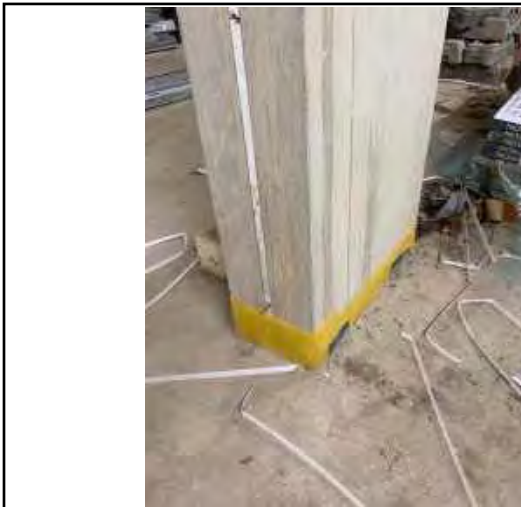
NOTES: Damp proof course has been applied to a large area

and a concrete screed has been poured on top. In the photos below the yellow damp proof course can be identified.

Left photo) this shows a concrete column with yellow visqueen damp proof course lapped up against it, coming out above the screed pour.

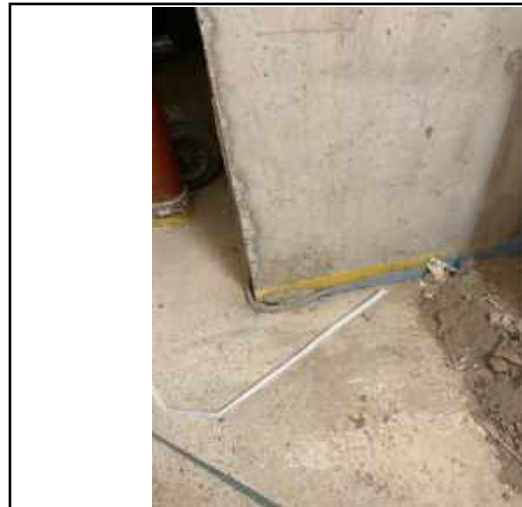
Right photo) this shows a corner detail of a concrete column, the damp proof course has again been lapped up the column and above the screed pour.

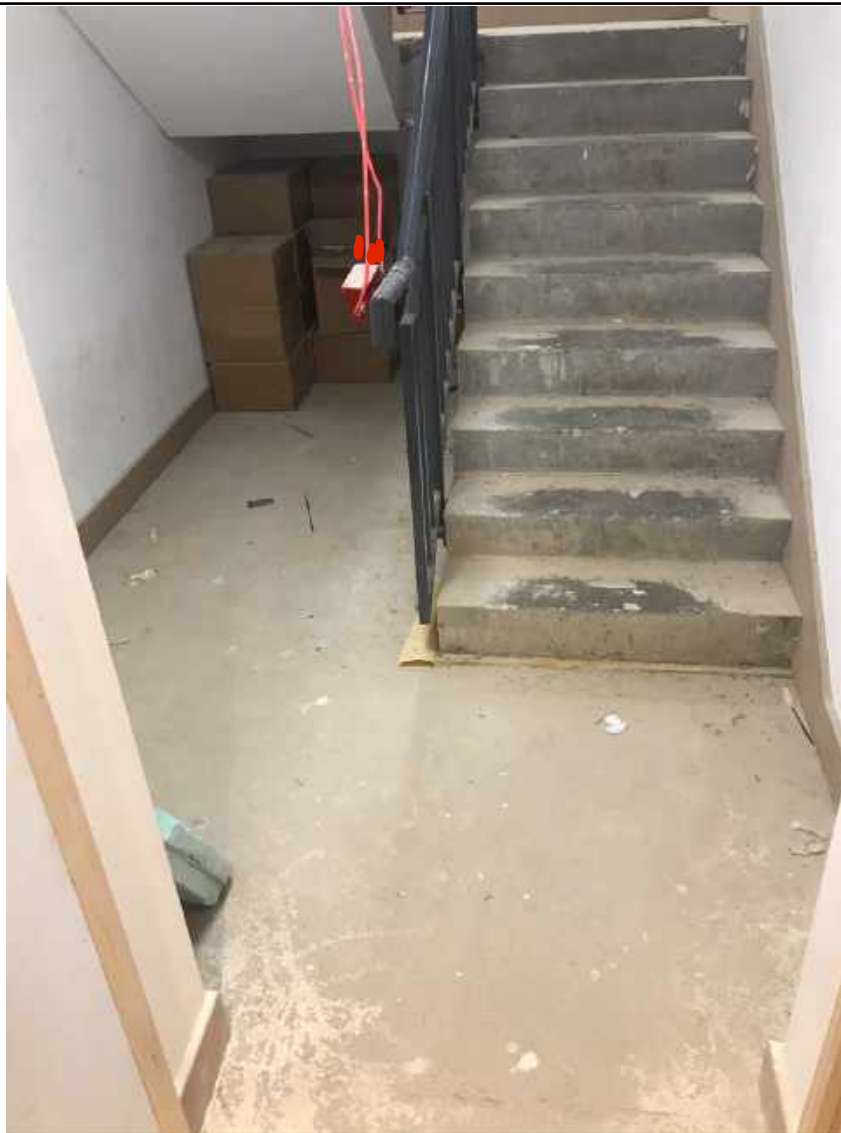
Above photo) the area highlighted above is a stair well that has had a concrete screed pour on top of the damp proof course. The dpc can be seen at the bottom off the stairs.
