Additional demolition - Level 7 slab

Job	65 KINGSWAY	Date	29/07/2020
Title	Revised Planning	Eng.	SO
Job No.	2028	Sheet	0

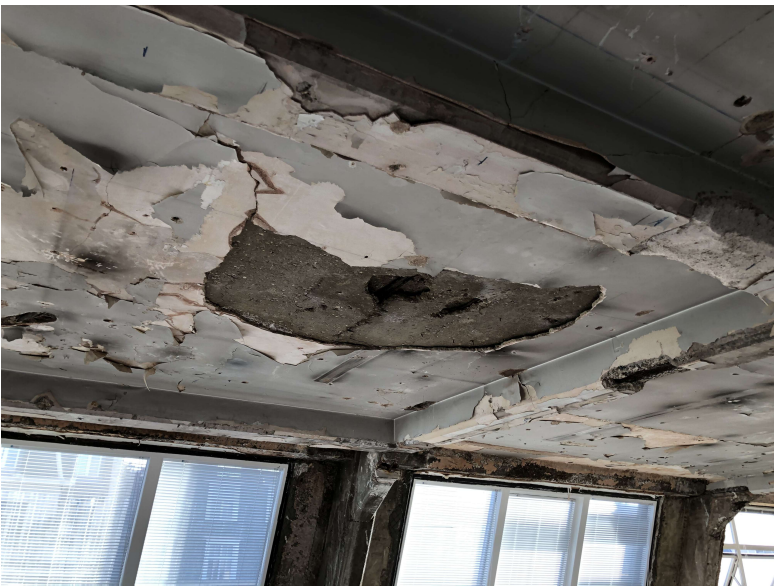
Site photo of condition following soft strip. All loose concrete was removed due to health and safety and to inspect the condition of the remaining slab

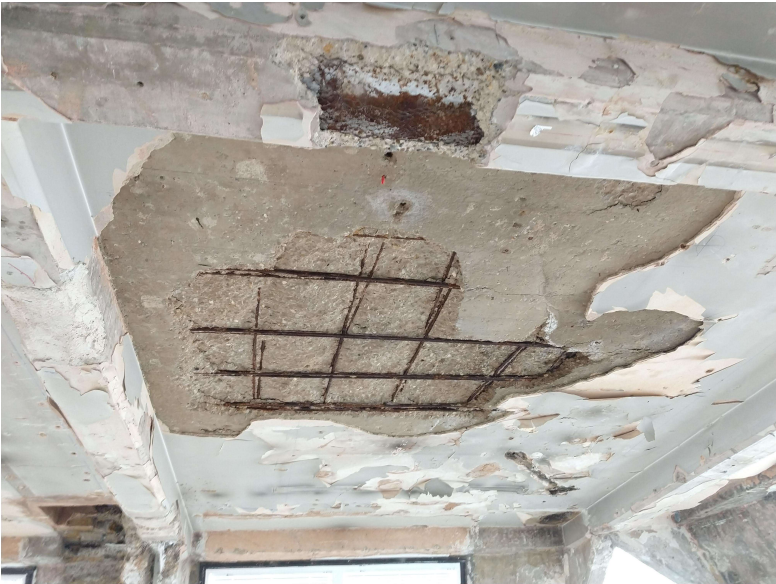
Site photo of slab soffit following loose concrete removal.

Many bars have suffered significant corrosion due to suspected water ingress.

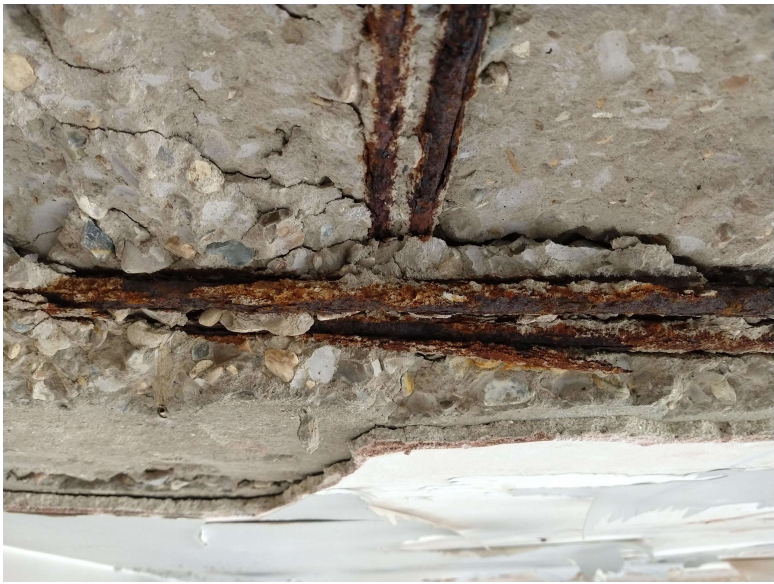
Site photo of corrosion to existing steel bars
