DESIGN & HERITAGE STATEMENT

Job Reference:	20 Downshire Hill, NW3	Date:	5 February 2021
Subject:	Replacement of Portico	Ref	P1
Issue:	Listed Building Application	Our reference:	20DOW-A4-ST-DHS210205

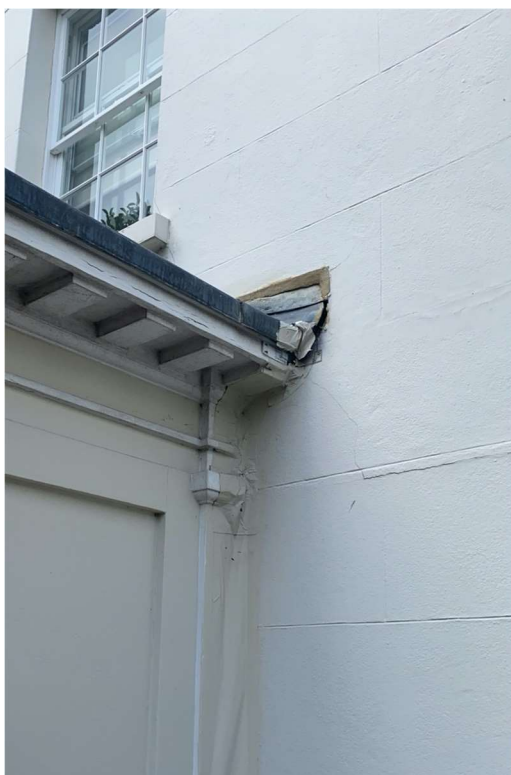
Widening gap covered with flashing tape

- 7.1 The fundamental problem is that continuous movement is caused either by ground conditions or the influence of the Magnolia tree, or a combination of both. Furthermore the portico does not appear to be tied to the main façade allowing it to move and tilt away from the house.

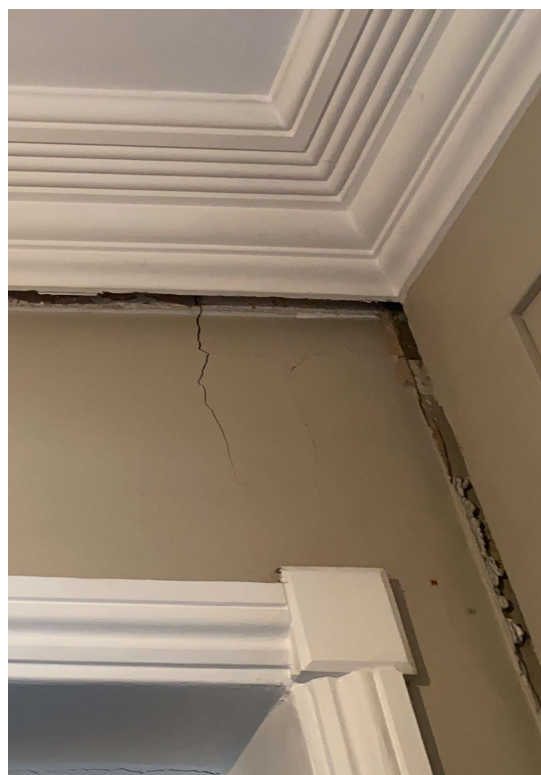
Internal cracking between portico and house

- 7.2 Ongoing remedial works are only able to provide temporary solutions. Not only are they unsightly, they also, crucially, do not address the actual issue. The problem has now advanced to a stage where, besides discomfort and significant heat loss, it is beginning to adversely affect the building fabric.
