**Cleaning Tests and Removal of black accretions using a laser  
Week commencing 22<sup>nd</sup> February 2021  
On the Tympanum of the British Museum , London**

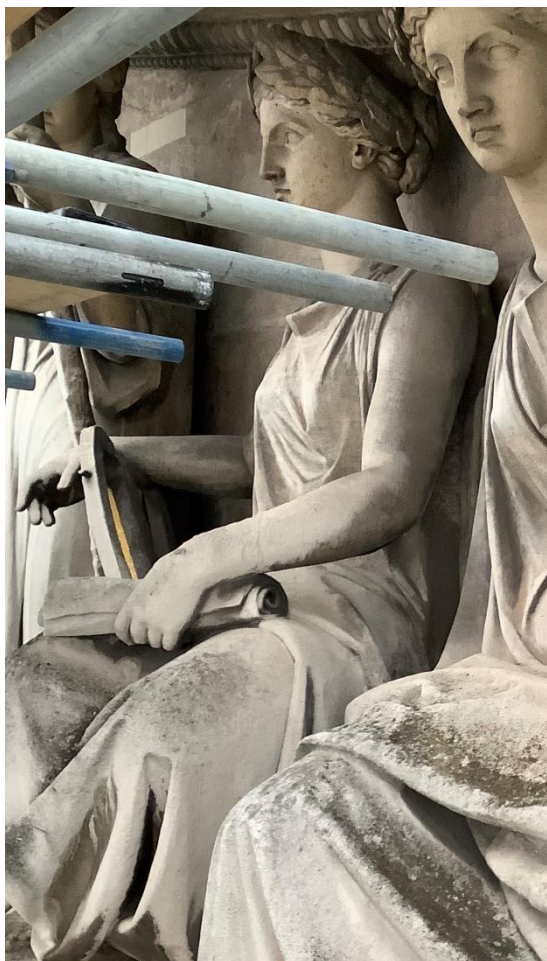
Image 1: Overall figure before tests, which also shows her proper left arm before cleaning off lighter black accretions with the laser

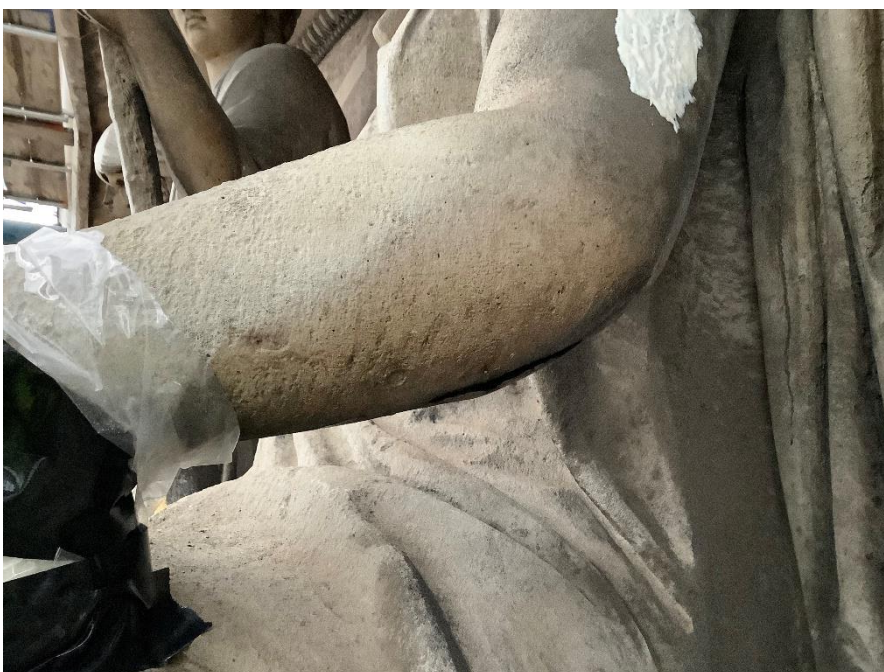
Image 2: Close up of arm after successful cleaning with laser, note the discolouration is due to iron oxide from the stone, this is not unsightly but could be reduced by ammonium carbonate poulticing if required

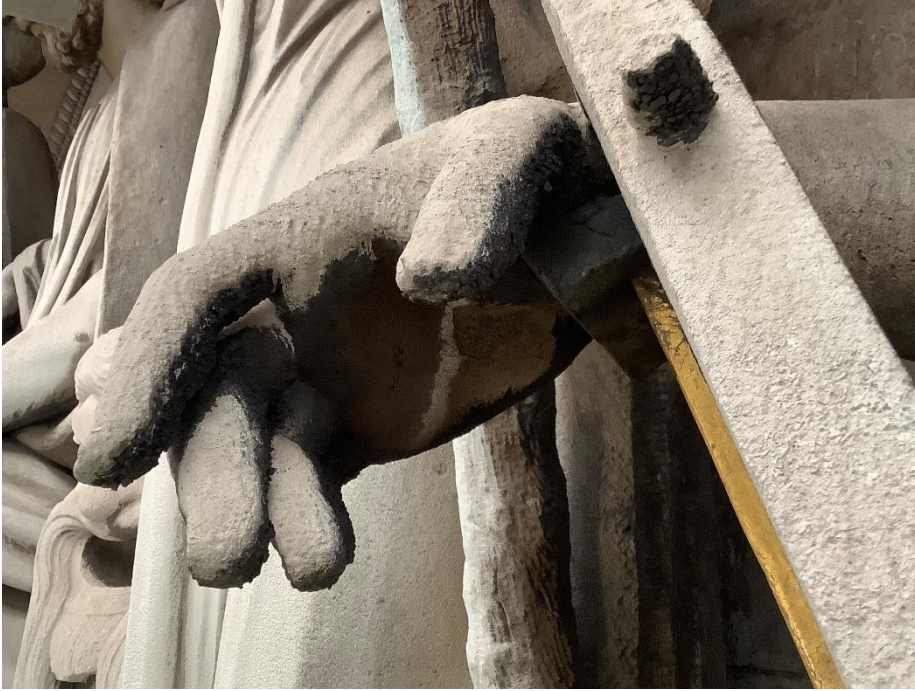
Image 3: Hand before laser cleaning

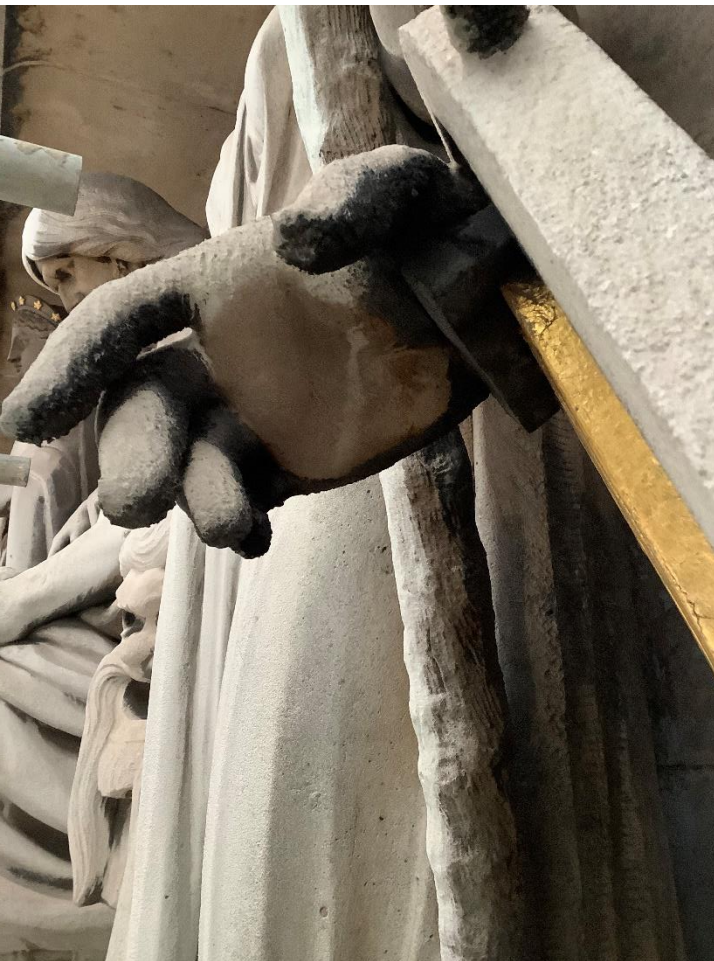
Image 4: Hand after partial laser cleaning showing removal of black gypsum crusts and no damage to underlying stone
