---

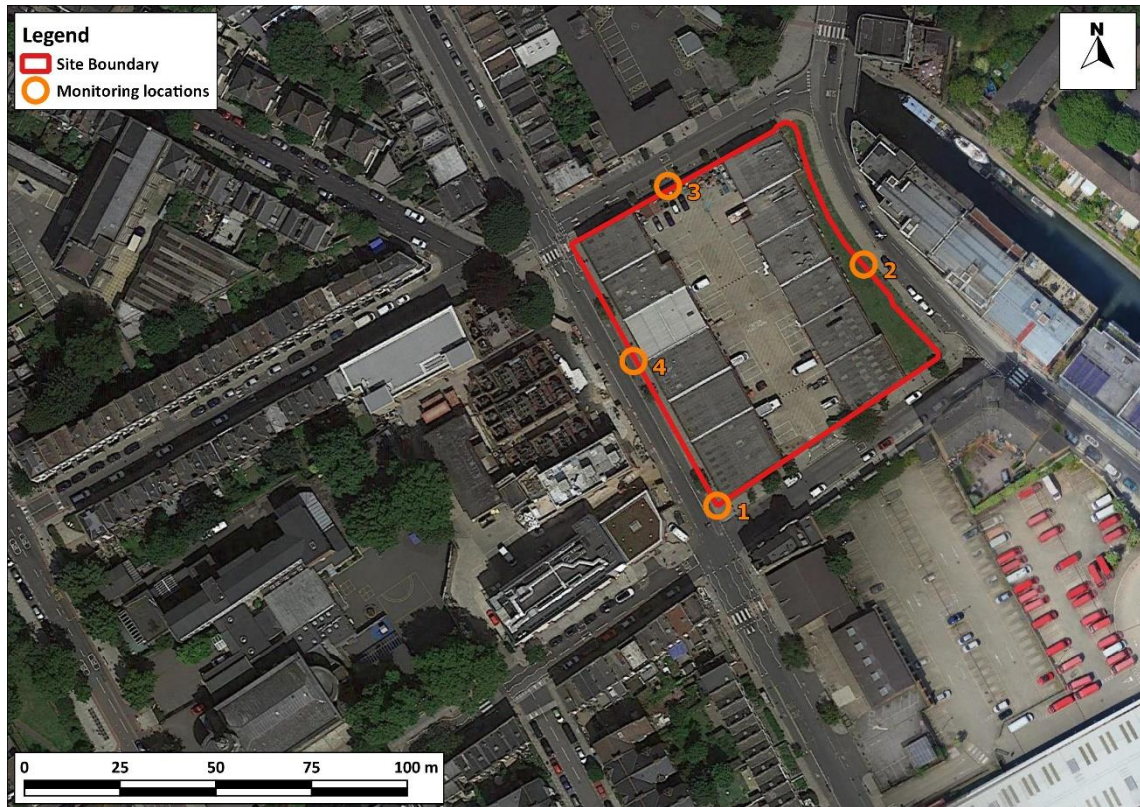
**Figure 1: Dust Monitor Locations**

- 2.4 There are four Osiris monitors installed, the current locations of which are shown in Figure 1. Photographs of the precise locations are shown in Appendix A2. The locations of the monitors were discussed and agreed with the London Borough of Camden in November 2020 during the preparation of the Air Quality Monitoring Strategy.

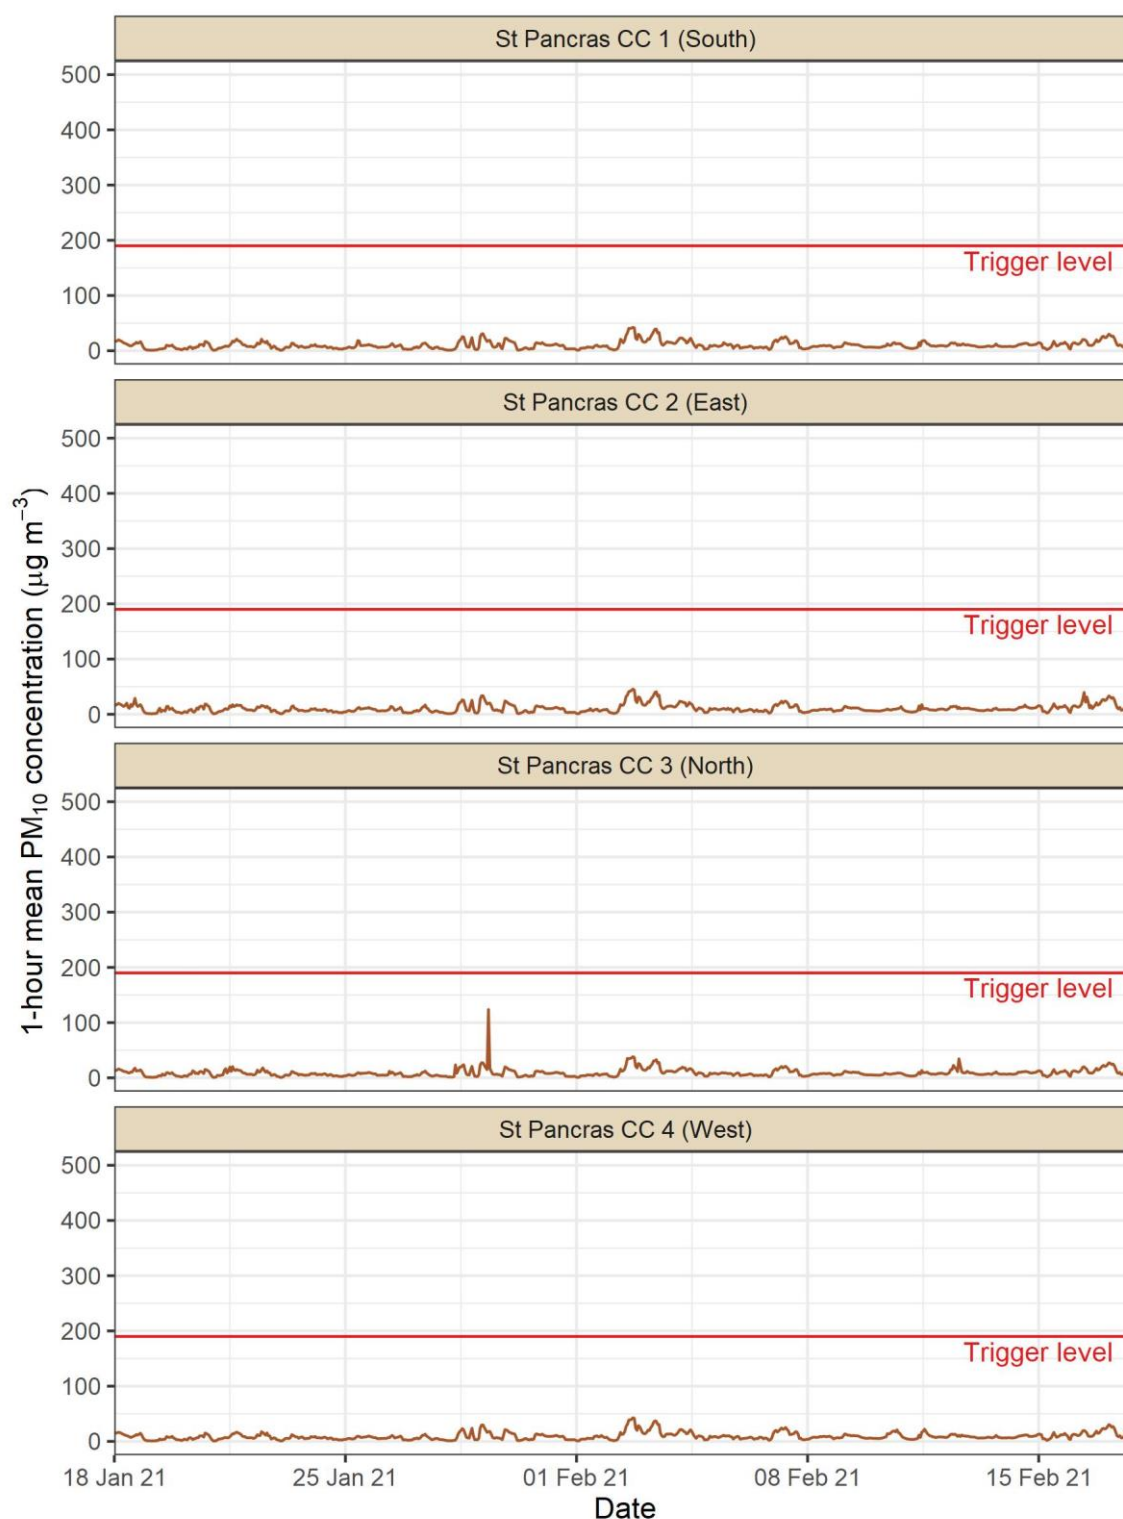
**Figure 2: 1-hour Mean PM<sub>10</sub> concentrations at St Pancras Commercial Centre**

- 3.1 Monitoring data for the period 18<sup>th</sup> January 2021 – 17<sup>th</sup> February 2021 are shown in Figure 2 and Figure 3, and summarised in Table 1.

- 3.2 Data capture was 100% at all monitors. St Pancras CC 3 (North) monitor measured one exceedance of the PM<sub>10</sub> trigger level for the 15-min averaging period, the details of which are presented in Table 2 below. The exceedance was short in duration and the exact cause is not known; no works were in progress on site at the time of the alert.

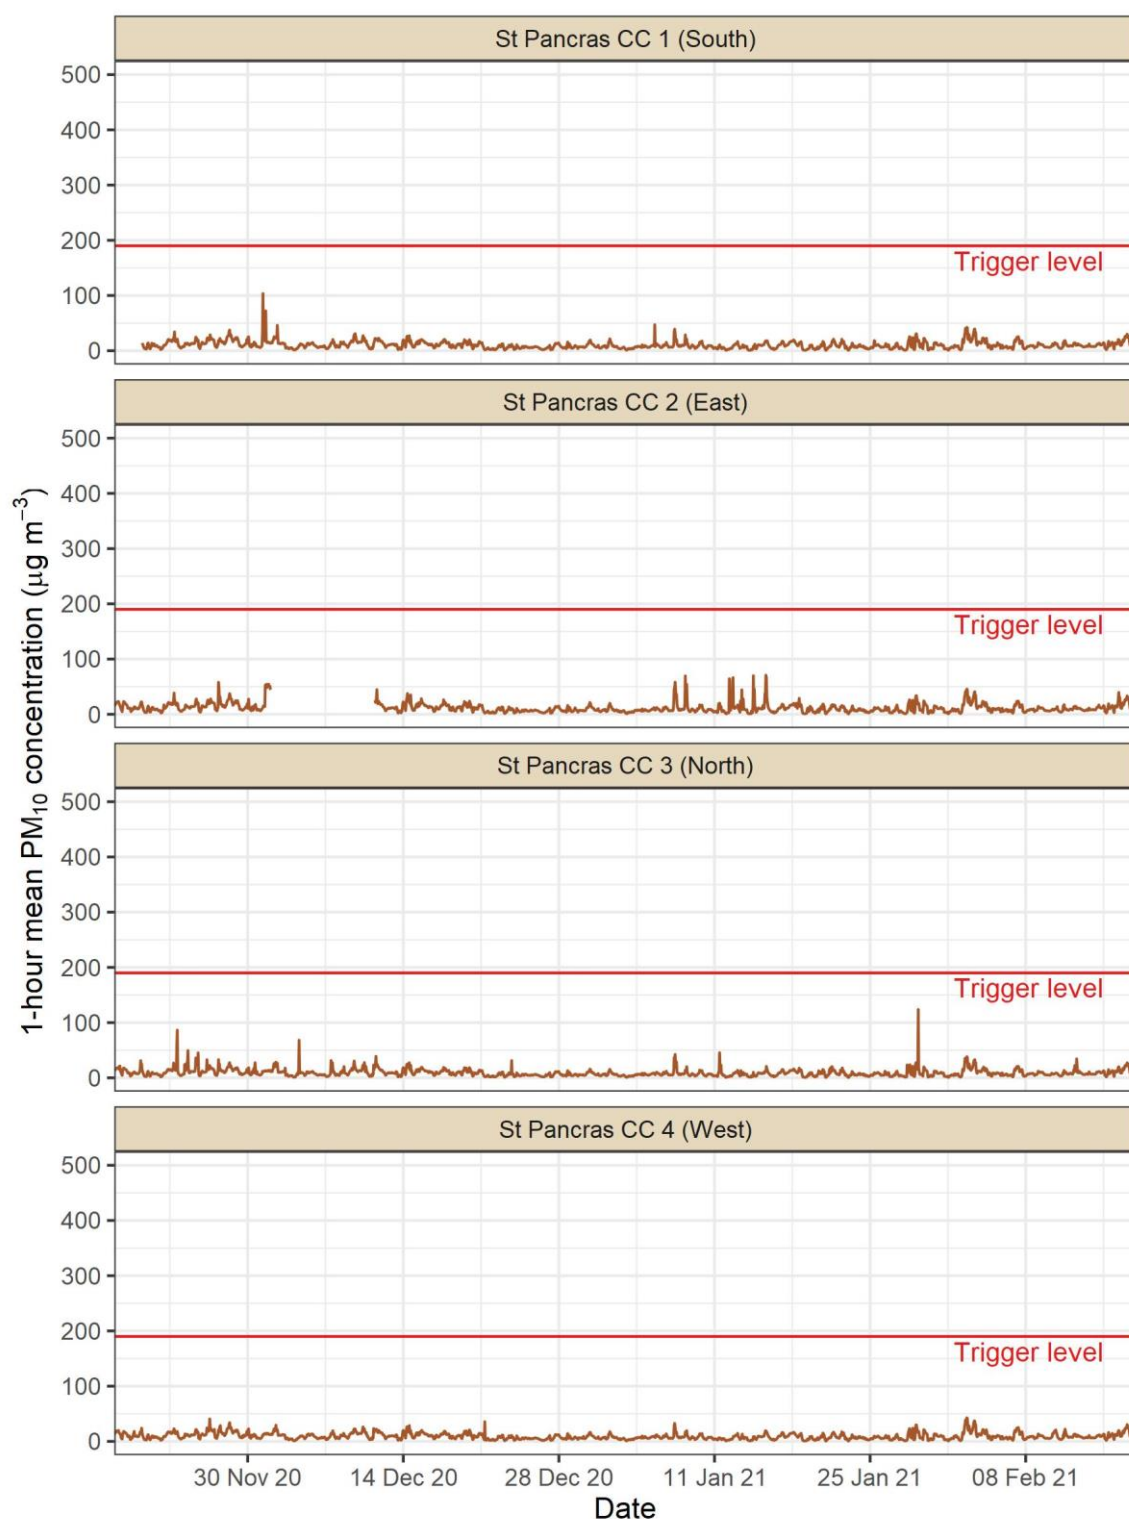
**Figure 4: 1-hour Mean PM<sub>10</sub> concentrations at St Pancras Commercial Centre**

- 3.3 Monitoring statistics for the full baseline monitoring period (18<sup>th</sup> November 2020 – 17<sup>th</sup> February 2021) are shown in Figure 4 and Figure 5, and summarised in Table 4.

- 3.4 Data capture was 90% or greater at all monitors. The St Pancras CC 3 (North) monitor measured one exceedance of the PM<sub>10</sub> trigger level for the 15-min averaging period, the details of which are presented in Table 4 below.
