Notes
 Automist System to specialist details to meet manufacturers recommendations and building control approval

Project
20-22 Theobalds Road
 Client
Fernglen Properties Ltd.
 Drawing Title
Typical Section Details
 Scale @ A1
1:5
 Scale @ A3
1:10

Number
032-TWA-XX-XX-DR-AX-93011
 Revision
 -

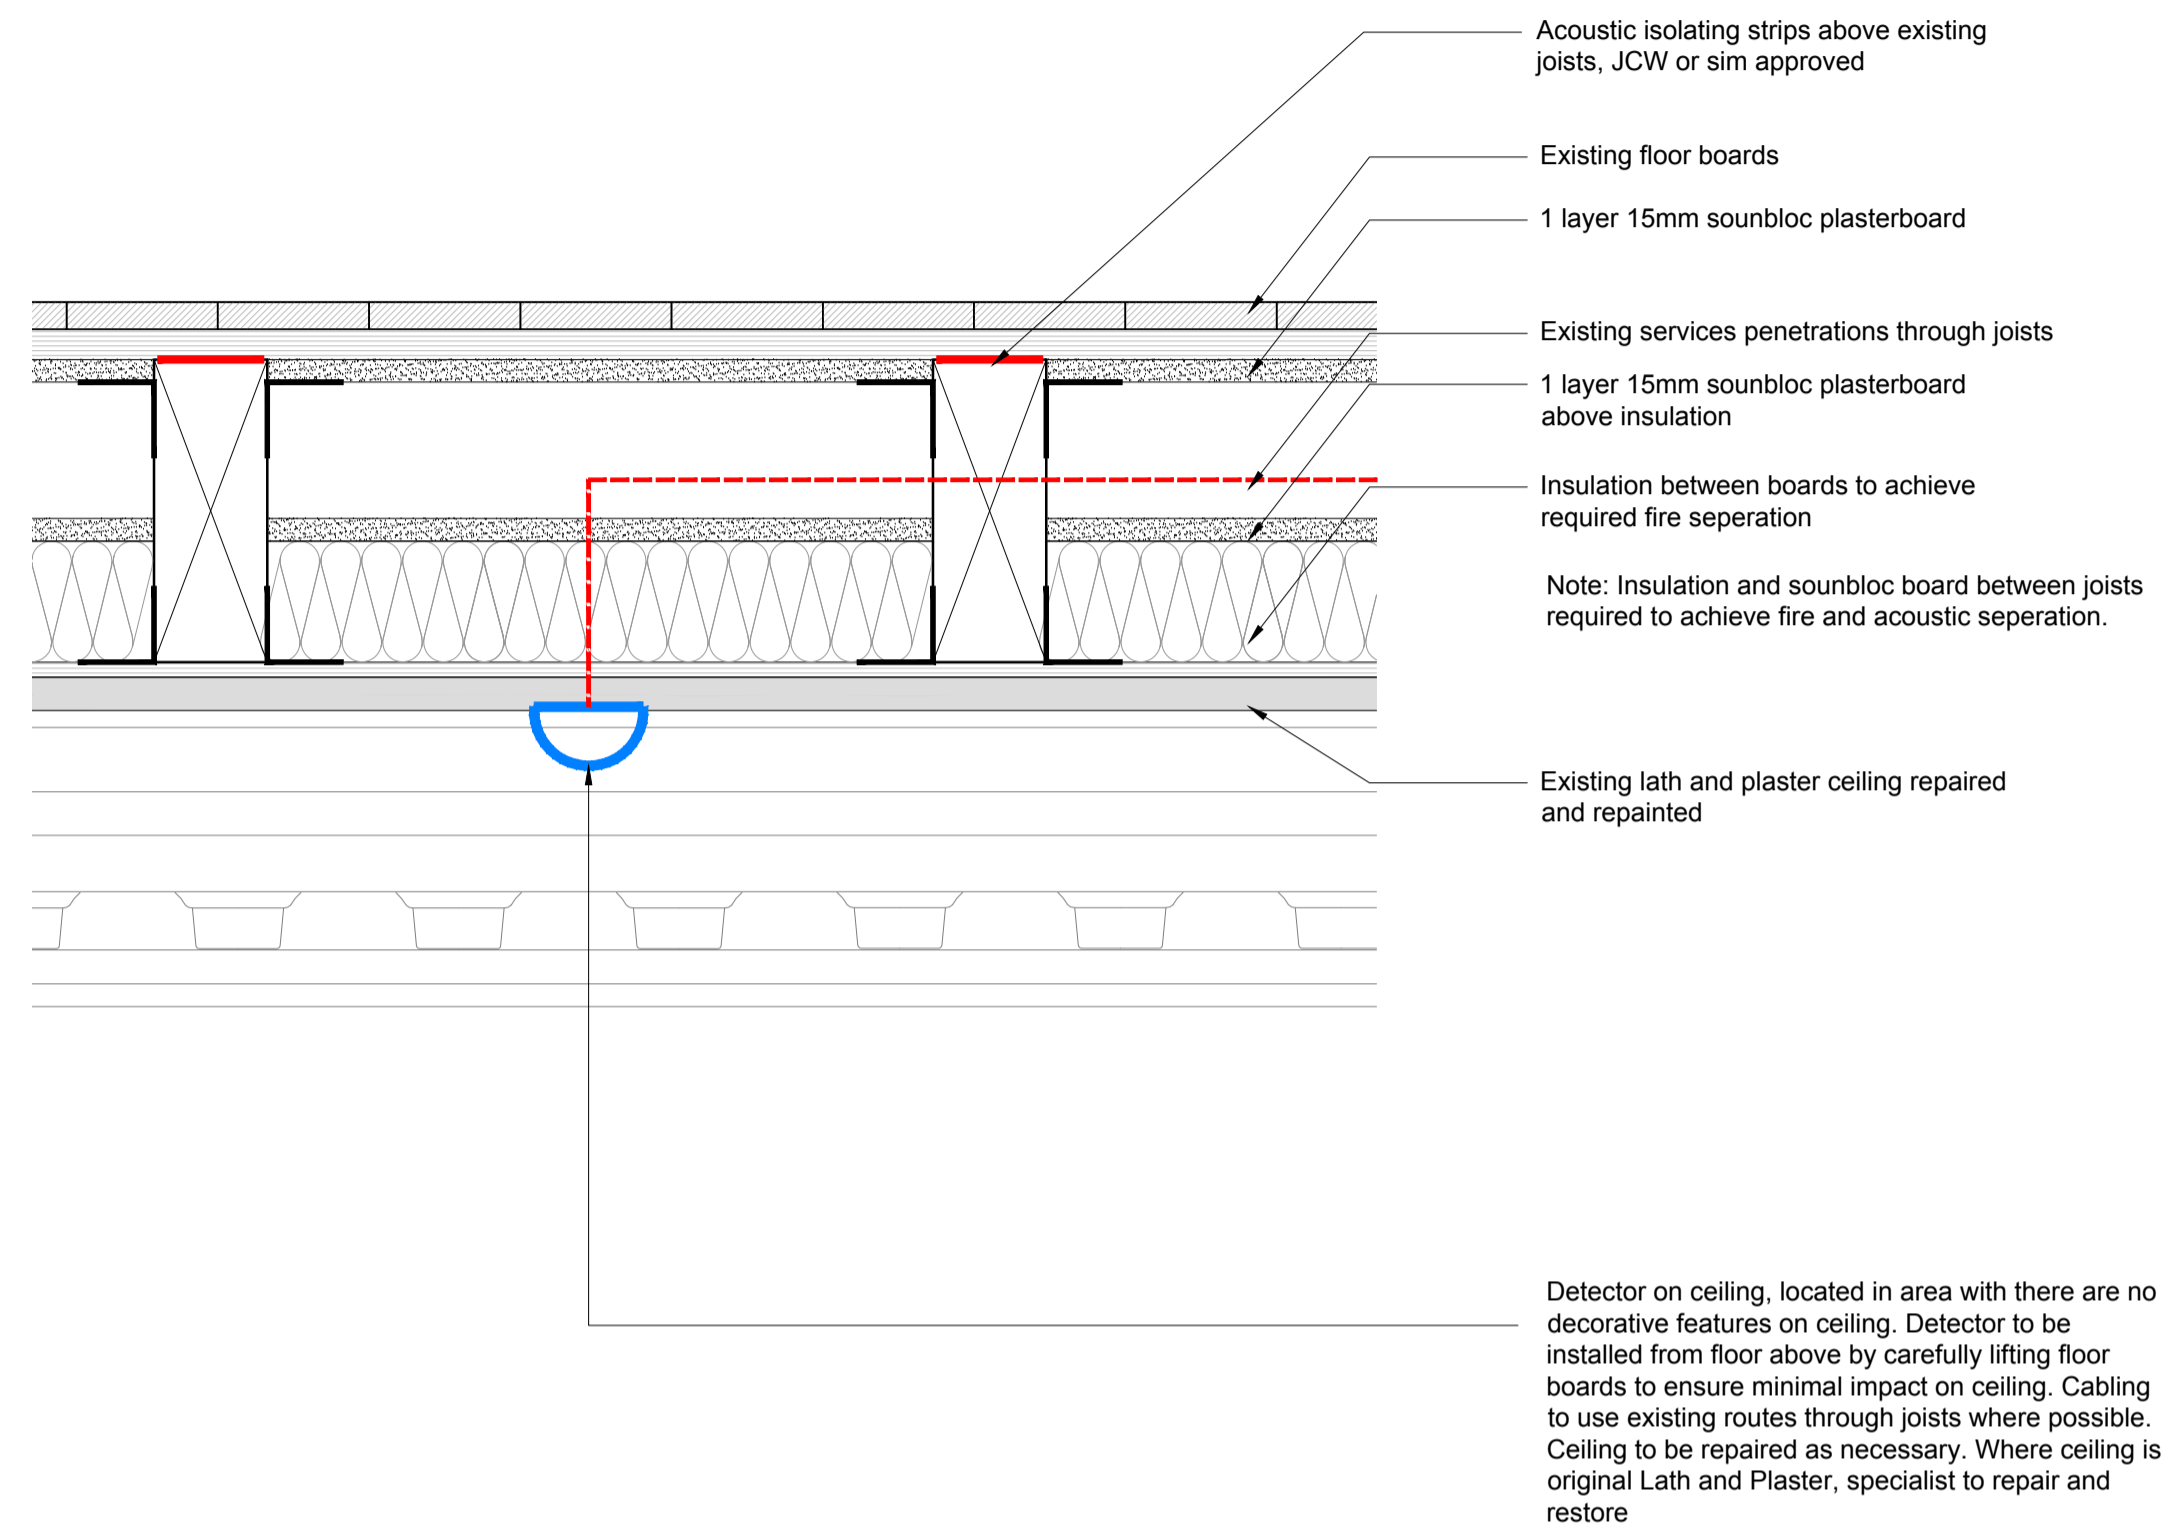
Detector on ceiling, located in area with there are no decorative features on ceiling. Detector to be installed from floor above by carefully lifting floor boards to ensure minimal impact on ceiling. Cabling to use existing routes through joists where possible. Ceiling to be repaired as necessary. Where ceiling is original Lath and Plaster, specialist to repair and restore

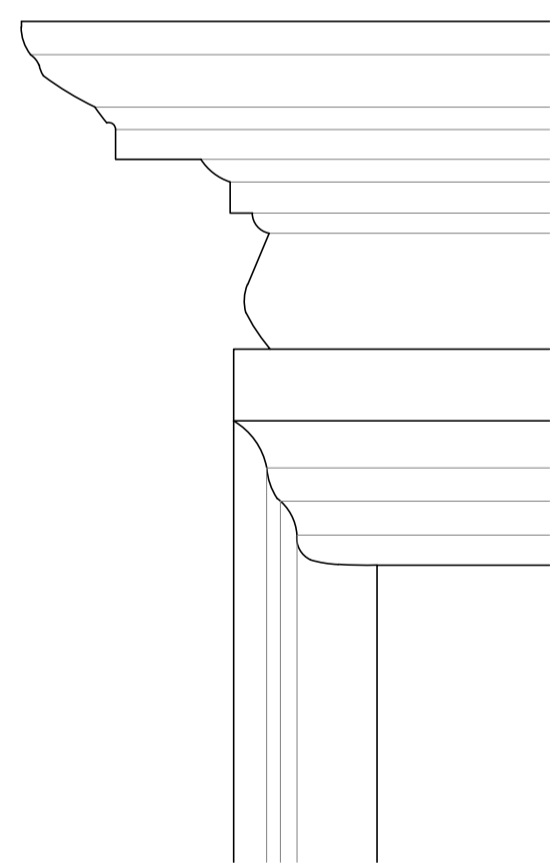
01 Detail 01 - Through Ceiling

Detector on ceiling

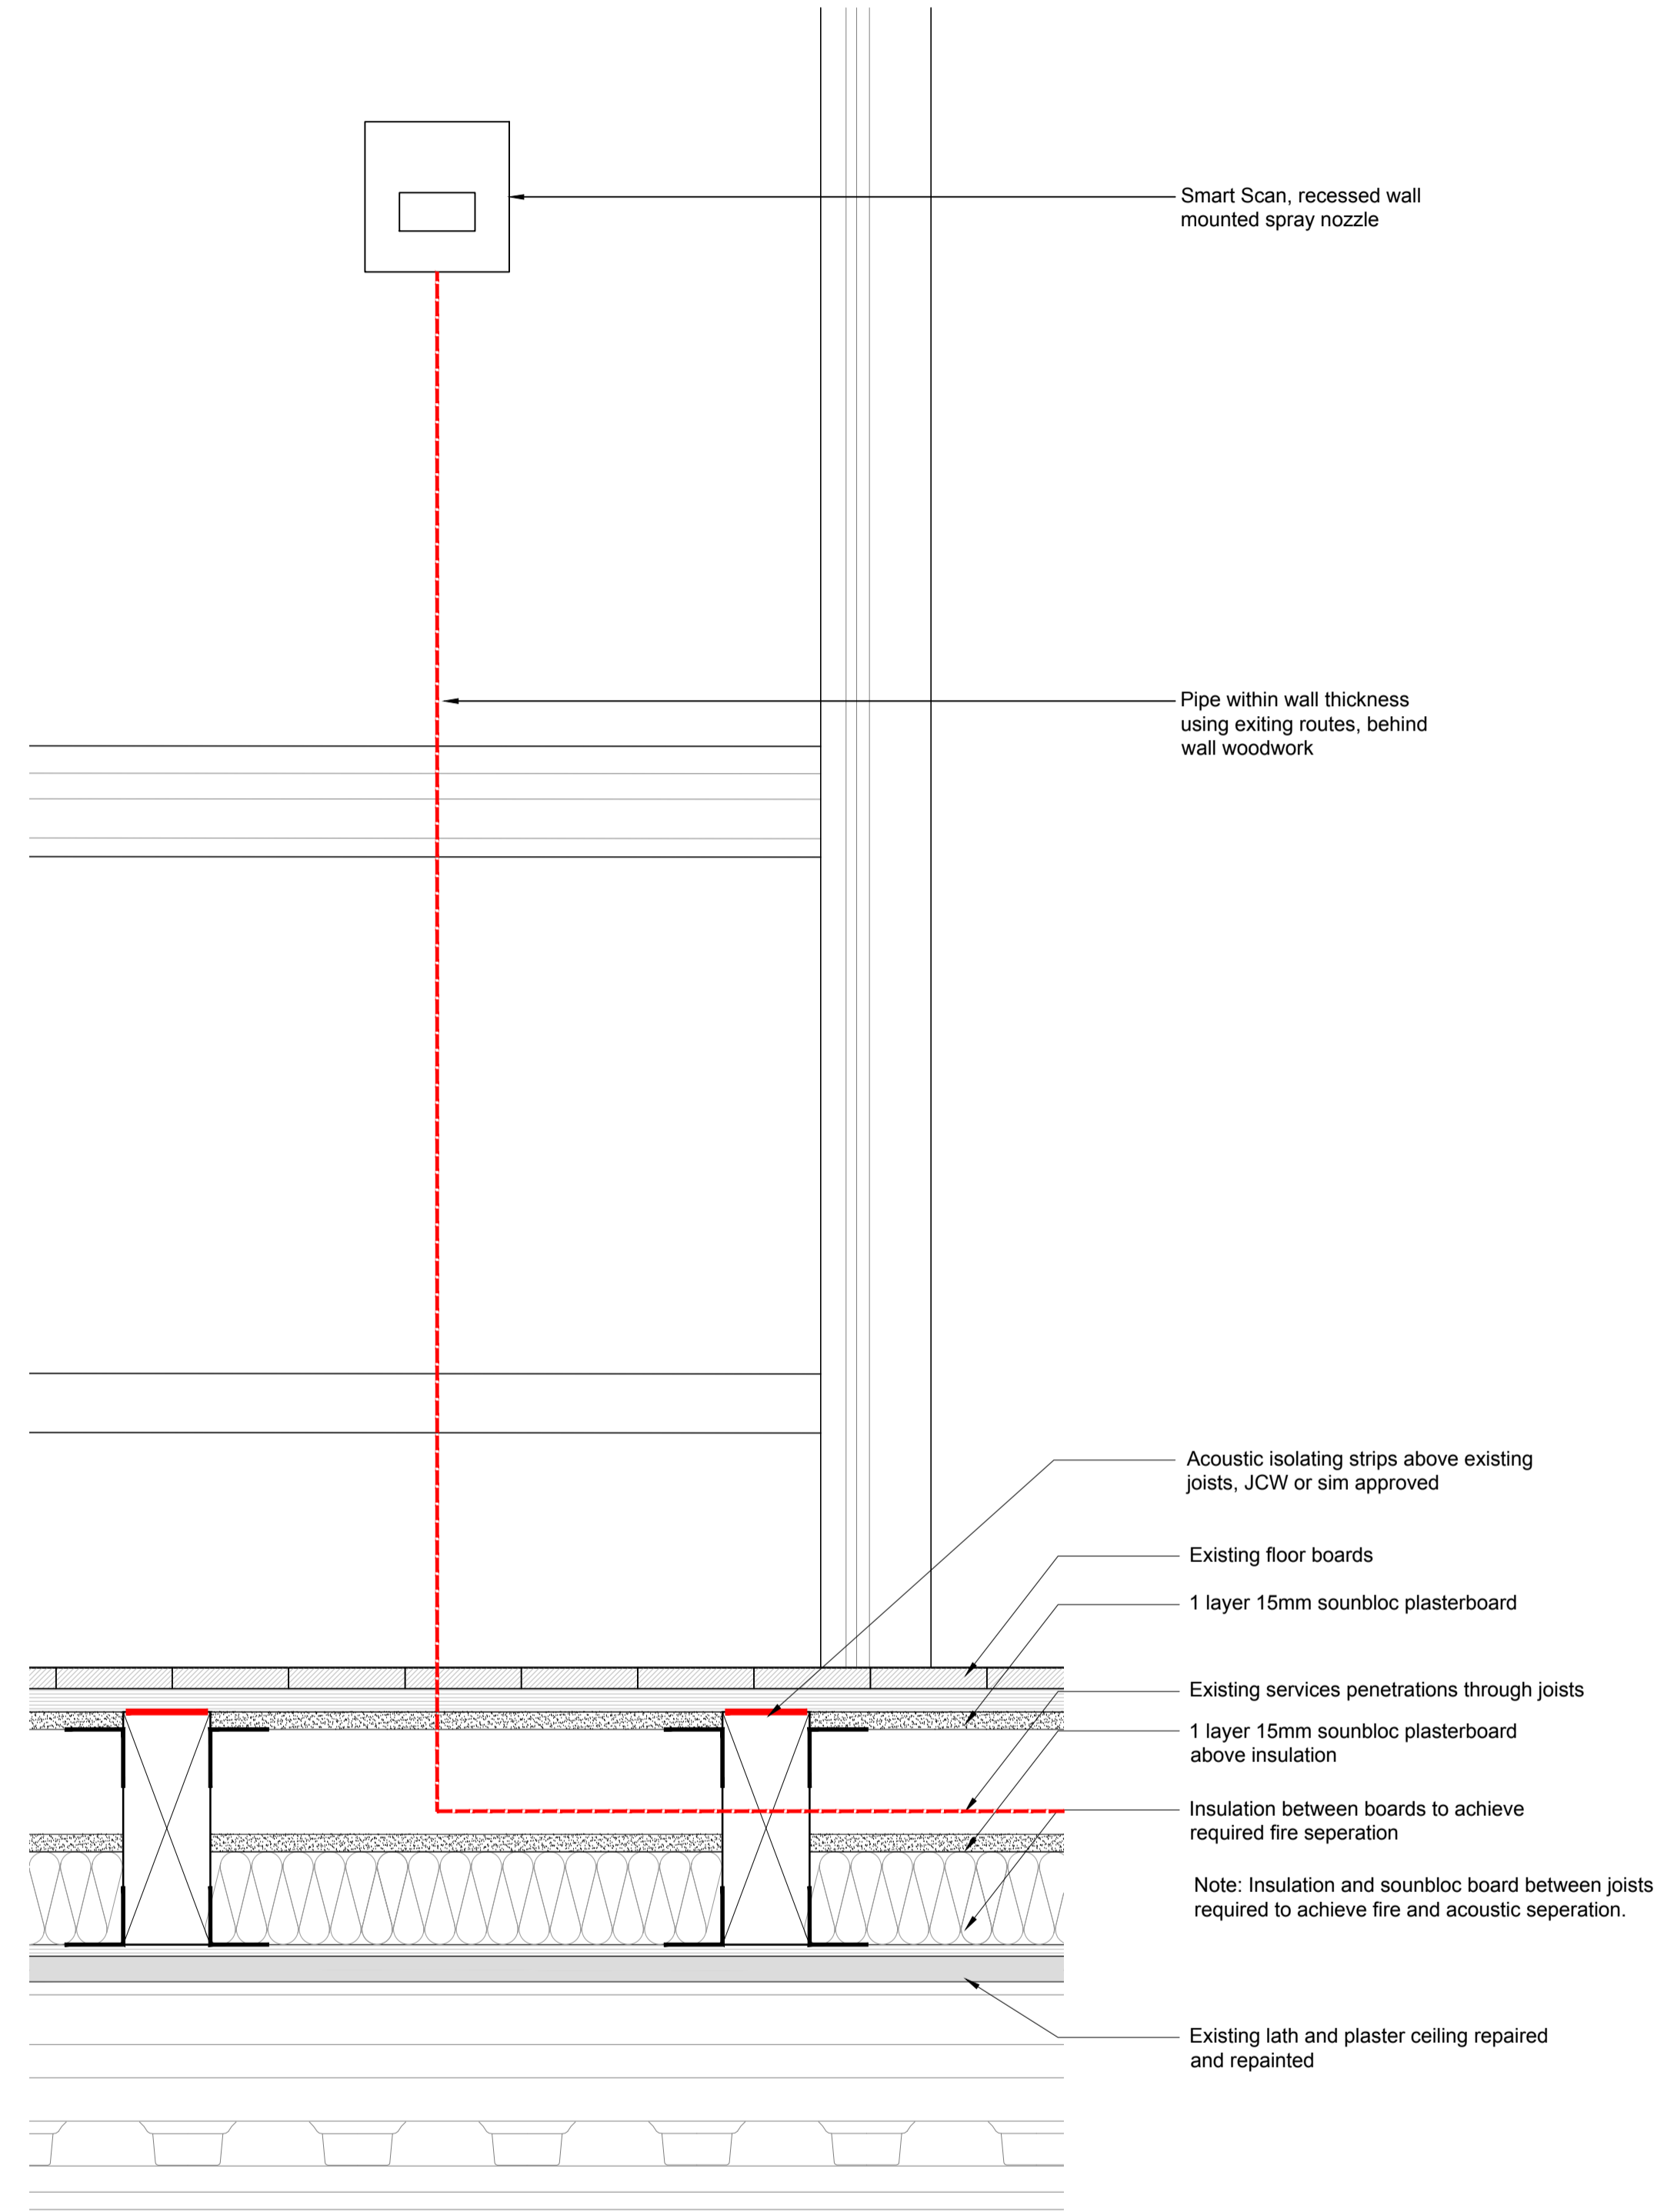
02 Detail 02 - Through Floor

cable/pipe route under floor from pump to nozzle, using existing routes wherever possible
