19 WELL ROAD
HAMPSTEAD
LONDON NW3 1LH

15no REFLECTLESS MOVEMENT MONITORING POSITIONS WALTERS CONSULTANCY LTD

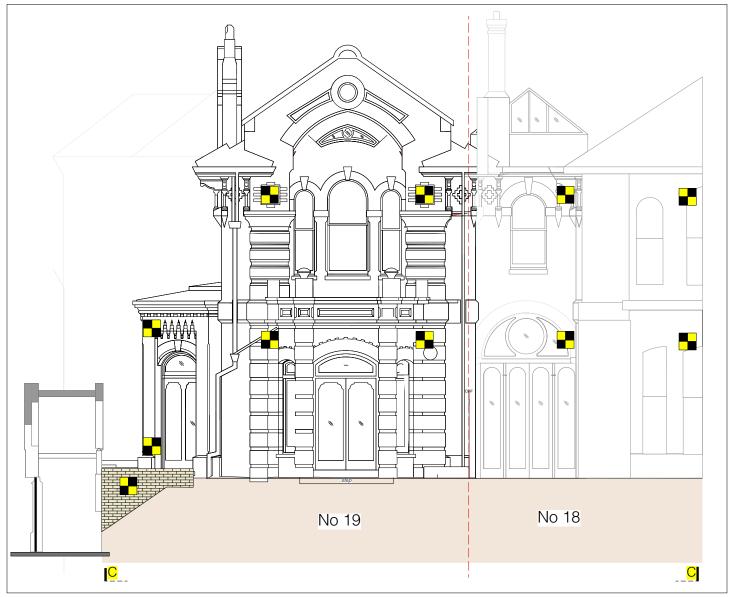
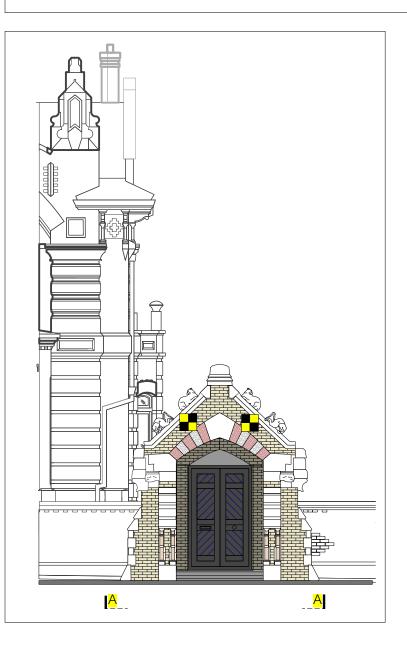
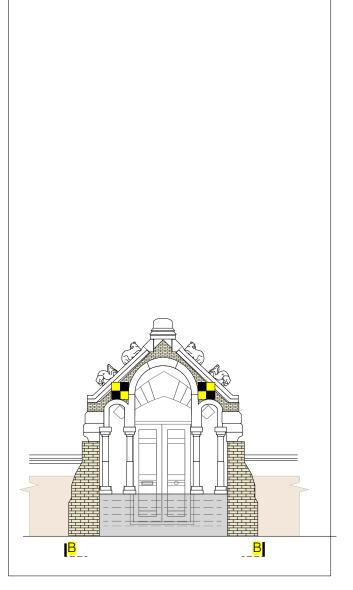
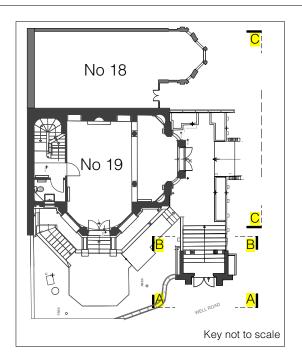
Self supporting timber frame work constructed away from but surrounding the Archway complete, incl the stone steps within and continuing along pavement wall. The profiles timber supporting the underside of the arch to be cushioned. Framed up openings are provided as shown to permit regular movement monitoring

Plywood sheathing to all framed up faces of the historic arch and incl both sides and top of the boundary wall. Access panels to be openable to allow weekly movement monitoring and recording No access for contractors permitted through archway during the cpmstruction works
