LB CAMDEN: 15 HOLLY LODGE GARDENS, LONDON N6 6AA

ADDENDUM TO PLANNING STATEMENT: APPLICATION FOR A LAWFUL DEVELOPMENT CERTIFICATE FOR A PROPOSED DEVELOPMENT.

APPENDIX OF PLANS AND PHOTOGRAPHS

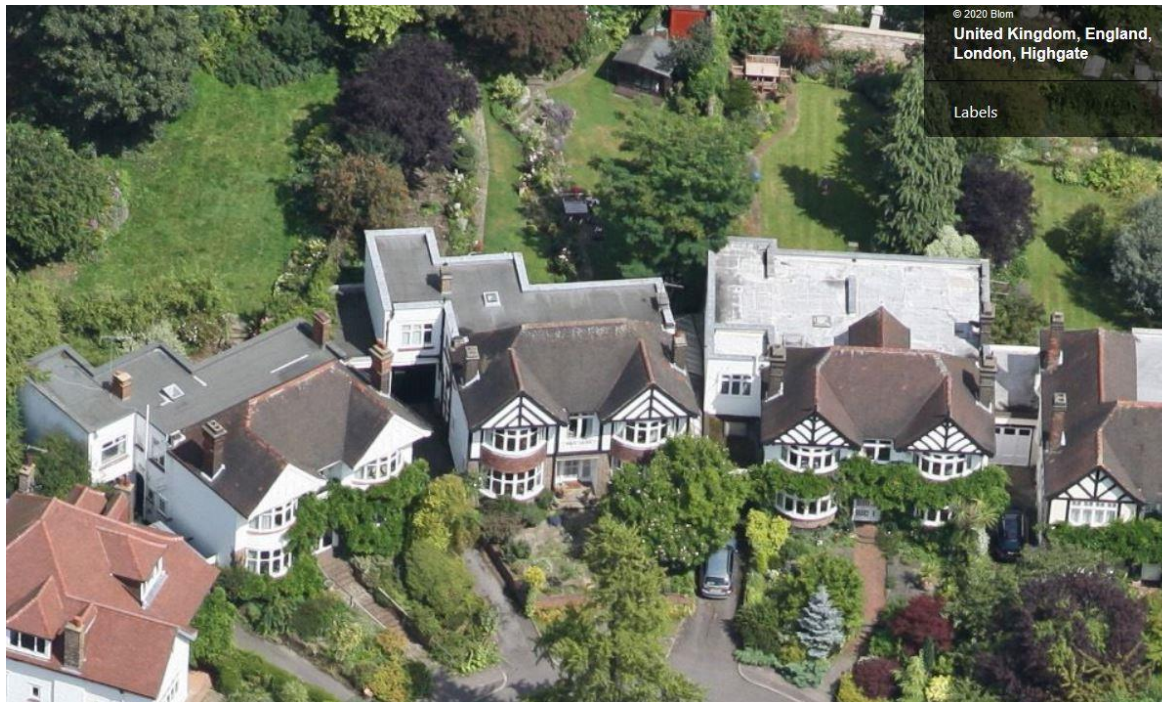
Figure 12: Aerial photograph showing, from left to right, No.14, No.15 and No.16. The latter has been extended at the rear whilst Nos. 14 and 15 retain the same roof configuration.

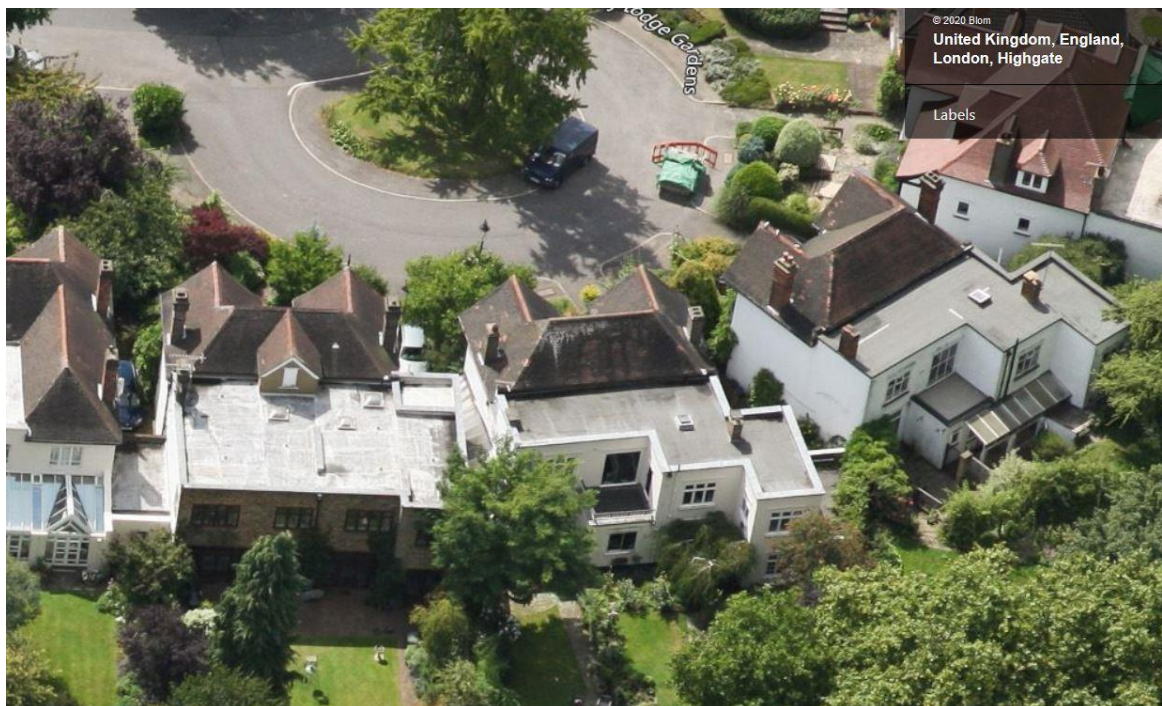
Figure 13: Aerial photograph showing the rears of Nos 14 to 16. With the exception of the conservatory additions, the massing of the rears of Nos. 14 and 15 are the same. In addition, where original windows remain in place, these are the same.

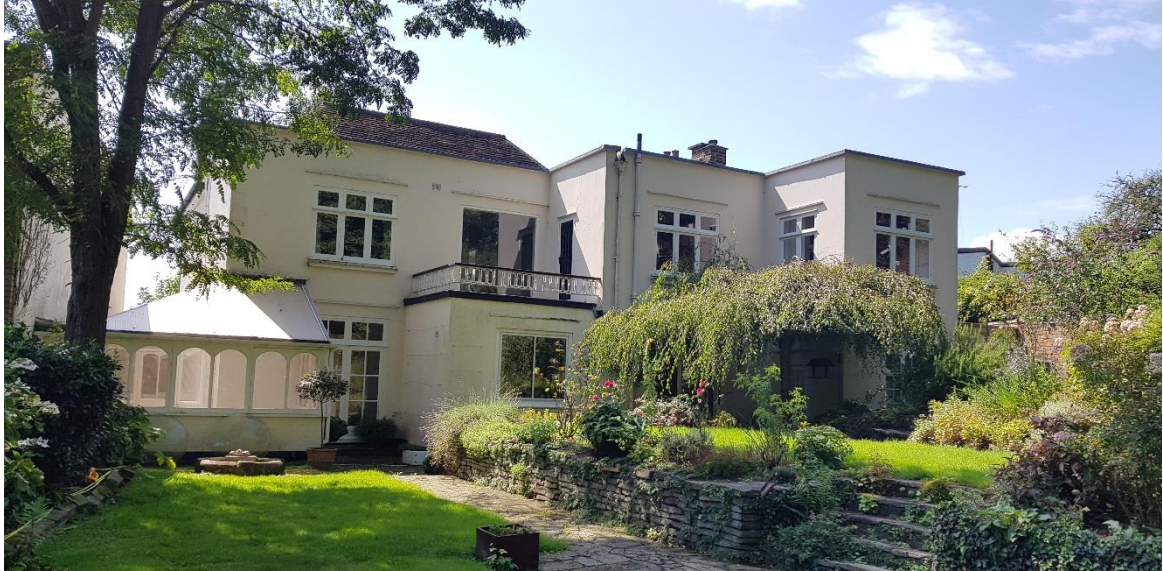
Figure 16: Rear elevation showing the identical proportions of the three upper floor windows on the upper floor and the tile details above.

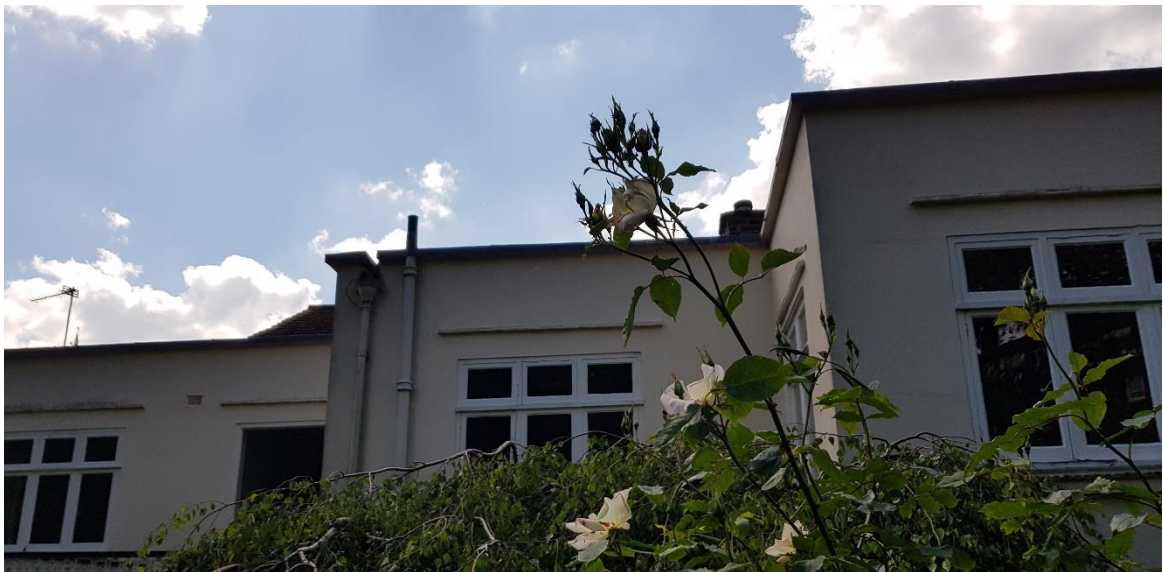
Figure 17: Rear elevation showing the identical proportions of the three upper floor windows and the tile details above the openings

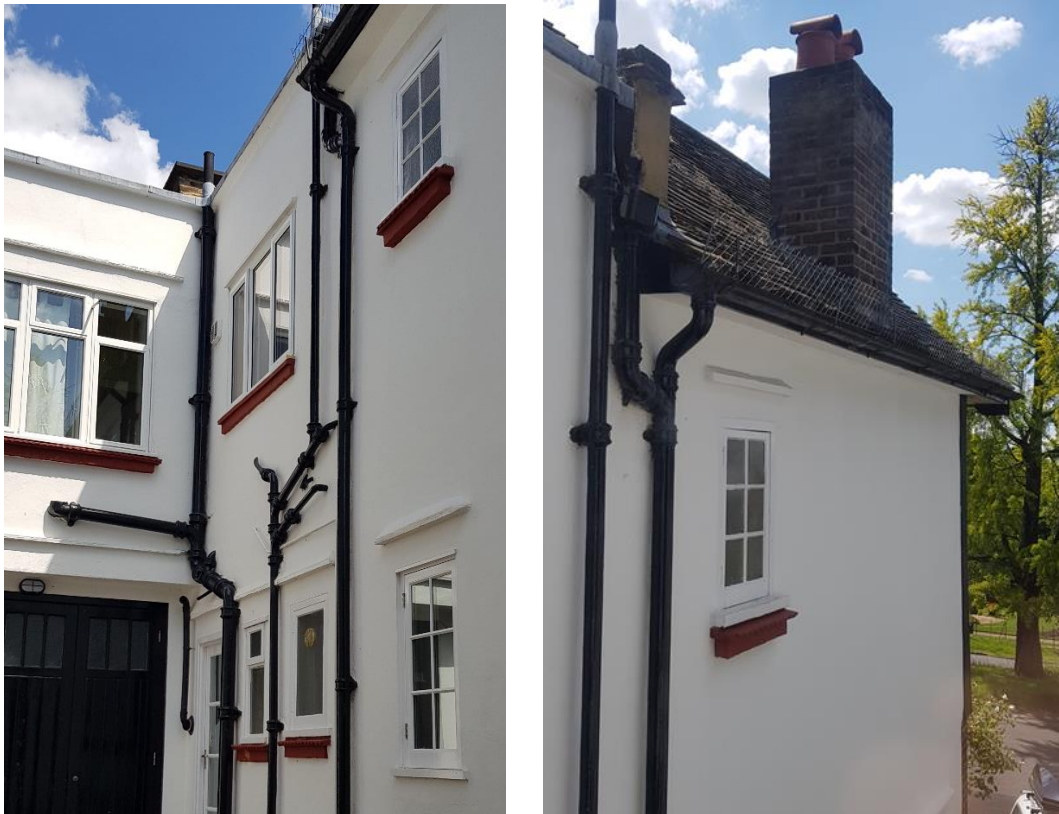
Figure 18: North elevation showing detail above windows and cills

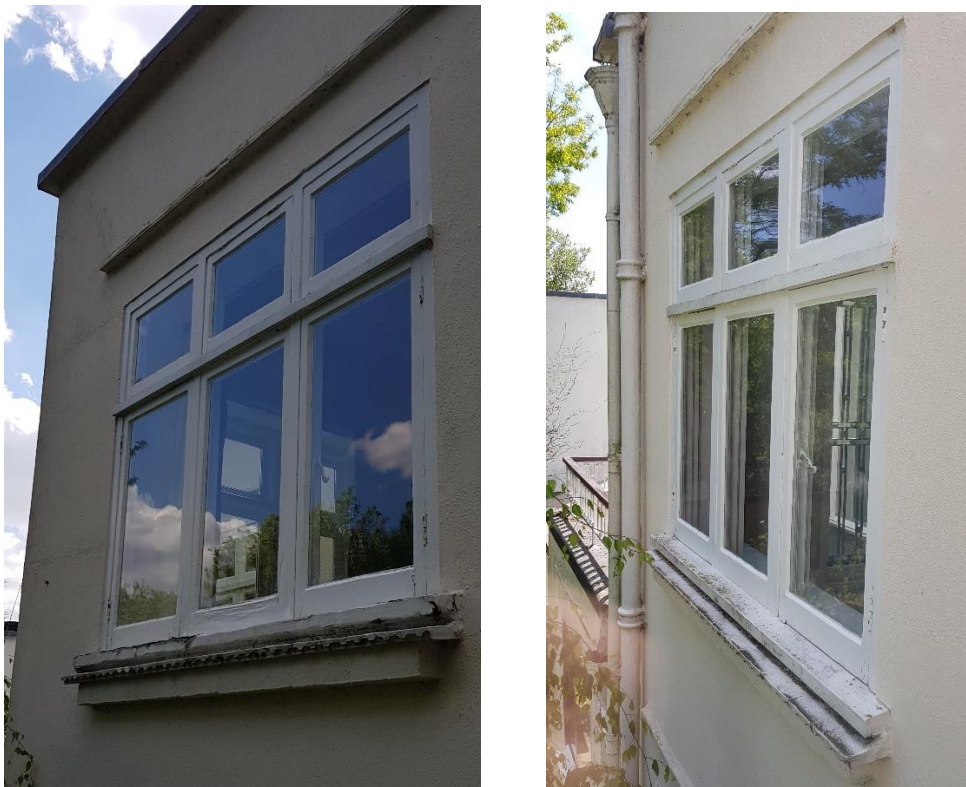
Figure 19: Two of the three upper floor rear windows showing the same details as above.

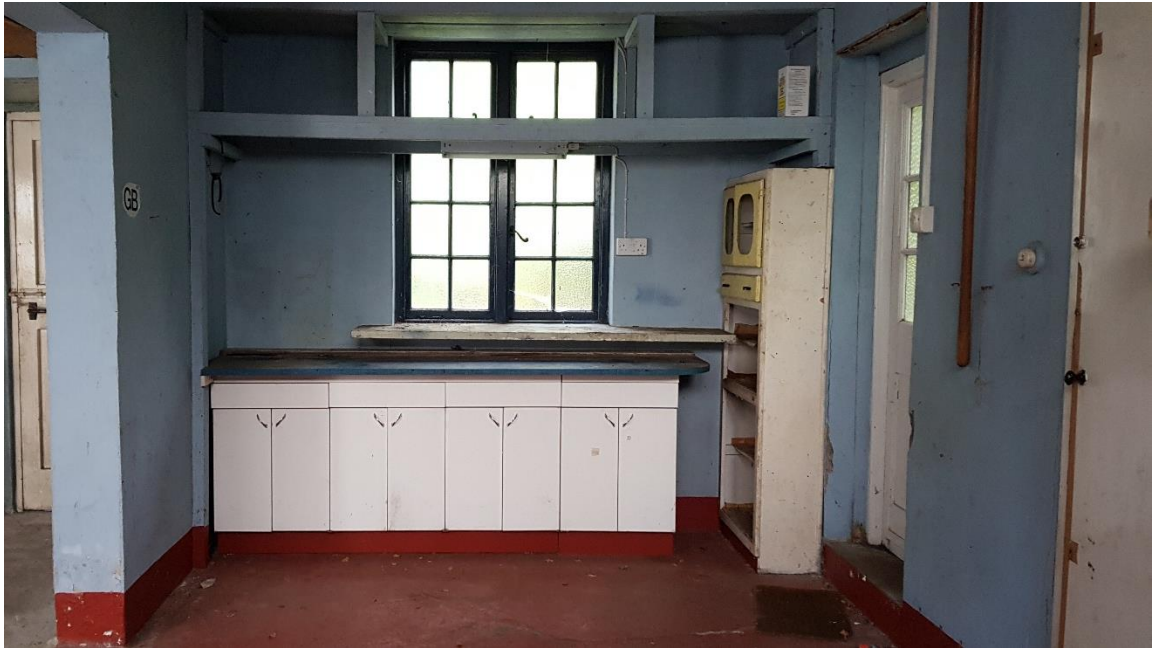
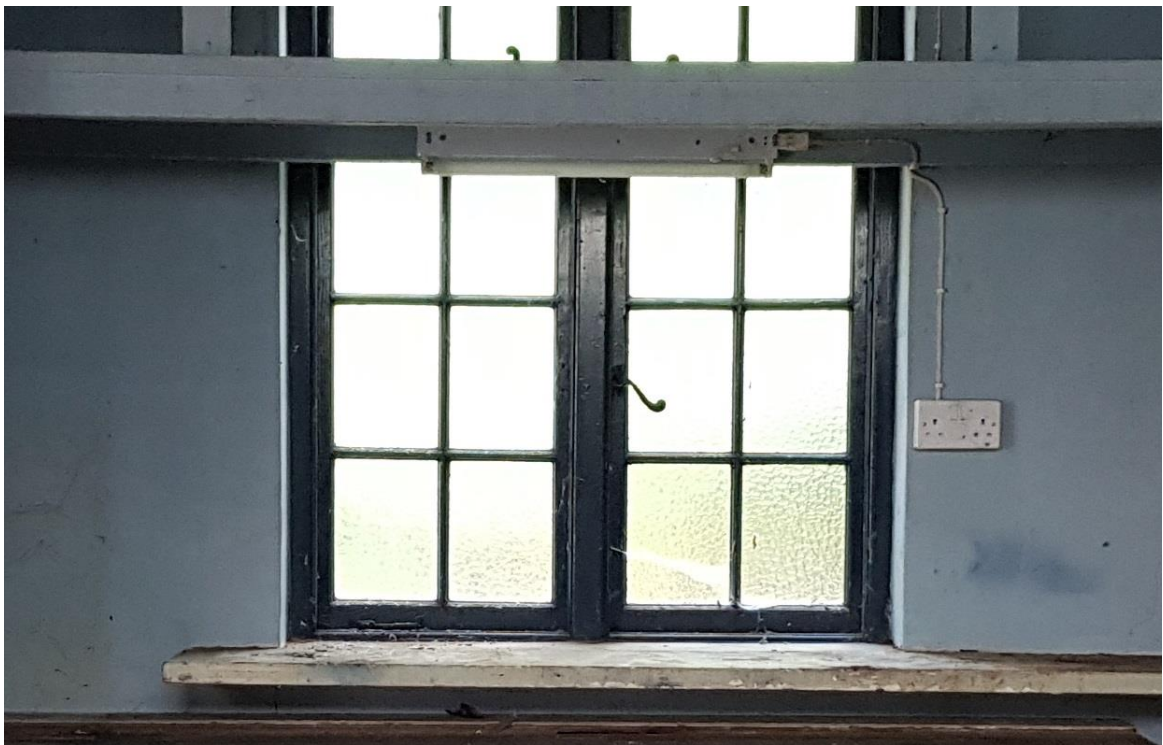
Figure 20: View of the rear wall of the garage including what appears to be a 1920s casement window.
