1.2 Site Analysis

Dormer Study - Neighbouring Side Dormers

Dormer Study - Neighbouring Dormers Size and Position

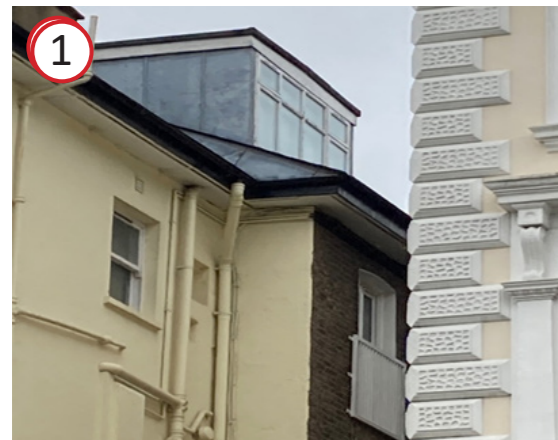
34 Belsize Park
4 casement windows with fanlight over

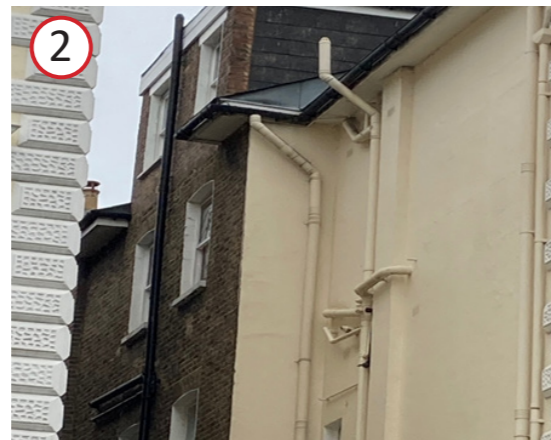
33 Belsize Park
2 sash windows

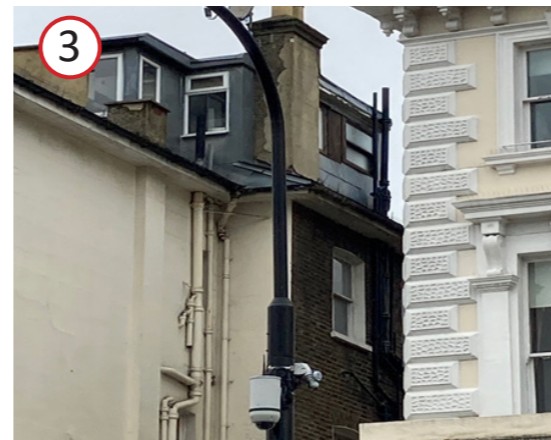
32 Belsize Park
2 casement windows with large side panels

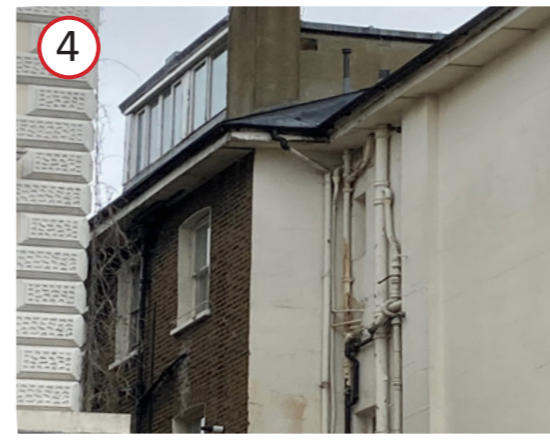
31 Belsize Park
6 casement windows

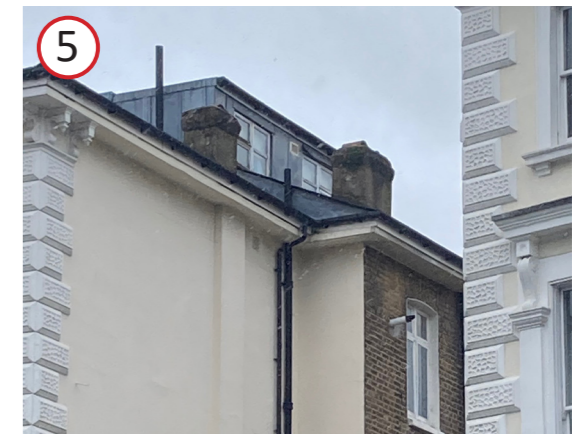
30 Belsize Park
4 casement windows with large side panels

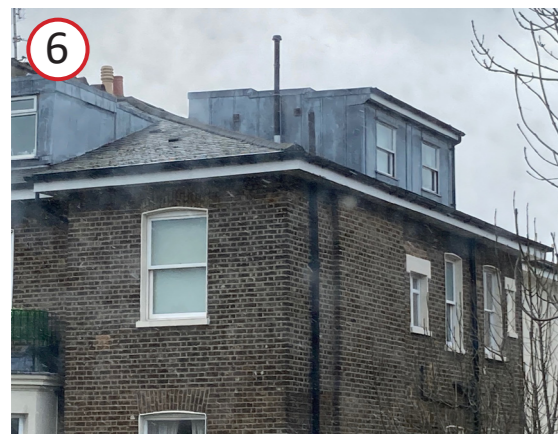
29 Belsize Park
2 sash windows with large side panels

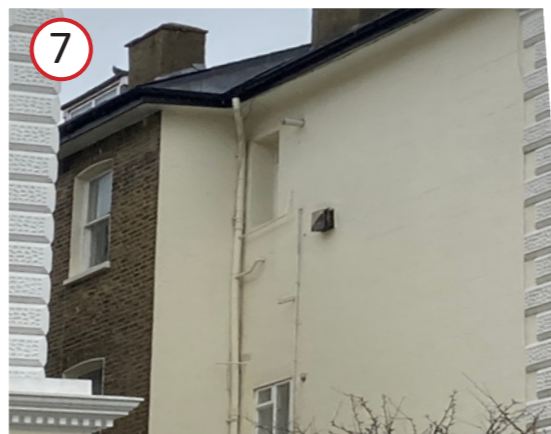
25 Belsize Park
2 casement windows

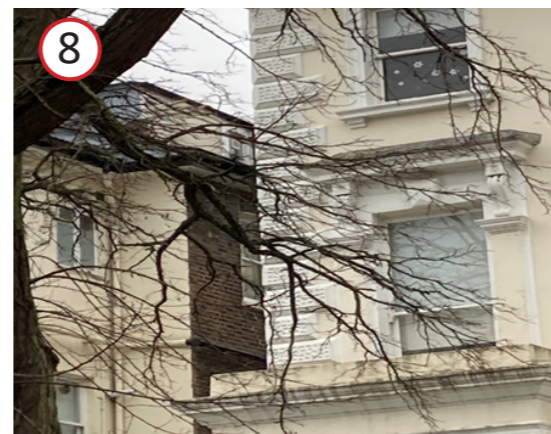
24 Belsize Park
4 casement windows

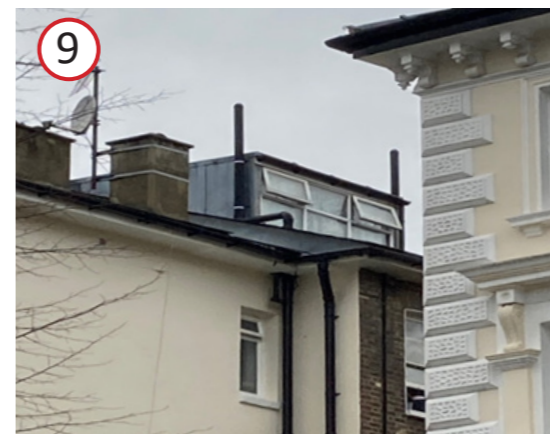
20 Belsize Park
3 casement windows

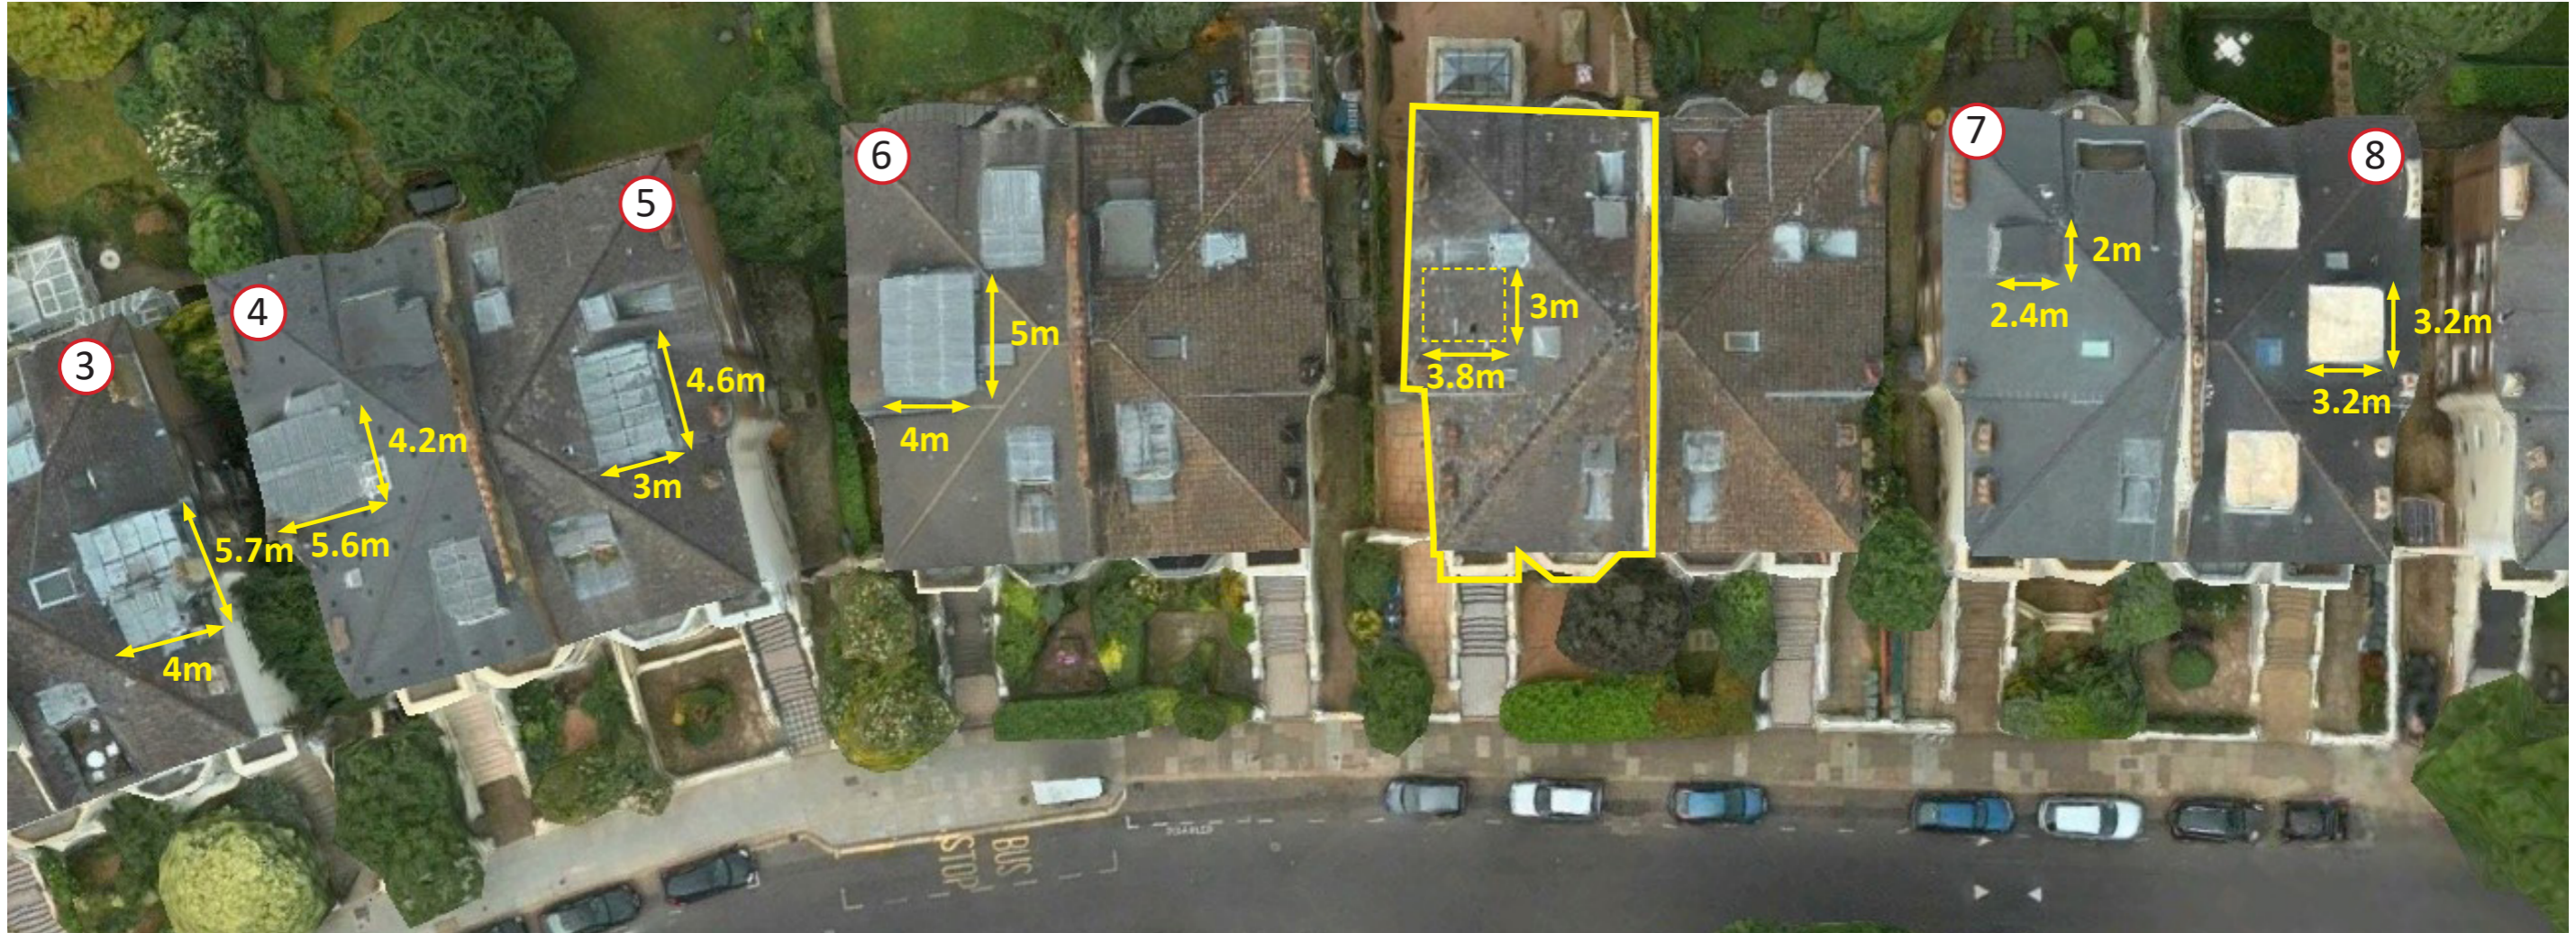
Measurements taken from Google Maps

Face of dormer in line with:

| <p>3</p> <p>32 Belsize Park

Outside wall</p> | <p>31 Belsize Park
Outside wall</p> | <p>30 Belsize Park
Face of front chimney</p> | <p>29 Belsize Park
Set back (No chimney)</p> | <p>27 Belsize Park
Face of rear chimney</p> | <p>25 Belsize Park
Face of front chimney</p> | <p>24 Belsize Park
Face of front chimney</p> |
