Ref: 15/23908-2
February 2021

15 LYNDHURST TERRACE, LONDON NW3 5QA

BASEMENT IMPACT ASSESSMENT

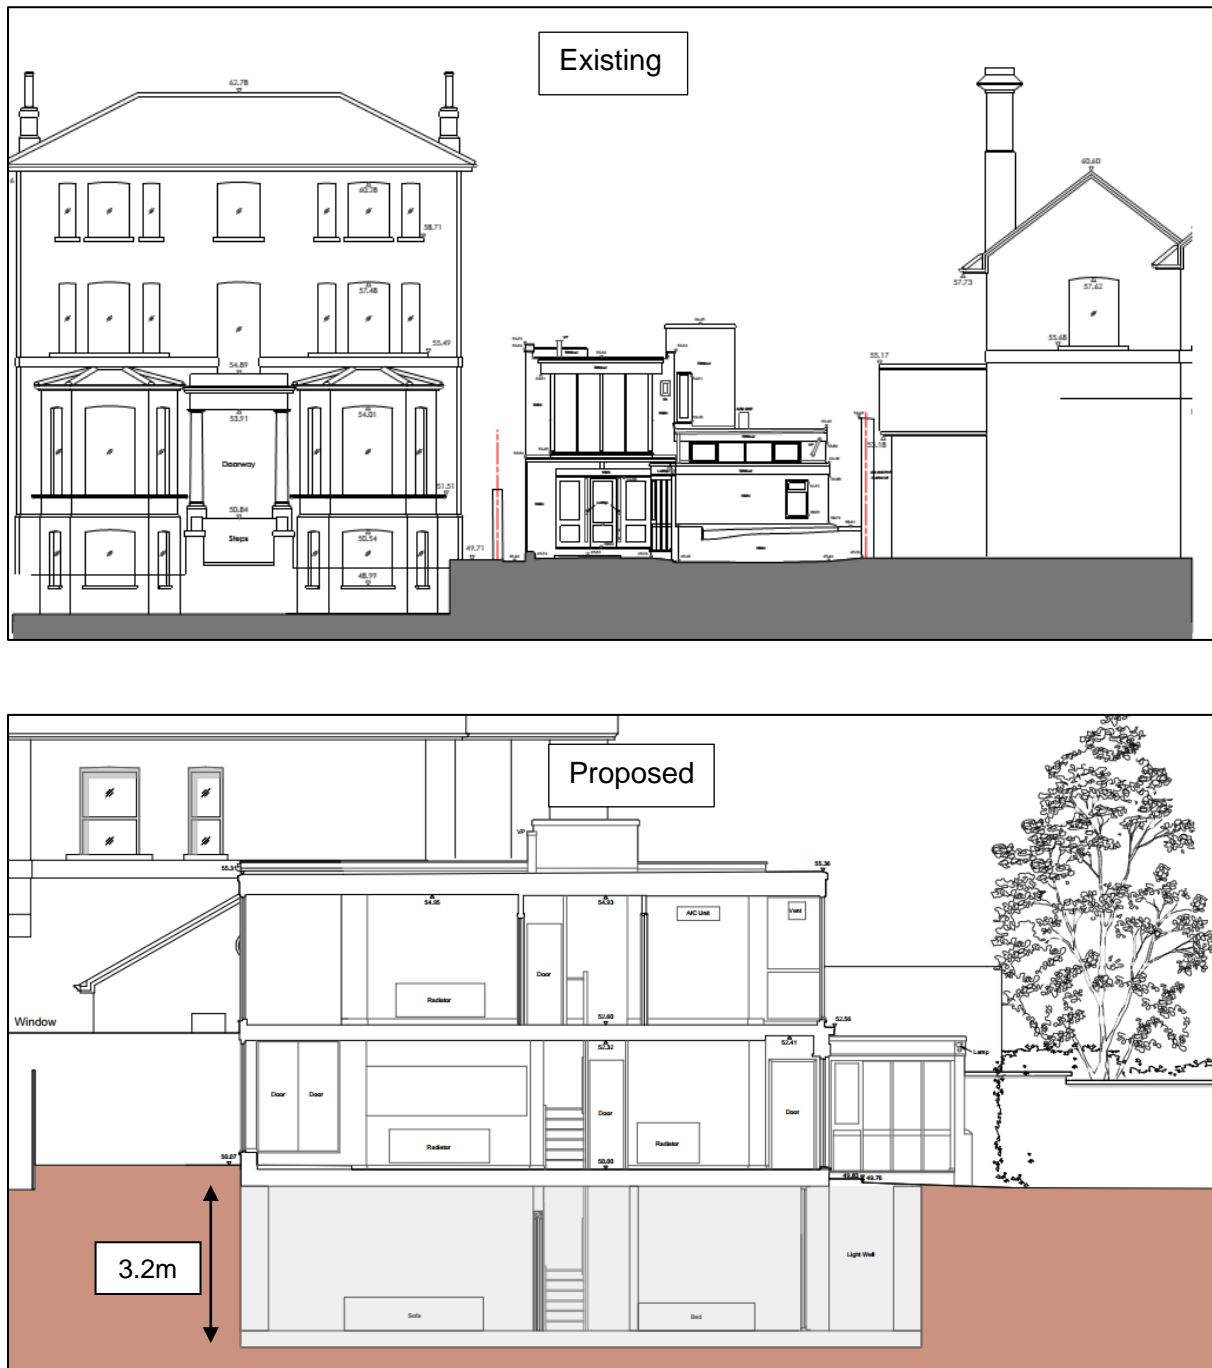
It is proposed to extend the existing property at the site and construct a new single storey basement to 3.20m maximum depth (46.80mSD). Sections showing the existing and proposed layouts are detailed in Figure 10 below.

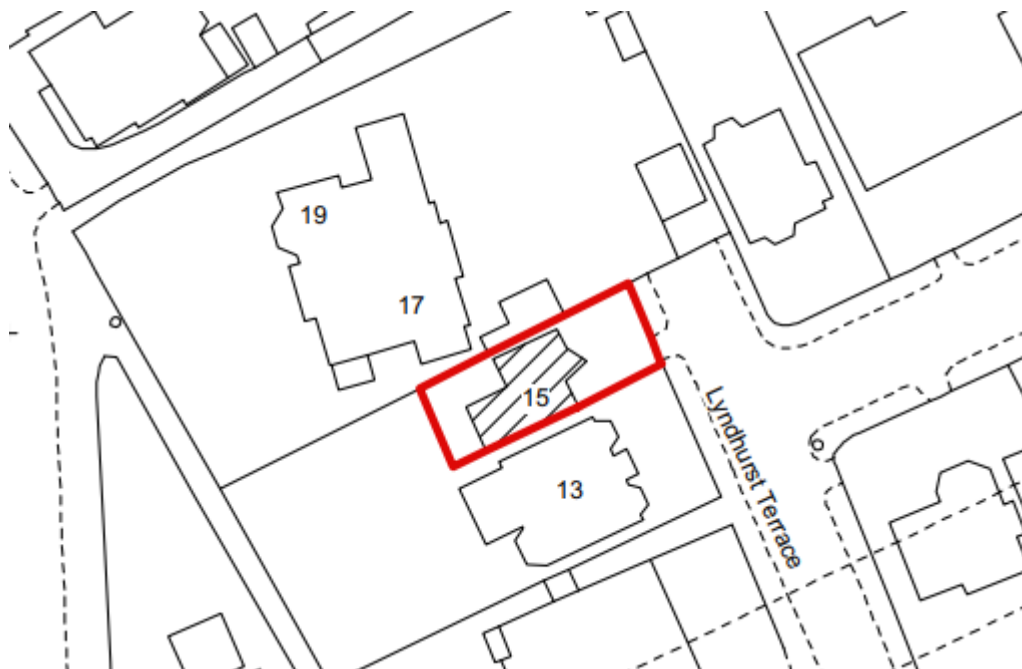
Figure 1-1 Assessment Location Plan.

Curtins have been commissioned by Site Analytical Services Limited (SASL) to complete a Ground Movement Assessment (GMA) in connection with a proposed residential development at 15 Lyndhurst Terrace, London, W8. The location of the site is detailed on Figure 1-1. The purpose of this assessment is to determine what effects the permanent construction may have on permanent structures.
