Re: Assessment of T1 Plane Tree: Highgate Newtown Community Centre, Bertram Street, London, N19 5DQ: Ref: Planning Reference - 2018/5774/P- Subsequent Section 73 Notification to fell and replace.

In this letter report I have set out my thoughts and observation following various site visits over the past two to three years and subsequent discussions throughout the detailed design phase of this project in relation to T1, London Plane regarding its suitability for retention, the thought processes behind the current decision to remove and replace it via this Section 73 Application.

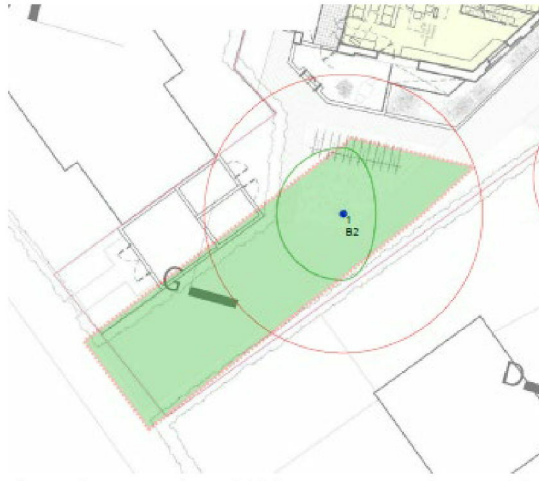
Figure 1: Extract from 2016's AIA report RCKa_HNCC_AIA_18042016_JP_v4

In summary, our initial site survey was carried out in March 2016 and the external dimensions of T1 have increased slightly however not significantly nor substantively in relation to this scheme. In relation to T1, the calculated Root Protection Area (RPA) extends across the entire Croftdown Road access to the south west, report reference: RCKa_HNCC_AIA_18042016_JP_v4.

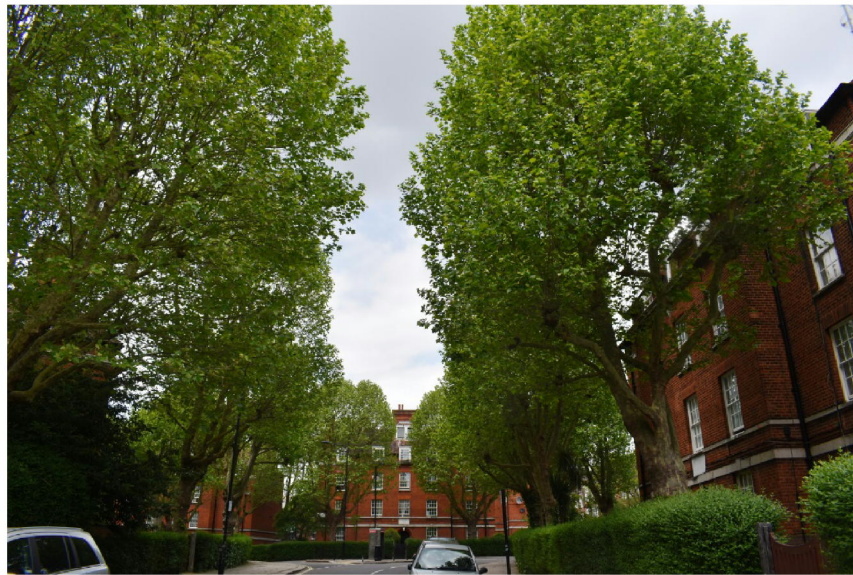
Plate 1: View north at Plane trees on Croftdown Road, just north of the proposed site access; contextual view of street scene.

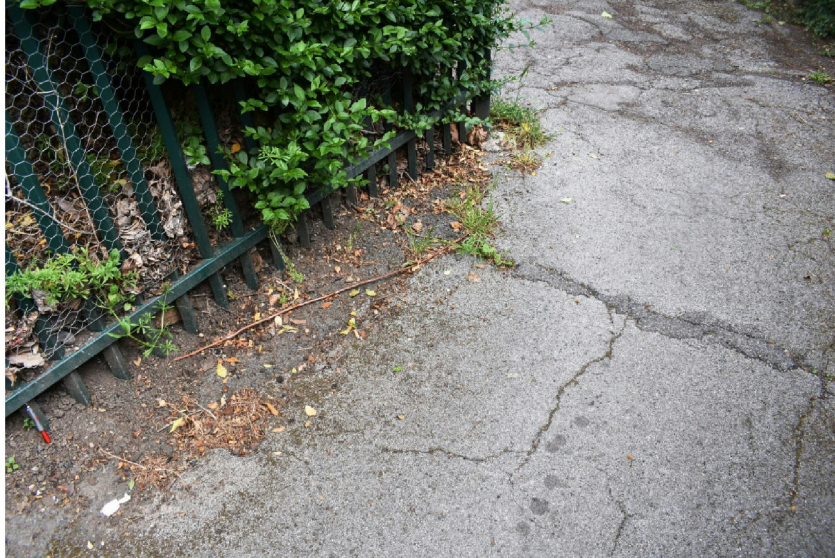
Plate 2: T1 in 2019 behind fence, ground deformation arrowed.

The actual rooting architecture is difficult to predict without ground investigation. The deformation of the footpath surface suggests surface roots therefore potentially compacted subsoil, however until ground is broken, this is not possible to establish until demolition and construction commences.

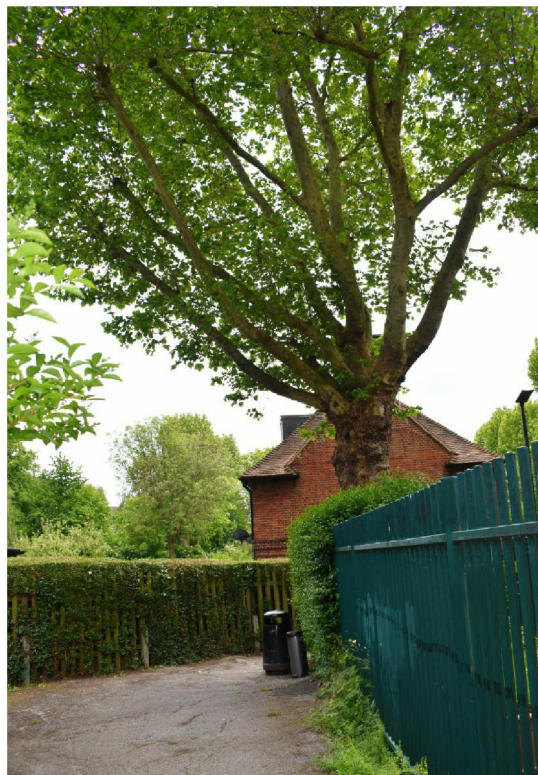
Plate 4: View south at T1 2019. Crown form and historic pollard points visible .
