# BS 5837 Arboricultural Report

Impact Assessment & Method Statement

**68 Caversham Road  
London  
NW5 2DS**

**Dated  
8<sup>th</sup> April 2021**

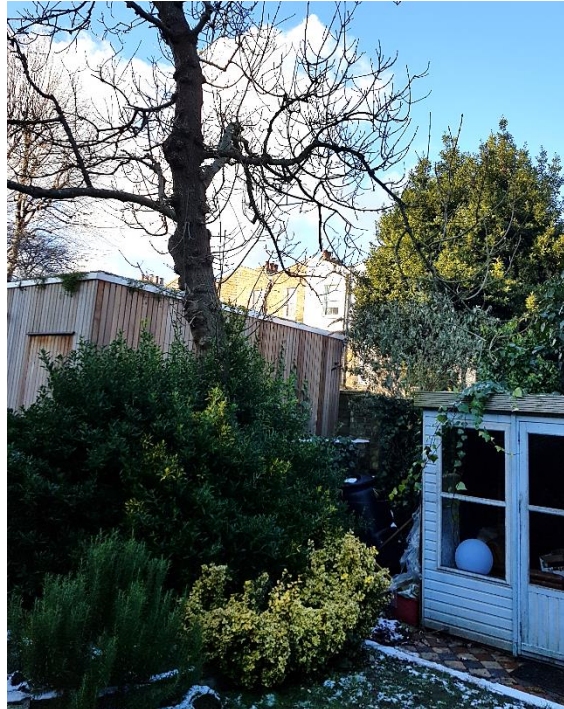
4.3.1. The proposed garden room shall be a maximum 3.2m in height and some crown lifting to the canopy of T1 will be required to facilitate the proposal. However, the canopy height of T1 is 3m above ground level and so the required pruning shall be minimal. It is proposed to remove the lower branches of T1 to a height of 4m where they overhang the proposal. This shall ensure adequate clearance height so as to prevent accidental breakage. The pruning works should be undertaken sympathetically (working to BS 3998: 2010 guidelines). To highlight this small amount of proposed pruning, the image below shows the canopy of T1 in relation to the area where the garden room is proposed.

4.3.2. It is also proposed to prune back the branches of T2 in order to create a clearance distance from the proposed garden room, as to prevent accidental breakage. Such pruning of a Retention Category C elder shall have no impact on local visual amenity and is not considered to be a material planning consideration.

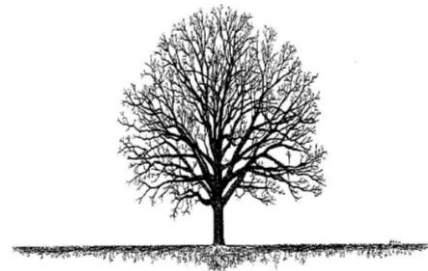
4.4.10. Healthy soils contain about 25% air space between solid particles. Increased loading of the soils caused by construction activity causes air to be squeezed out as the soil becomes compacted preventing roots from breathing. Even an increase in pedestrian activity may cause some soil compaction.

4.4.11. It is important therefore that ground compaction and soil disturbance over Root Protection Areas should be avoided during the construction phase. This may be done by installing protective fencing and ground protection measures as recommended within the accompanying Arboricultural Method Statement.

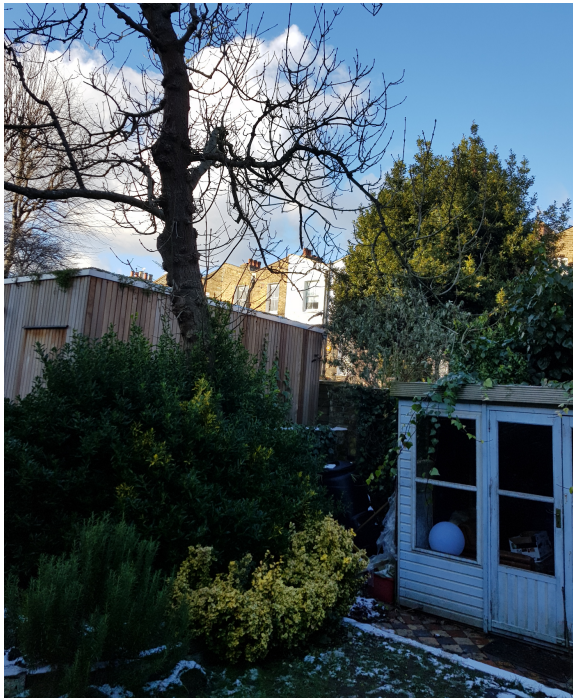
Impact Assessment Plan

(Existing Layout with Proposals Overlaid)

The proposed garden room shall be a maximum 3.2m in height and some crown lifting to the canopy of T1 will be required to facilitate the proposal. However, the canopy height of T1 is 3m above ground level and so the required pruning shall be minimal. It is proposed to remove the lower branches of T1 to a height of 4m where they overhang the proposal. This shall ensure adequate clearance height so as to prevent accidental breakage. To highlight this small amount of proposed pruning, the adjacent image shows the canopy of T1 in relation to the area where the garden room is proposed.
