LEVEL MONITORING - RELATIVE SURVEY READINGS

File MHN level monitoring 10.07.19 - 04.11.20.xls.XLS.XLS

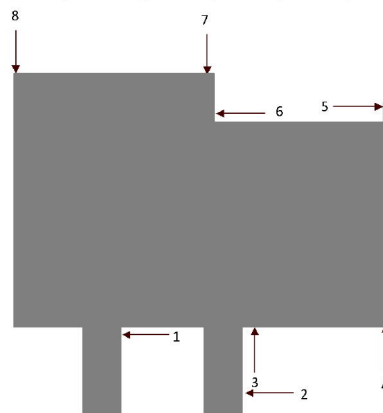
- 05/11/2020
The Occupier expressed no new c
- It was not possible to install all sta within a common brickcourse. The initial readings cannot be interpre Distortion Data.
- Unable to sight through house. Fr readings have been made relative station 1. Rear readings have bee relative to level station 8. They ha assumed values of 10.0000m. If t appropriate, please advise if a dex is required?
- No further readings to be taken.
