## ***Phase I DESK TOP STUDY REPORT***

***72 – 76 Eversholt Street  
London  
NW1 1BY***

***March 2021  
Report No. 16571***

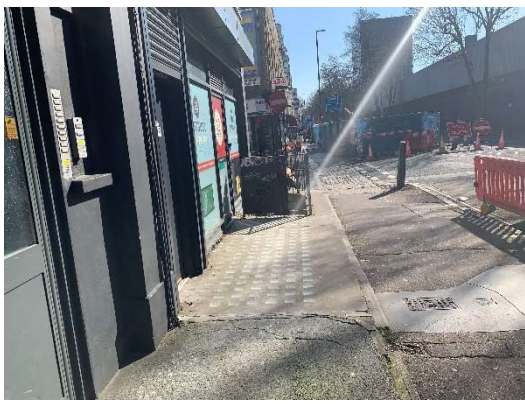
#### 2.5 Site Reconnaissance – Photos

Print 1	View of the west of the site area looking to the south along Eversholt	Print 2	View of the southern side of the site area looking to the north from the junction of Eversholt and Drummond Crescent

Print 3	View of the west of the site area looking to the south along Eversholt	Print 4	View of the light well and steps in place to the west of the site area

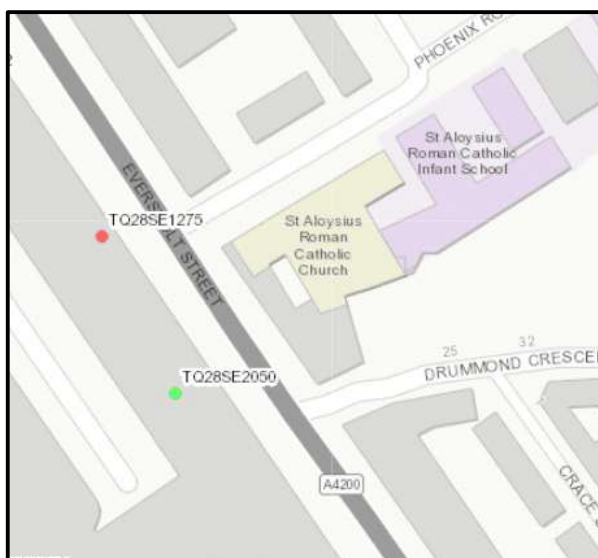
To the west of the site area BGS Boreholes are reported.

Q28SE2050 — EUSTON STATION RECONSTRUCTION BH22  
529550,182850 Depth: 19.35m.

Made ground is noted to 3.66m where clay is recorded in place to 19.2m. Woolwich and Reading Beds are then recorded to the close of the borehole at 23.61m. The water level was recorded as 8.99m in 1961.

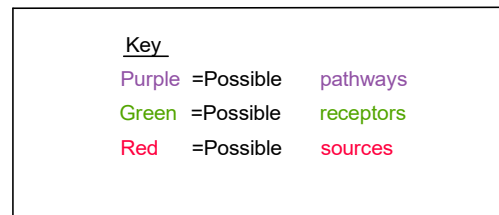
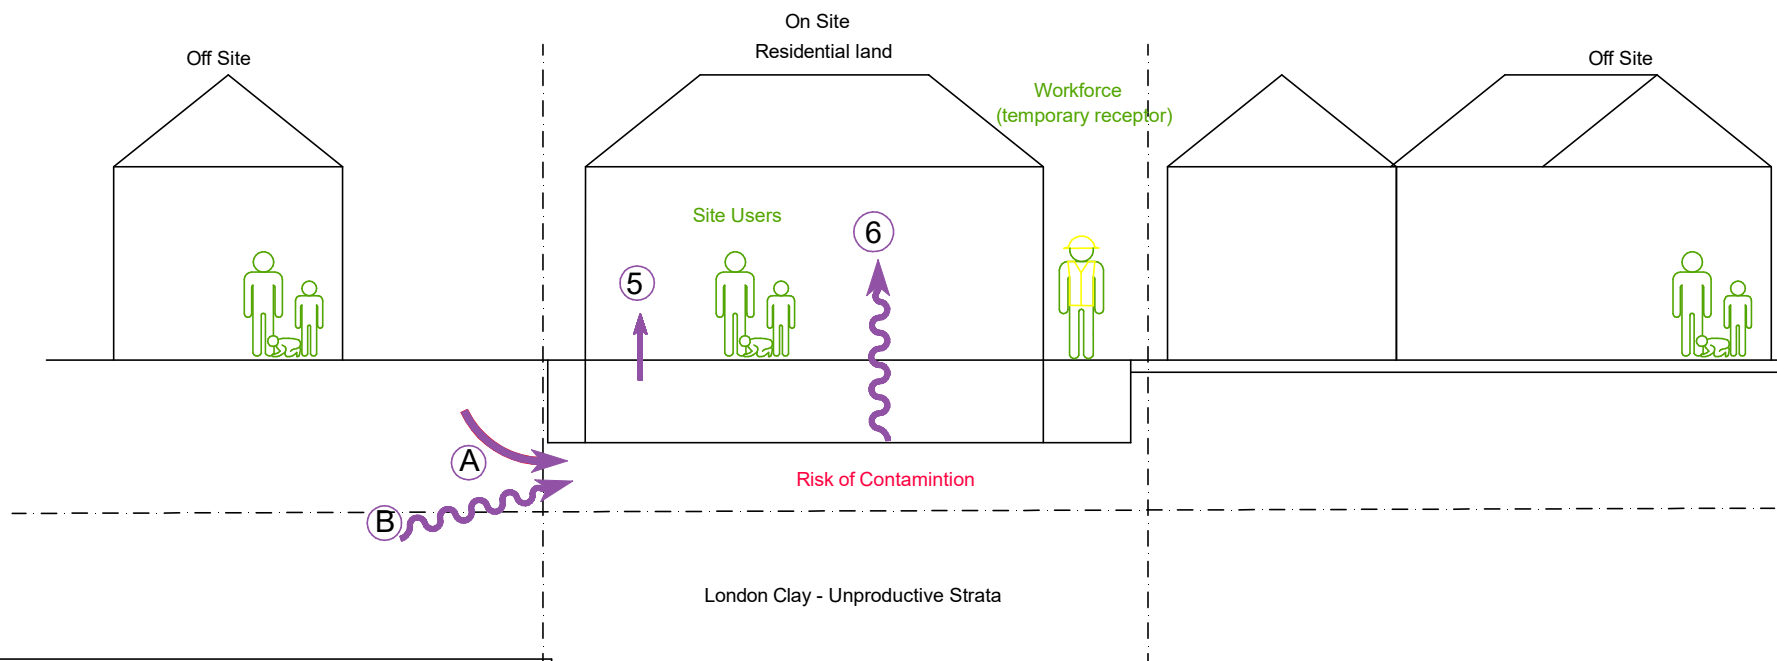
Not to Scale  
Sketch No. : DTS / 16021 / 01 / 01

Site Conceptual Model - Proposed Site Plan

- (A) Migration of contamination to the site area
- (B) Migration of land gases/ Vapours to the site area
- (C) Migration of contaminated groundwater to the site area
