550 // 9 Grove Terrace

D_002_Tree Report

9 Grove Terrace

This document provides additional information on the position, species and heights of trees surrounding the proposed structure at the rear of 9 Grove Terrace.

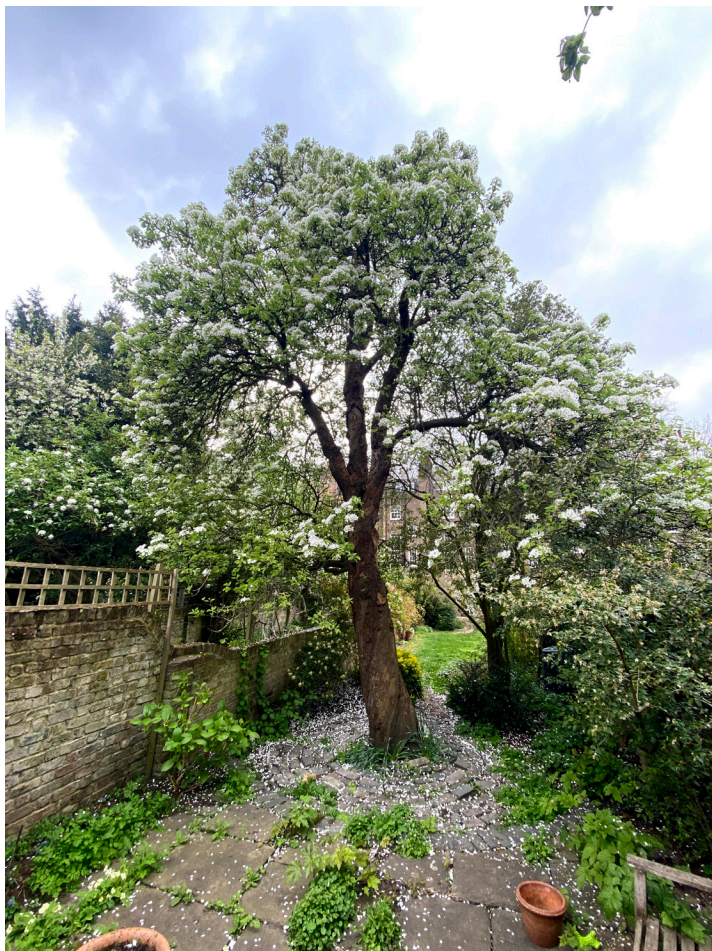
T.1 - Pear Tree

- 2.1 This Pear tree is certainly the most significant tree in the applicants garden. Located 7 m southwest of the proposed works.
- 2.2 It is believed to predate the construction of Grove Terrace and so may be 200 or so years old.
- 2.3 The tree has a significant lean to the south-east
- 2.4 It is heavily diseased with Brown Rot and may in future require support to prevent it falling over prematurely.
- 2.5 The client is particularly adamant that this protected regardless of proximity to proposed works.

- 2.6 We do not believe the tree or roots are in particular danger of damage during the works as it is sufficiently far away from where the proposed replacement structure.
- 2.7 The existing hard Granite and Yorkstone paving surrounding the tree will be retained to protect from accidental damage to roots from above. (ie shovels, heavy loads). The paving extends 6.2 m beyond the trunk of the tree and so extends just beyond the Root Protection Area of 6m.
- 2.8 The works area will be fenced off with a barrier 1 m from the back of the existing garage. The protective barrier will make a Construction Exclusion Zone (CEZ) which also encloses the Root Protection area.
- 2.9 There will be no access beyond this point permitted at all as indicated on 550-PW-ZZ-00-DR-A-0020.

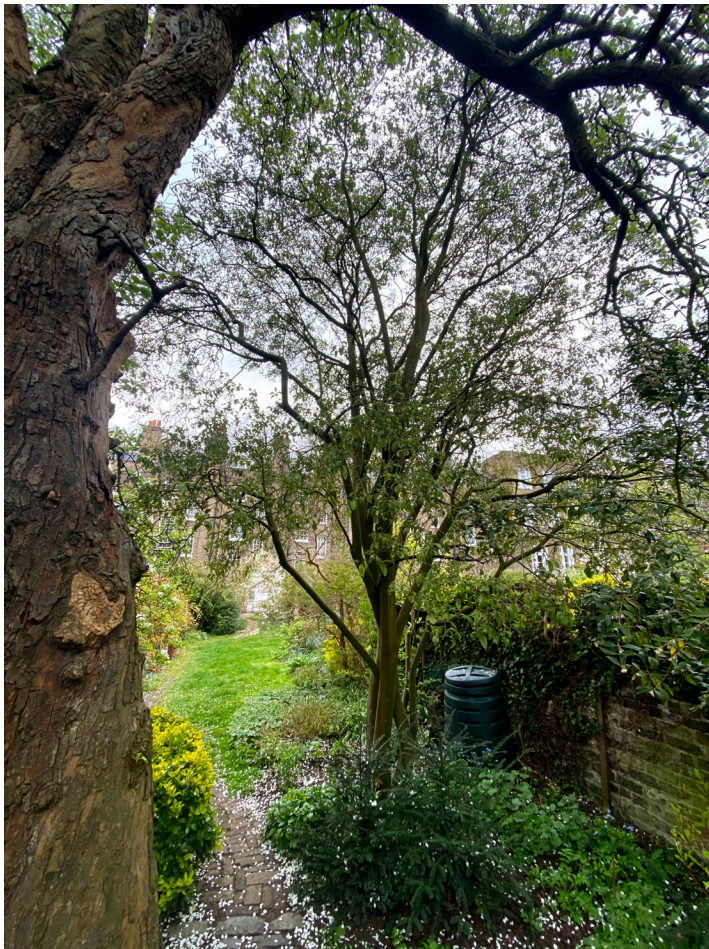
T.2 - *Hoheria sexstylosa*

- 2.10 This is a tree variety of a common bush.
- 2.11 It is located to the southwest beyond the pear tree (T.1)

- 2.12 This is well beyond the proposed works within the construction exclusion zone so no additional protection is proposed.

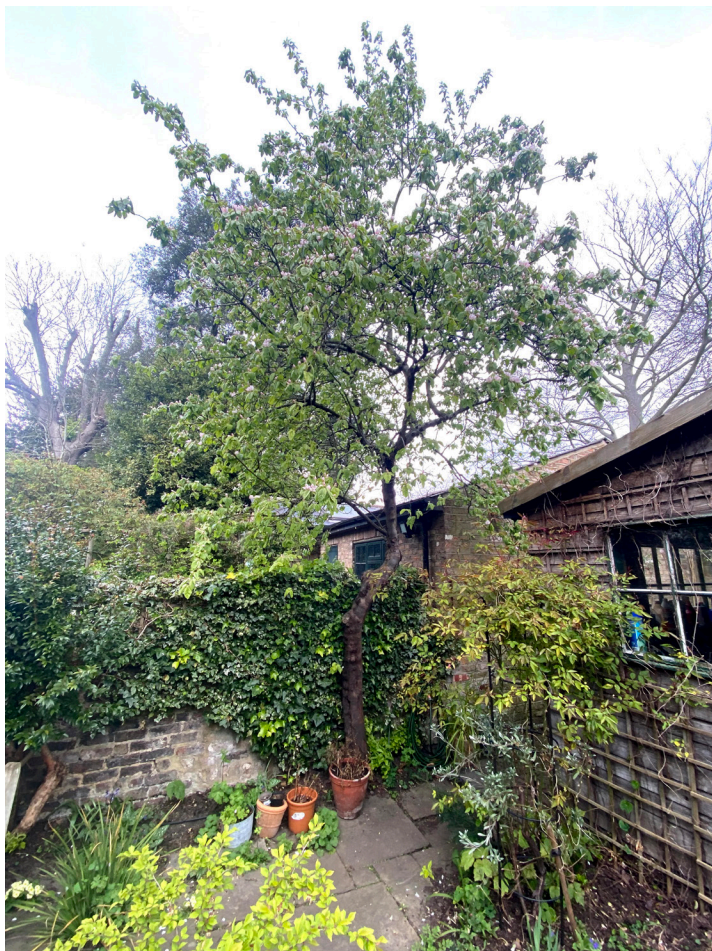
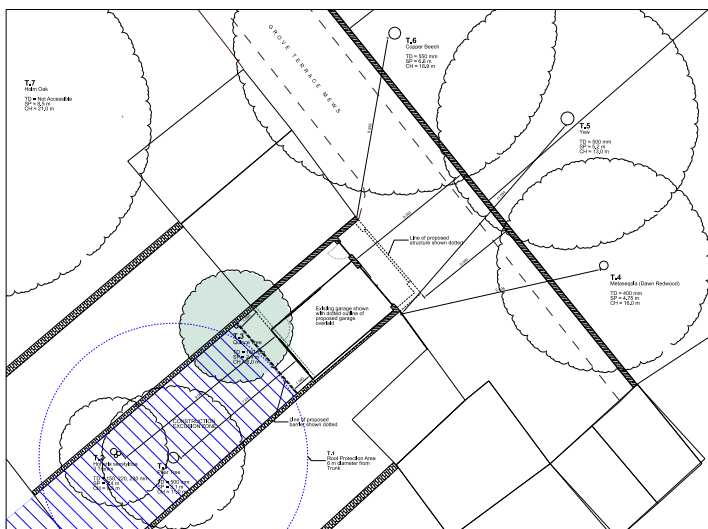
T.3 - Quince

- 2.13 This tree was planted by the applicant between 2000-2003 and has grown rapidly since then
- 2.14 It is located approximately 1 m from the wall of the proposed garage.
- 2.15 The trunk already abuts the adjacent garden wall and causes the wall to move slightly when the tree is 'wobbled'

- 2.16 As the tree is already de-stabilising the adjacent wall this presents a potential safety risk to the applicant and adjacent occupants, should the wall collapse.
- 2.17 The applicant does not wish to remove this tree but is also concerned with the ongoing safety of the garden wall.
- 2.18 The proposal therefore is to remove this tree and plant a new one in approximately the same position in the garden. But further away from the adjacent garden wall.

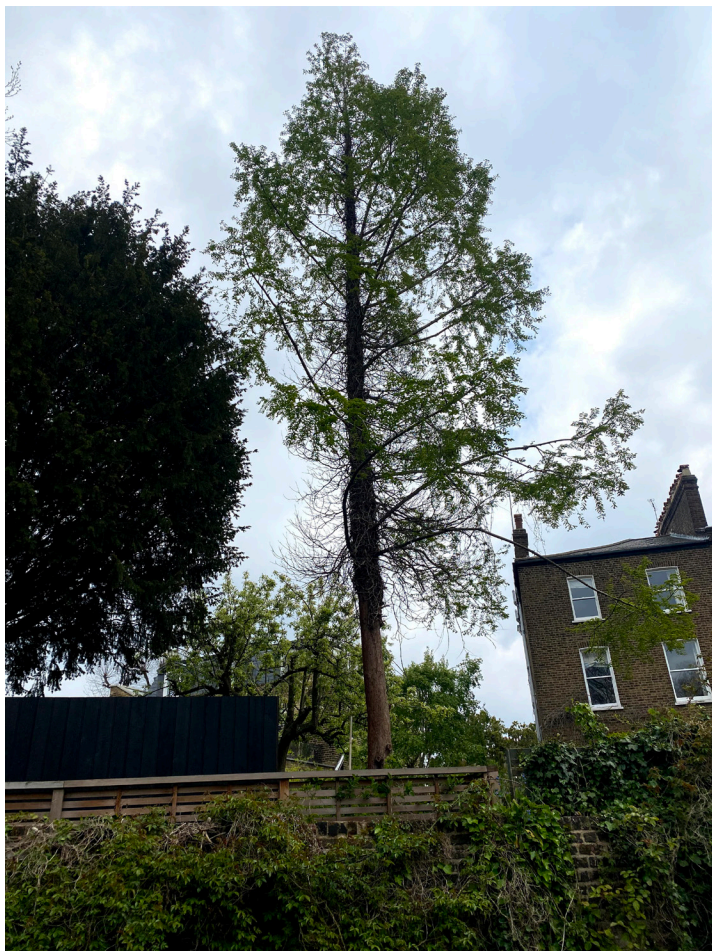
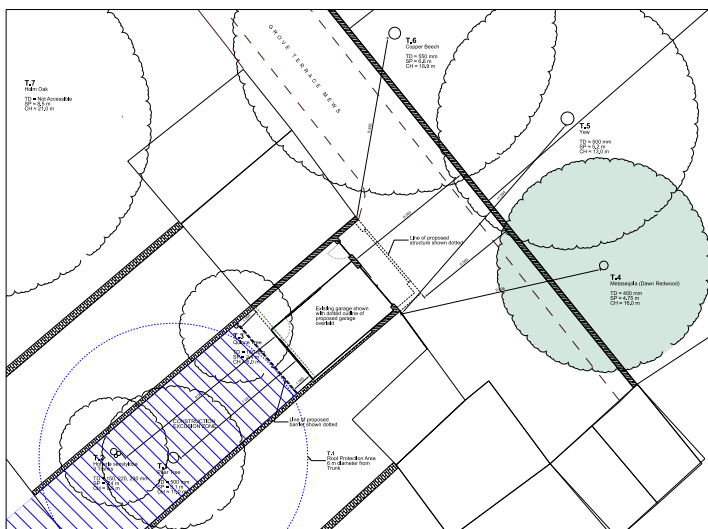
T.4 - Metasequoia (Dawn Redwood)

- 2.19 This tree was planted by the applicant in approximately 1986/87 when she lived in the adjacent property.
- 2.20 It is located approximately 2 m behind a 2.1 m high brick garden wall forming the boundary between Boscastle House and Grove Terrace Mews and over 8 m from the corner of the proposed structure.
- 2.21 The tree has been allowed to become overgrown with Ivy in the past and some of the lower branches have been affected.
- 2.22 The Ivy has since been cut back.

- 2.23 The tree is already protected by virtue of distance from the proposed work area and large garden wall.
- 2.24 No additional protection is proposed here.

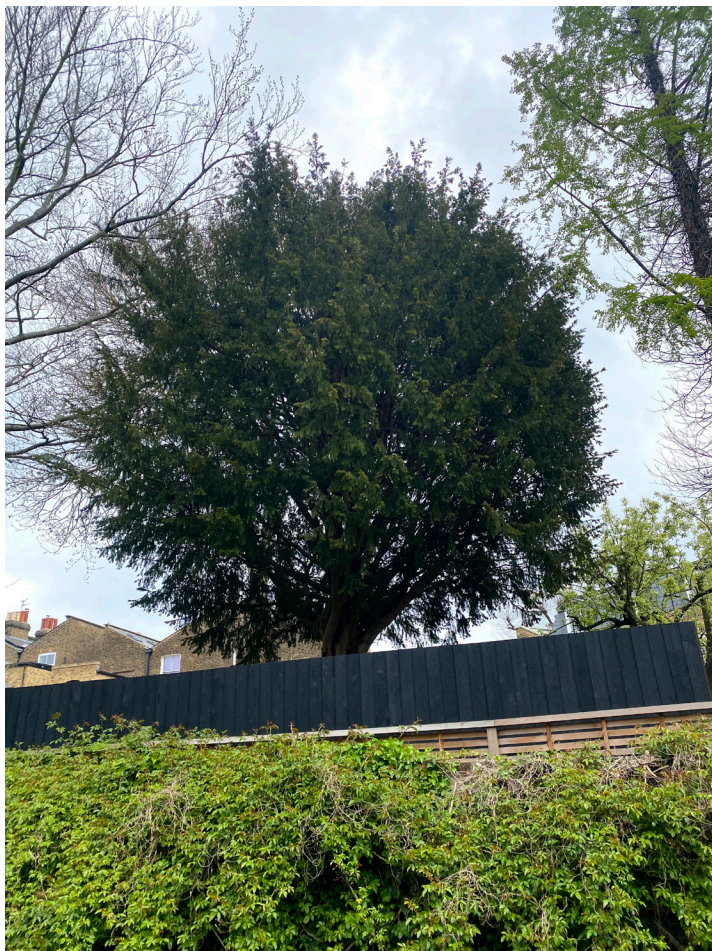
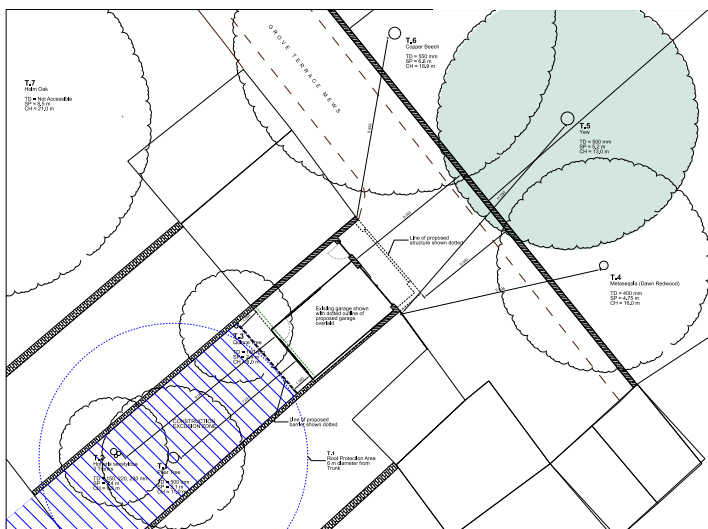
T.5 - Yew

- 2.25 It is located approximately 4.9 m behind a 2.1 m high brick garden wall forming the boundary between Boscastle House and Grove Terrace Mews and over 10 m from the face of the proposed structure.

- 2.26 The tree is already protected by virtue of distance from the proposed work area and large garden wall.
- 2.27 No additional protection is proposed here.

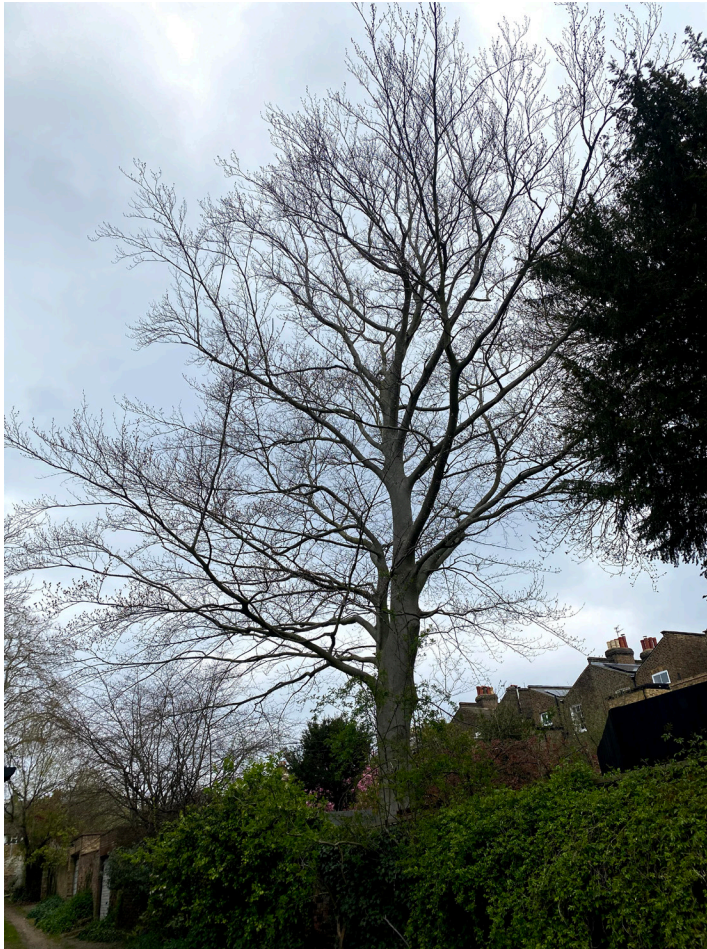
T.6 - Copper Beech

- 2.28 It is located approximately 1.2 m behind a 2.1 m high brick garden wall forming the boundary between the adjacent property and Grove Terrace Mews and over 8.5 m from the corner of the proposed structure.

- 2.29 The tree is already protected by virtue of distance from the proposed work area and large garden wall.
- 2.30 No additional protection is proposed here.

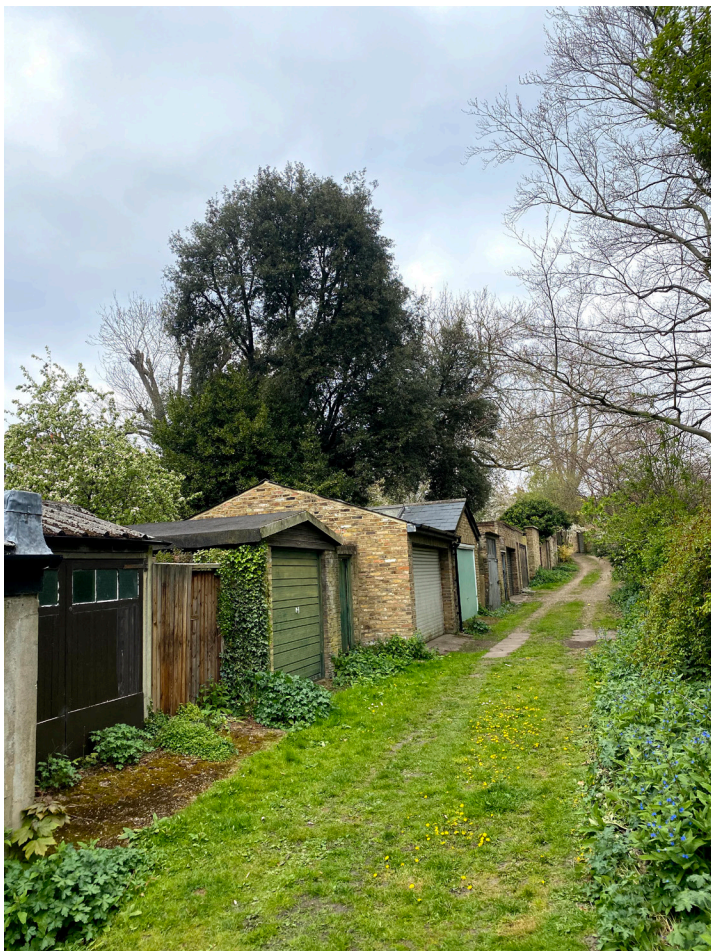
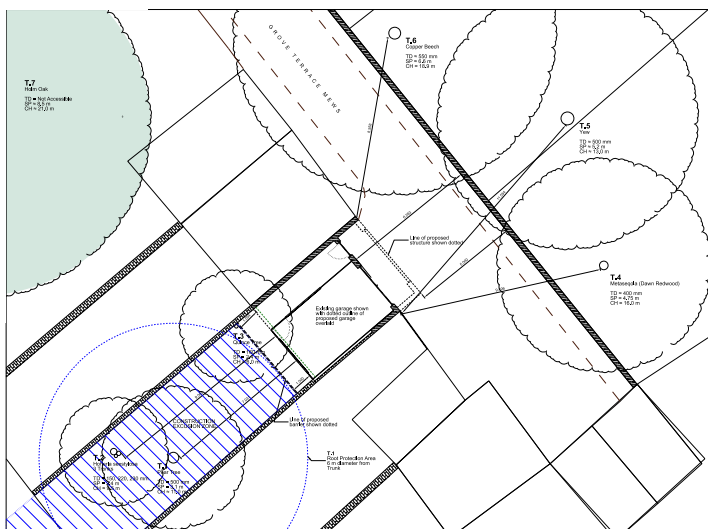
T.7 - Holm Oak

- 2.31 It is included as it is approximately 15 m away from the proposed structure.
- 2.32 It is located to the Northwest of the proposed garage and three gardens away.

- 2.33 There are three brick garden walls separating this tree from the proposed work
- 2.34 No additional protection is proposed here.
