## Site Investigation Report

Client	Crawford & Co - Allianz (Subsidence)
Client ref	
Visit date	14/02/2020
Report date	16/03/2020

## Geotechnical Testing Analysis Report

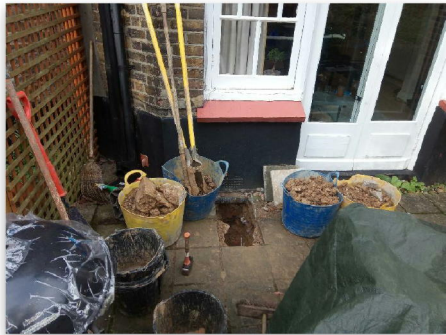
Trial Hole 1	
Fig 1.1: Trial Hole 1 Location	Fig 1.2: Trial Hole 1 Footing

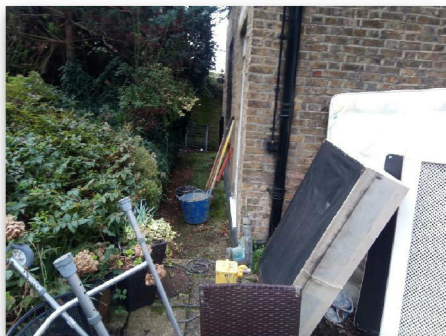
Trial Hole 2	
Fig 2.1: Trial Hole 2 Location	Fig 2.2: Trial Hole 2 Footing

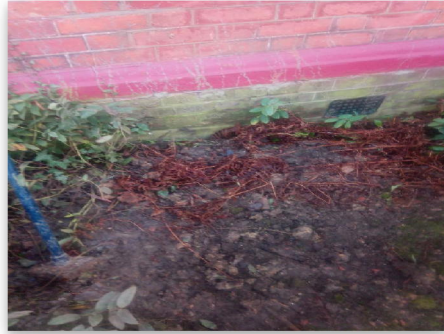
Fig 7.1: Trial Hole 3 Location

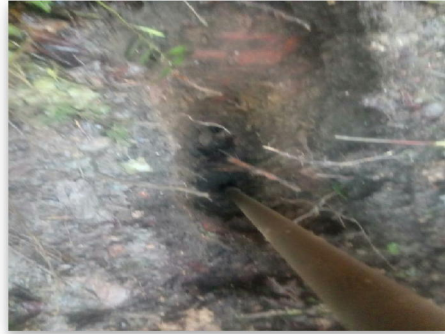
Fig 7.2: Trial Hole 3 Footing

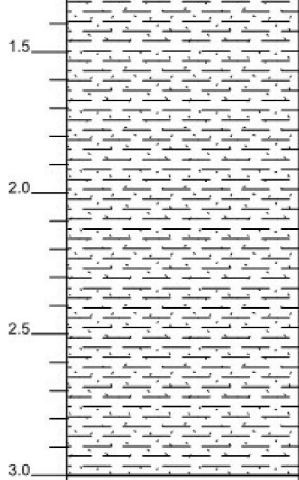
## Trial Hole Log No.1

Location: Rear LH bay

Ground Level				
0.5		Flagstones				
1.0

Brickwork				
1.5		Step Underpinned				
2.0

Brown sandy fine to medium gravelly silty CLAY	80kpa		Soil @ 1.3m	Root @ 1.3m
2.5			84kpa		Soil @ 1.8m	Root @ 1.8m
3.0

TRIAL HOLE TERMINATED	88kpa		Soil @ 2.3m	Root @ 2.3m
			90kpa			
			96kpa

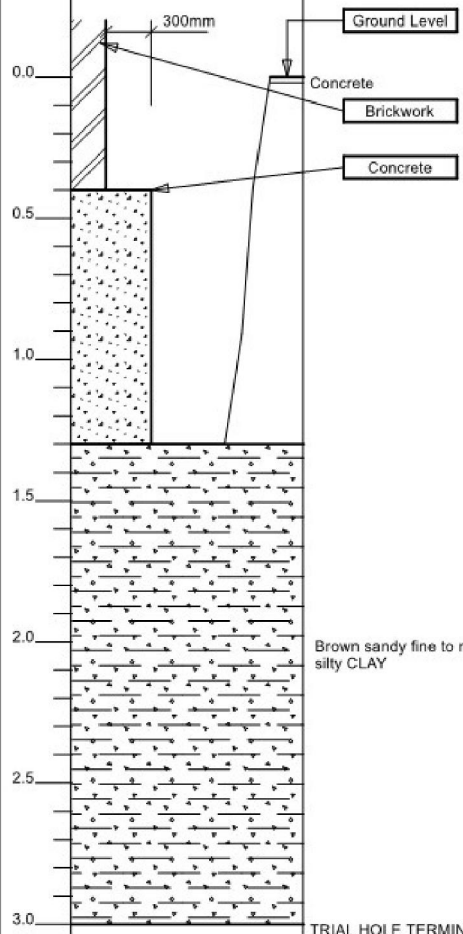
## Trial Hole Log No.2

Location: Rh outrigger

Ground Level				
0.5		Concrete				
1.0		Brickwork				
1.5		Concrete				
2.0		Brown sandy fine to medium gravelly silty CLAY	22blows		Soil @ 1.3m	Root @ 1.3m
2.5			25blows		Soil @ 1.8m	
3.0		TRIAL HOLE TERMINATED	32blows		Soil @ 2.3m	
			36blows			
			36blows

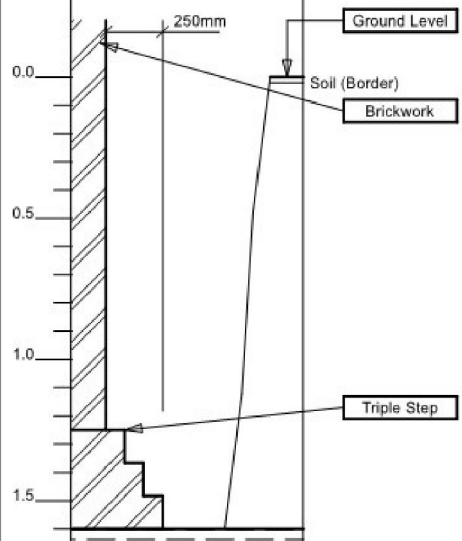
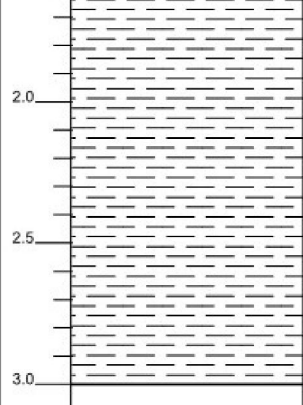
## Trial Hole Log No.3

Location: Front of bay at front of property

0.5						
1.0						
1.5						
2.0			76kpa		Soil @ 1.6m	Root @ 1.65m
2.5

Moist very stiff brown CLAY	92kpa		Soil @ 2.1m	
3.0			98kpa		Soil @ 2.6m	
		TRIAL HOLE TERMINATED	94kpa

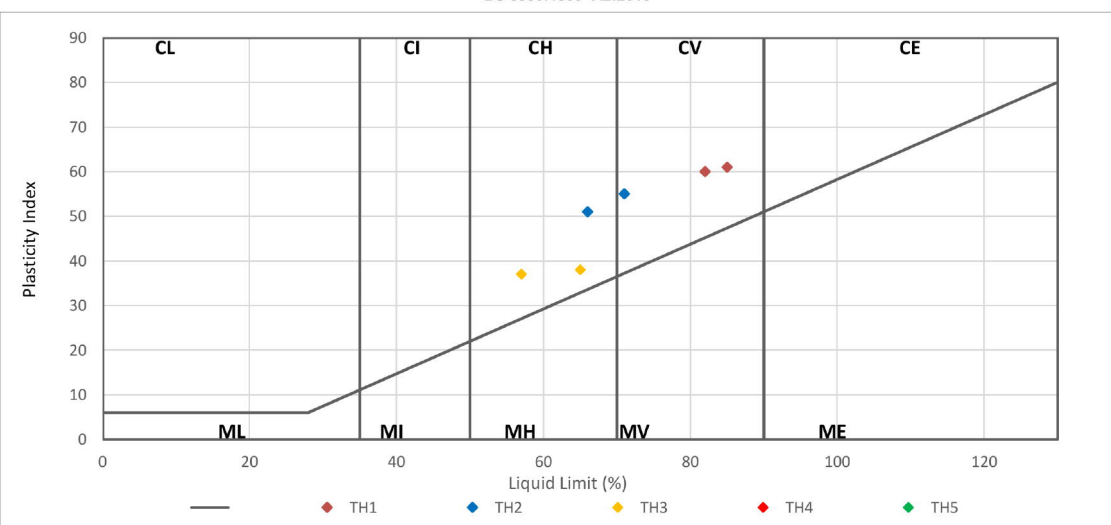
PLASTICITY CHART FOR CASAGRANDE CLASSIFICATION  
BS 5930:1999+A2:2010

Modified Plasticity Index (PI) <10 : Non Classified  
 Modified PI = 10 to <20 : Low volume change potential (LOW VCP)  
 Modified PI = 20 to <40 : Medium volume change potential (Med VCP)  
 Modified PI = 40 or greater : High volume change potential (HIGH VCP)

The Atterberg Limits May also be used to classify the volume change potential of fine soils using the National House building system, as given in the NHBC's Standards Chapter 4.2 (2003) "Building Near Trees"
