**FLAT 2, 21 POND STREET,  
LONDON, NW3 2PN**

**RETROSPECTIVE APPLICATION FOR BOILER AND FLUE INSTALLATION  
FULL PLANNING AND LISTED BUILDING CONSENT  
DESIGN AND ACCESS STATEMENT & PHOTOGRAPHS**

Ref: AM\_2122\_DAS

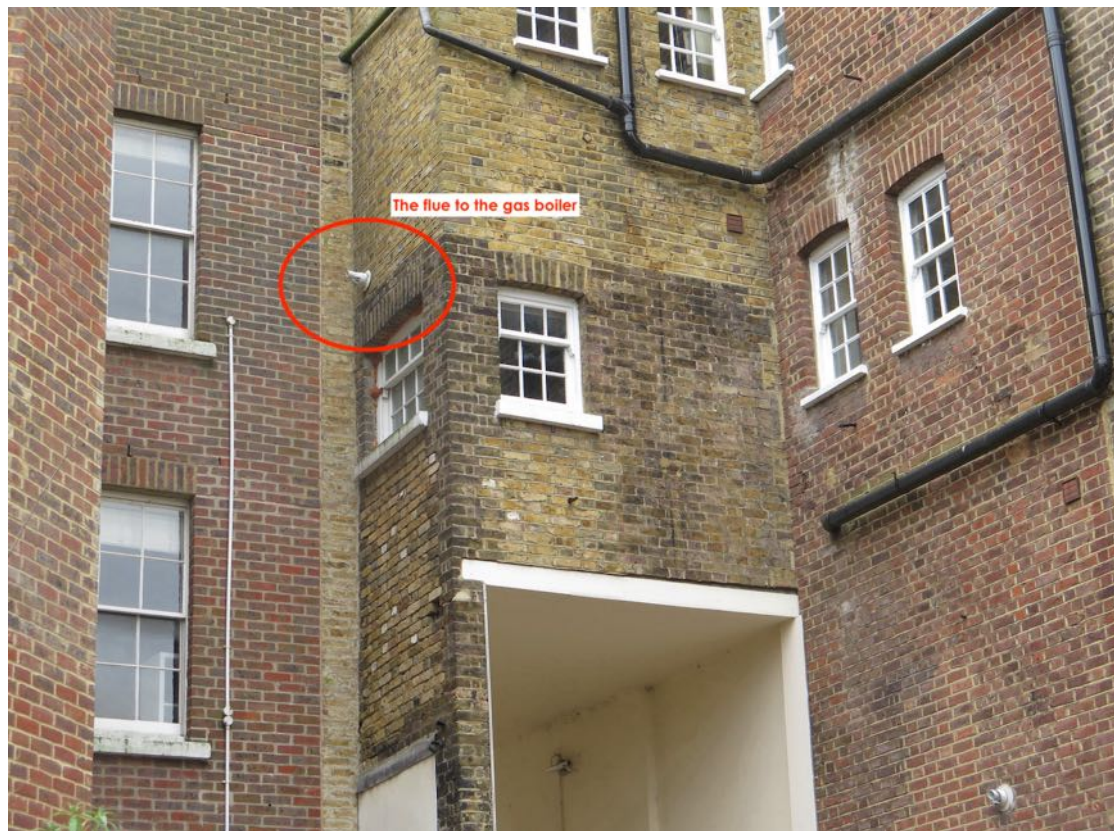
Enlarged view of the boiler exhaust flue above the east facing window in the rear bathroom of Flat 2.

- The new boiler was boxed in a cupboard and the flue routed out through the external east facing window at high level

- The boiler flue was installed on 14/02/2017, it cannot be seen from the public highway as the flue is inset on the rear east side elevation. As such it maintains the existing character and appearance of the building and area.
- Other apartments in the same block also have external boiler flues (See photos included in 9.0 Additional Photographs and drawing PL102).

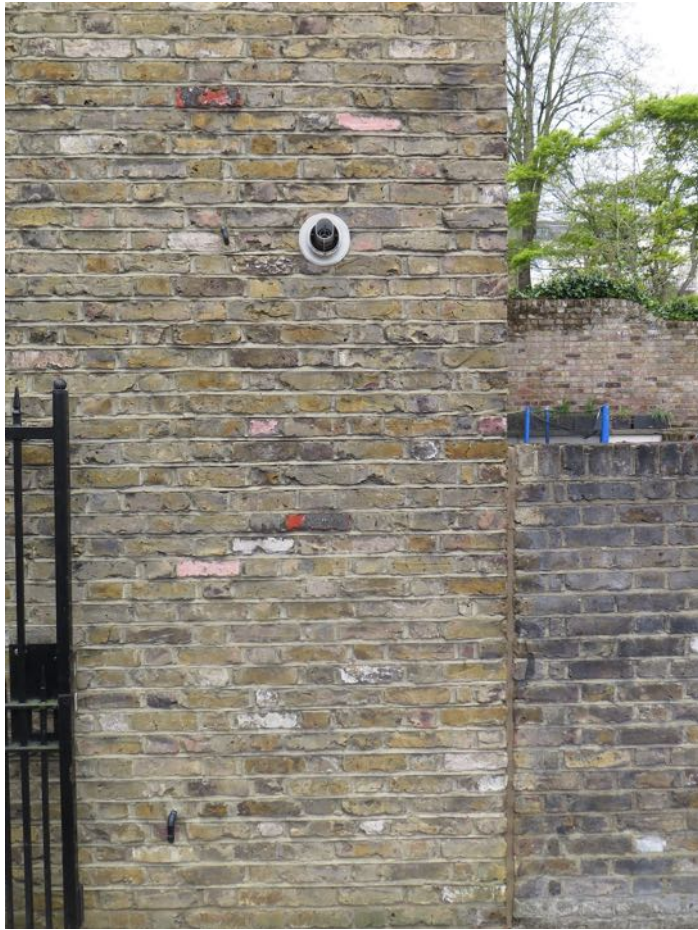
*Similar boiler flue on east wall of existing basement flat.*

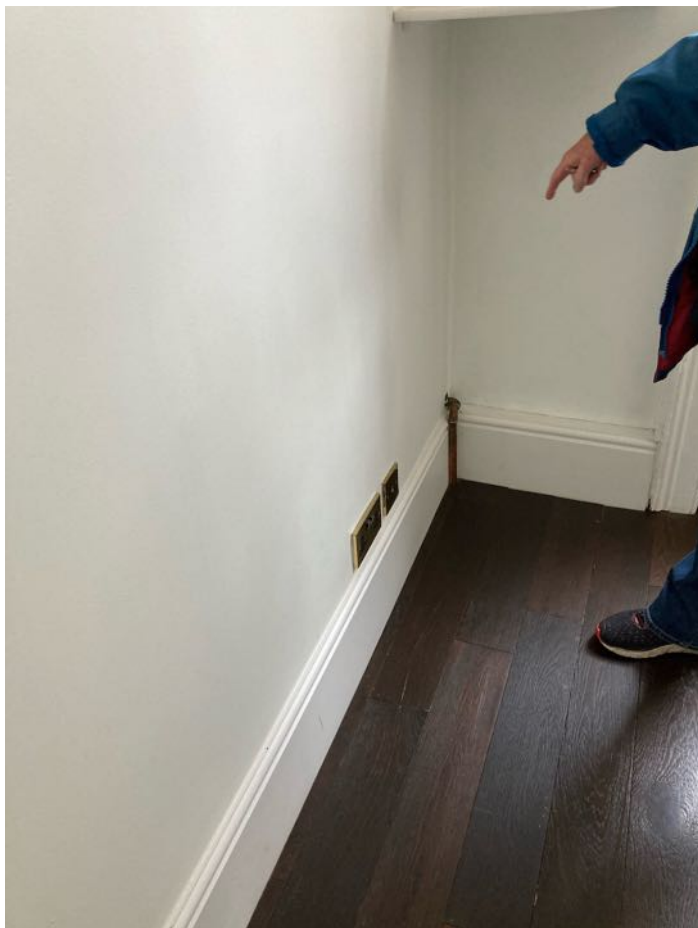
*Gas pipe entering Bed 2 from services cupboard at ground floor.*

- The new gas pipework is shown in the attached photographs and located on the plan drawing PL101, and runs from the existing supply pipework, through into the main bedroom and then into the rear bathroom, set just above skirting level.

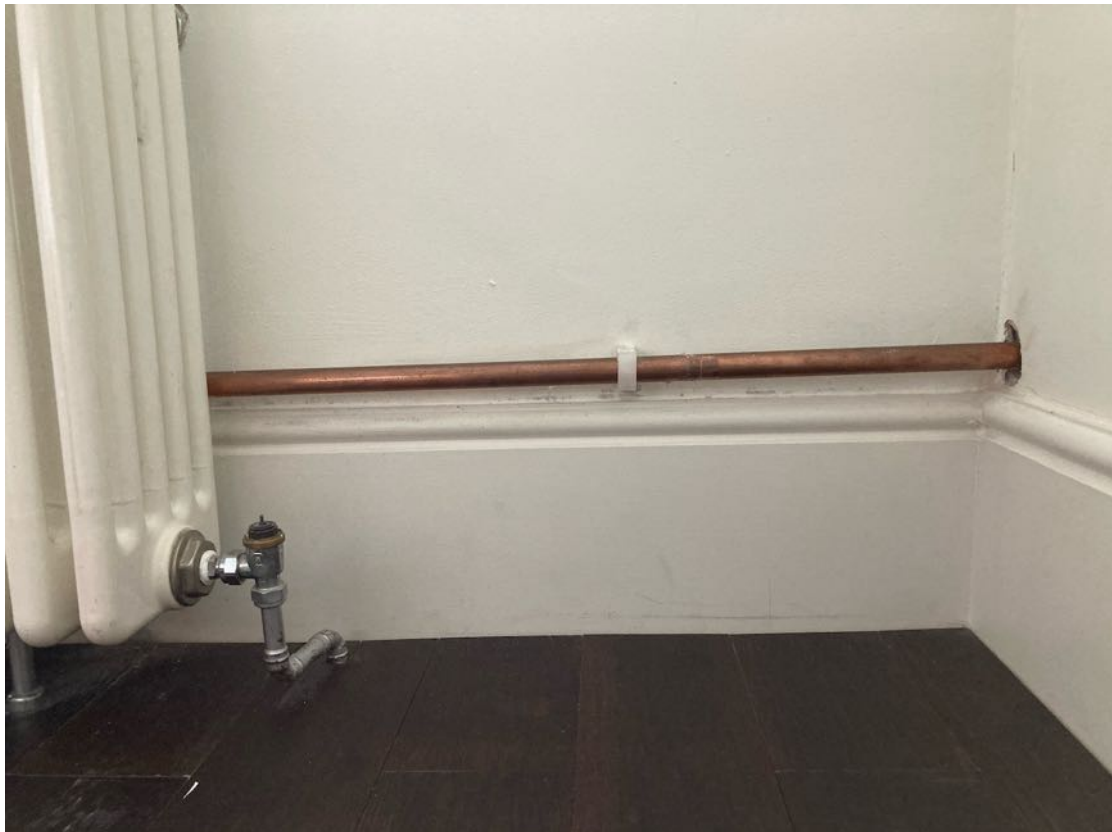
*Gas pipe entering Bed 1 through wall from Bed 2.*

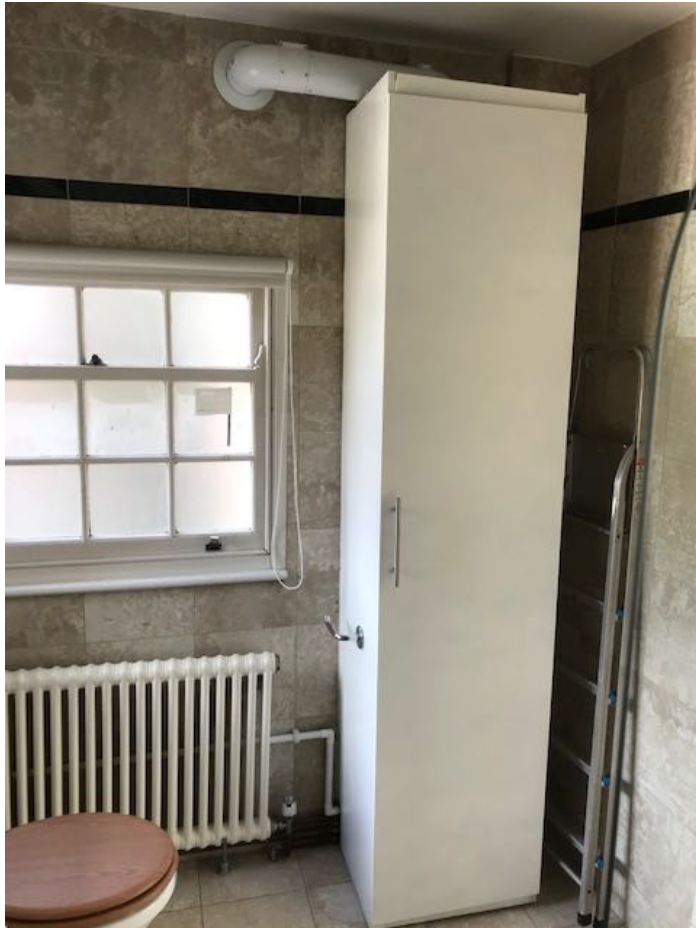
Bathroom boiler cupboard with flue above.

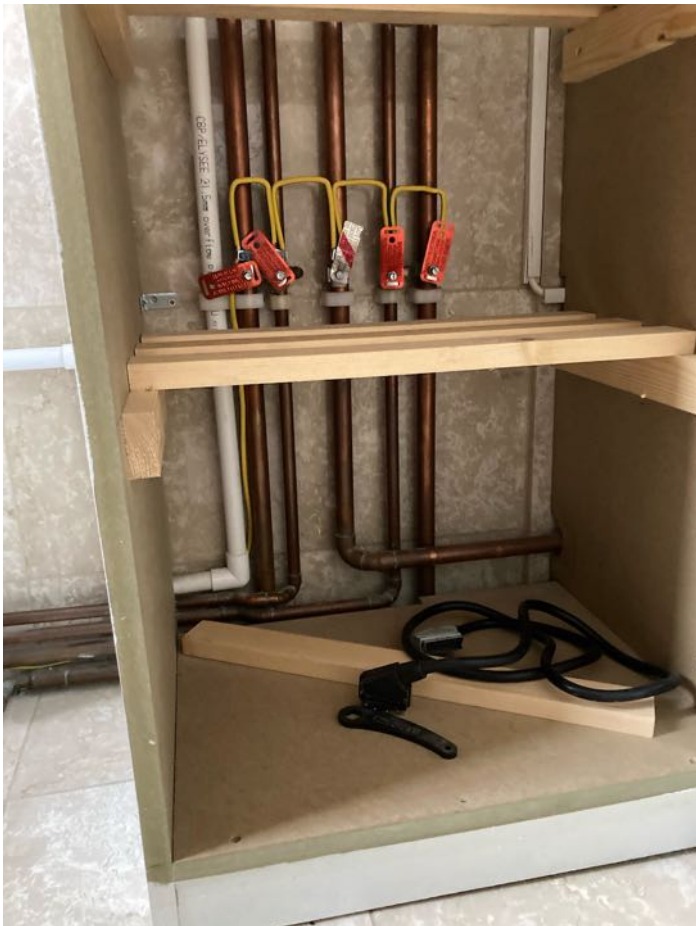
New pipework within boiler cupboard.

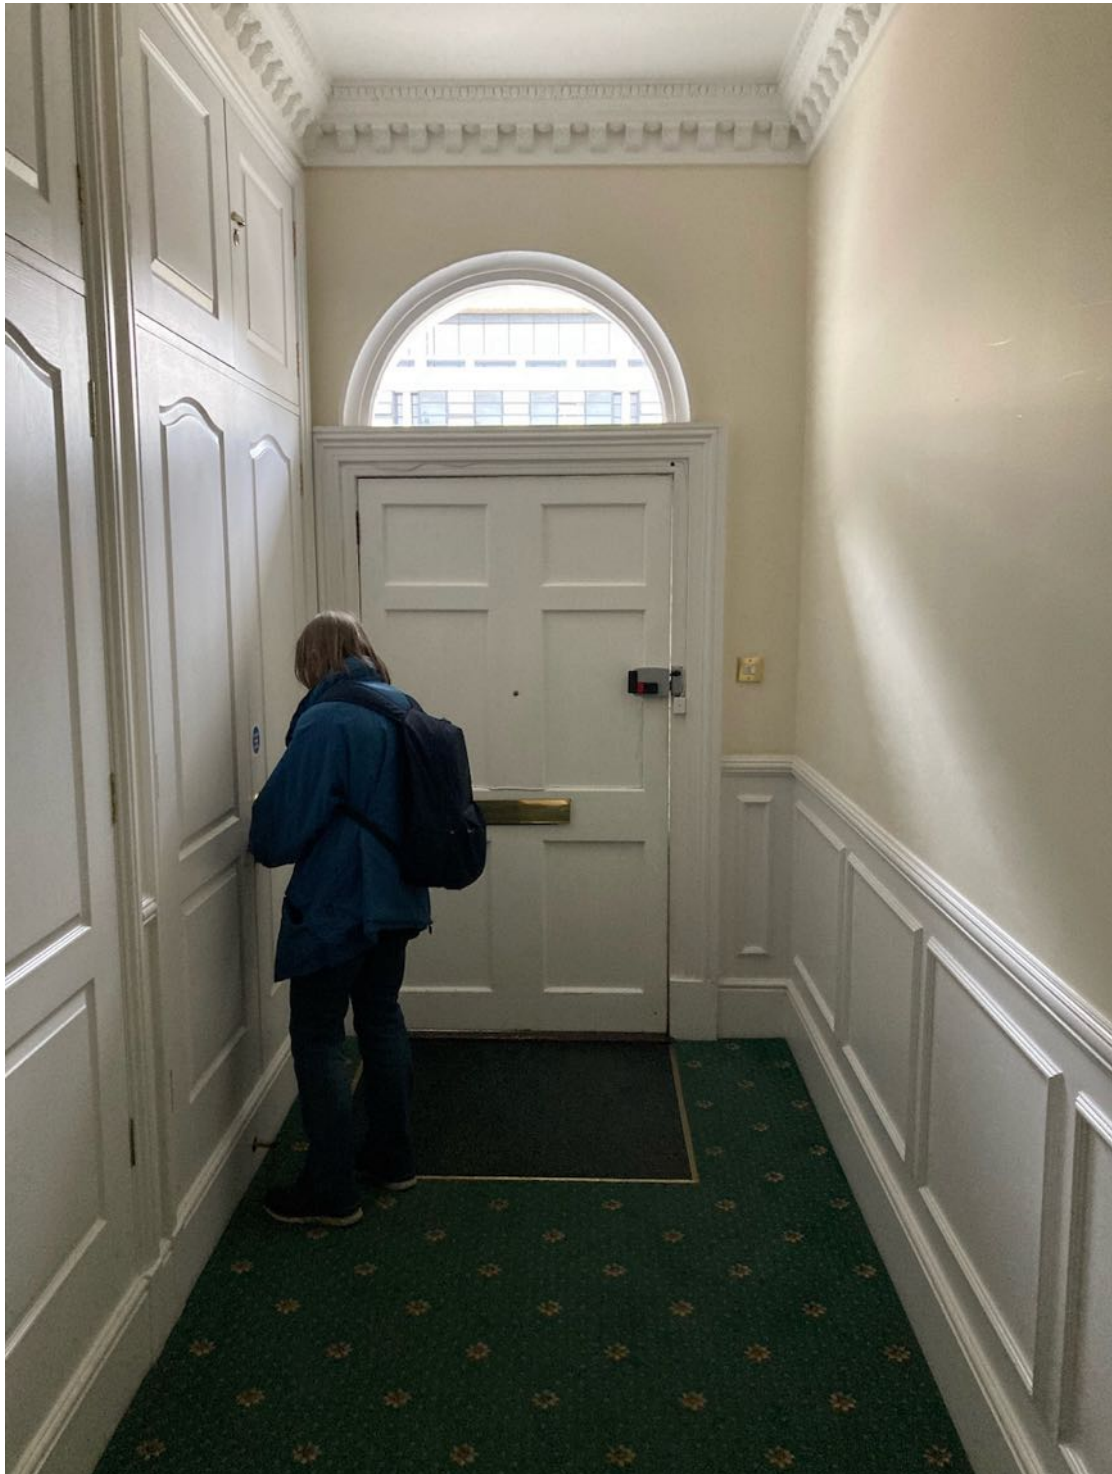
*Services cupboard at communal ground floor entrance.*

- The boiler had broken down in the middle of winter (Jan/Feb. 2017), so there was some urgency in getting a replacement. The only outside walls that could be used for the new flue were the front elevation, facing the street, which would affect the appearance of the building as seen from the street (and would mean having the boiler in the living room or bedroom), or the west wall of the bathroom, where it would be largely concealed on a side (east facing elevation). My Client was advised that the only place a new boiler could be installed was on the bathroom wall. This required the rerouting of the gas pipes (which came up into the second bedroom from the existing services cupboard directly below, located within the communal hallway at ground floor.
