Migration Museum Study

Option 01 - Flatiron Model

H1 Desk Study

EXPLORATORY HOLE RECORDS

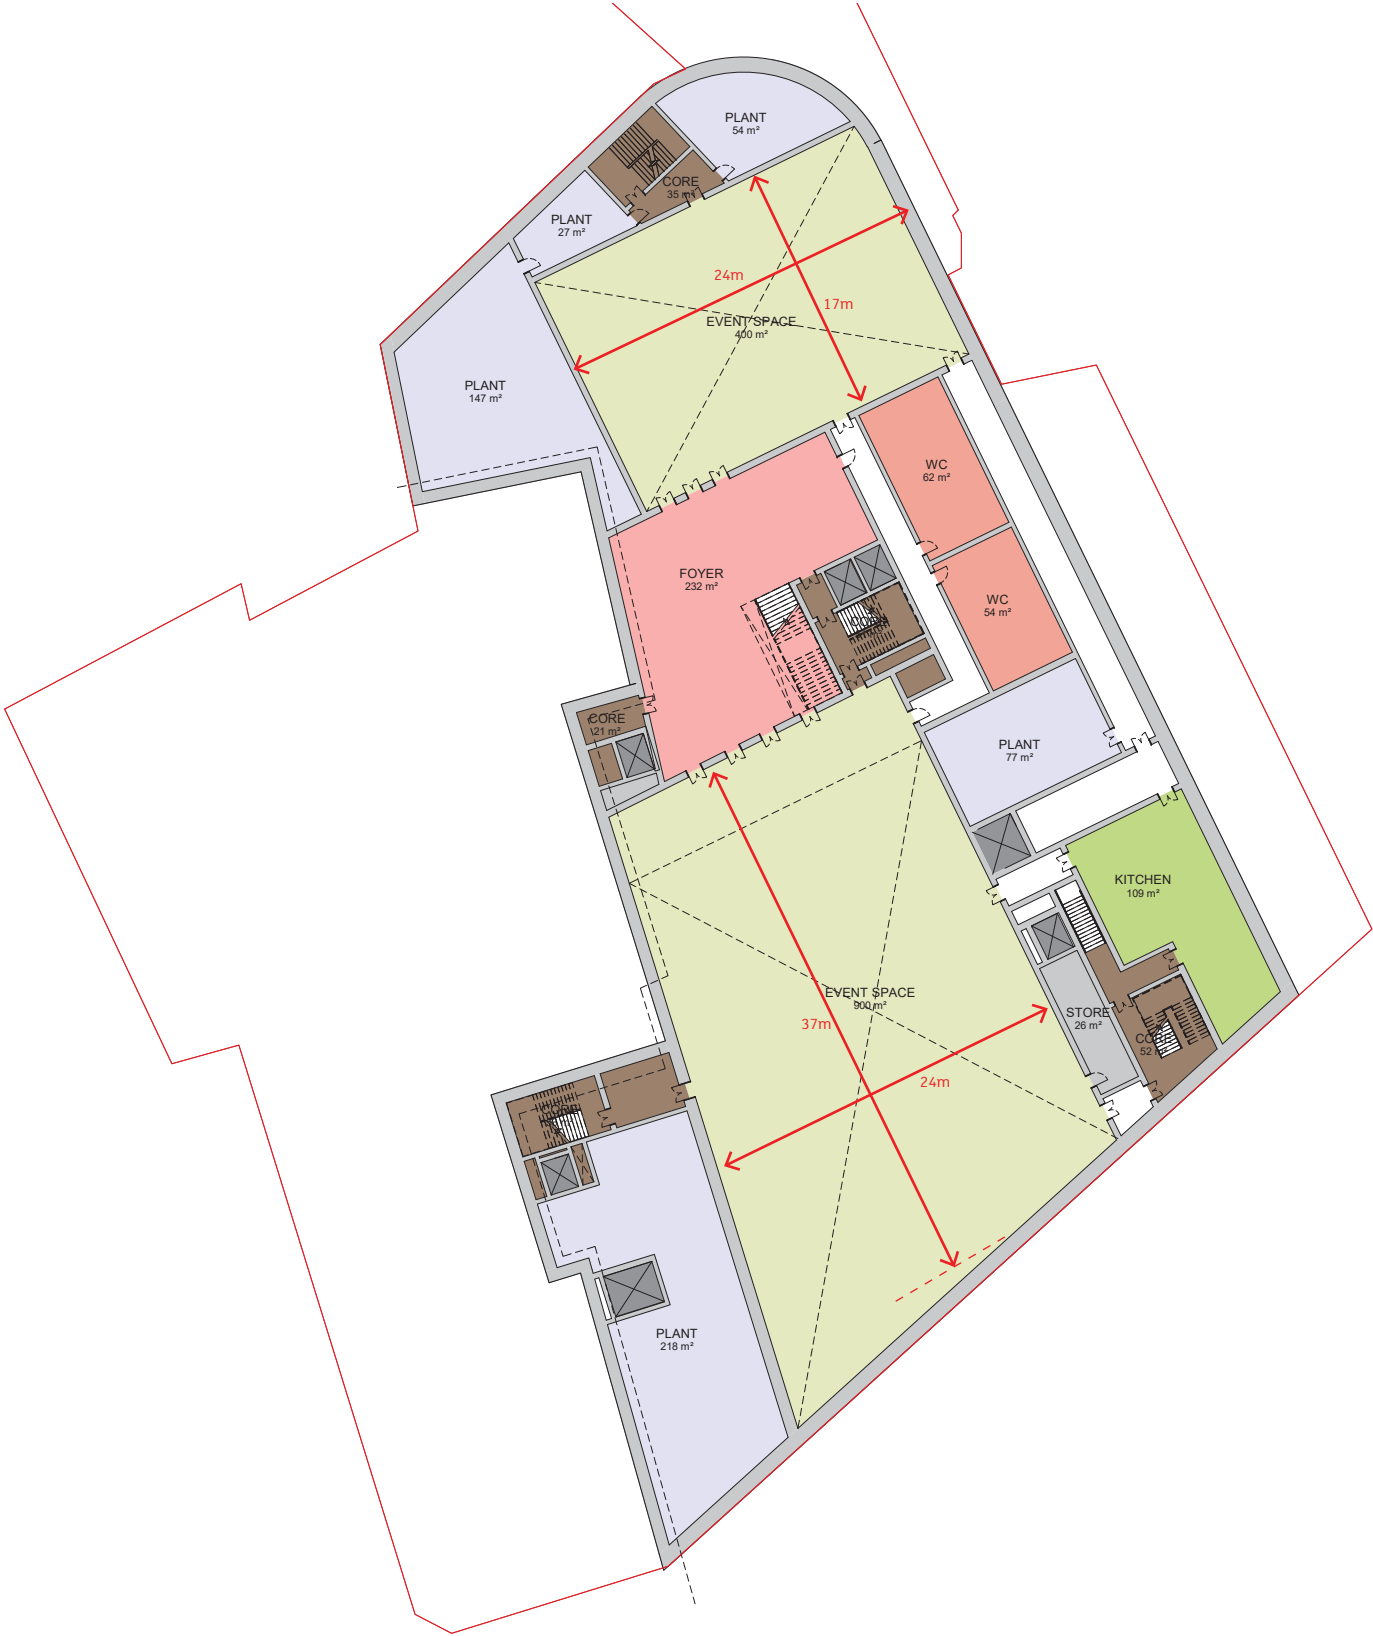
Basement 2 Plan

----- 1.4m offset

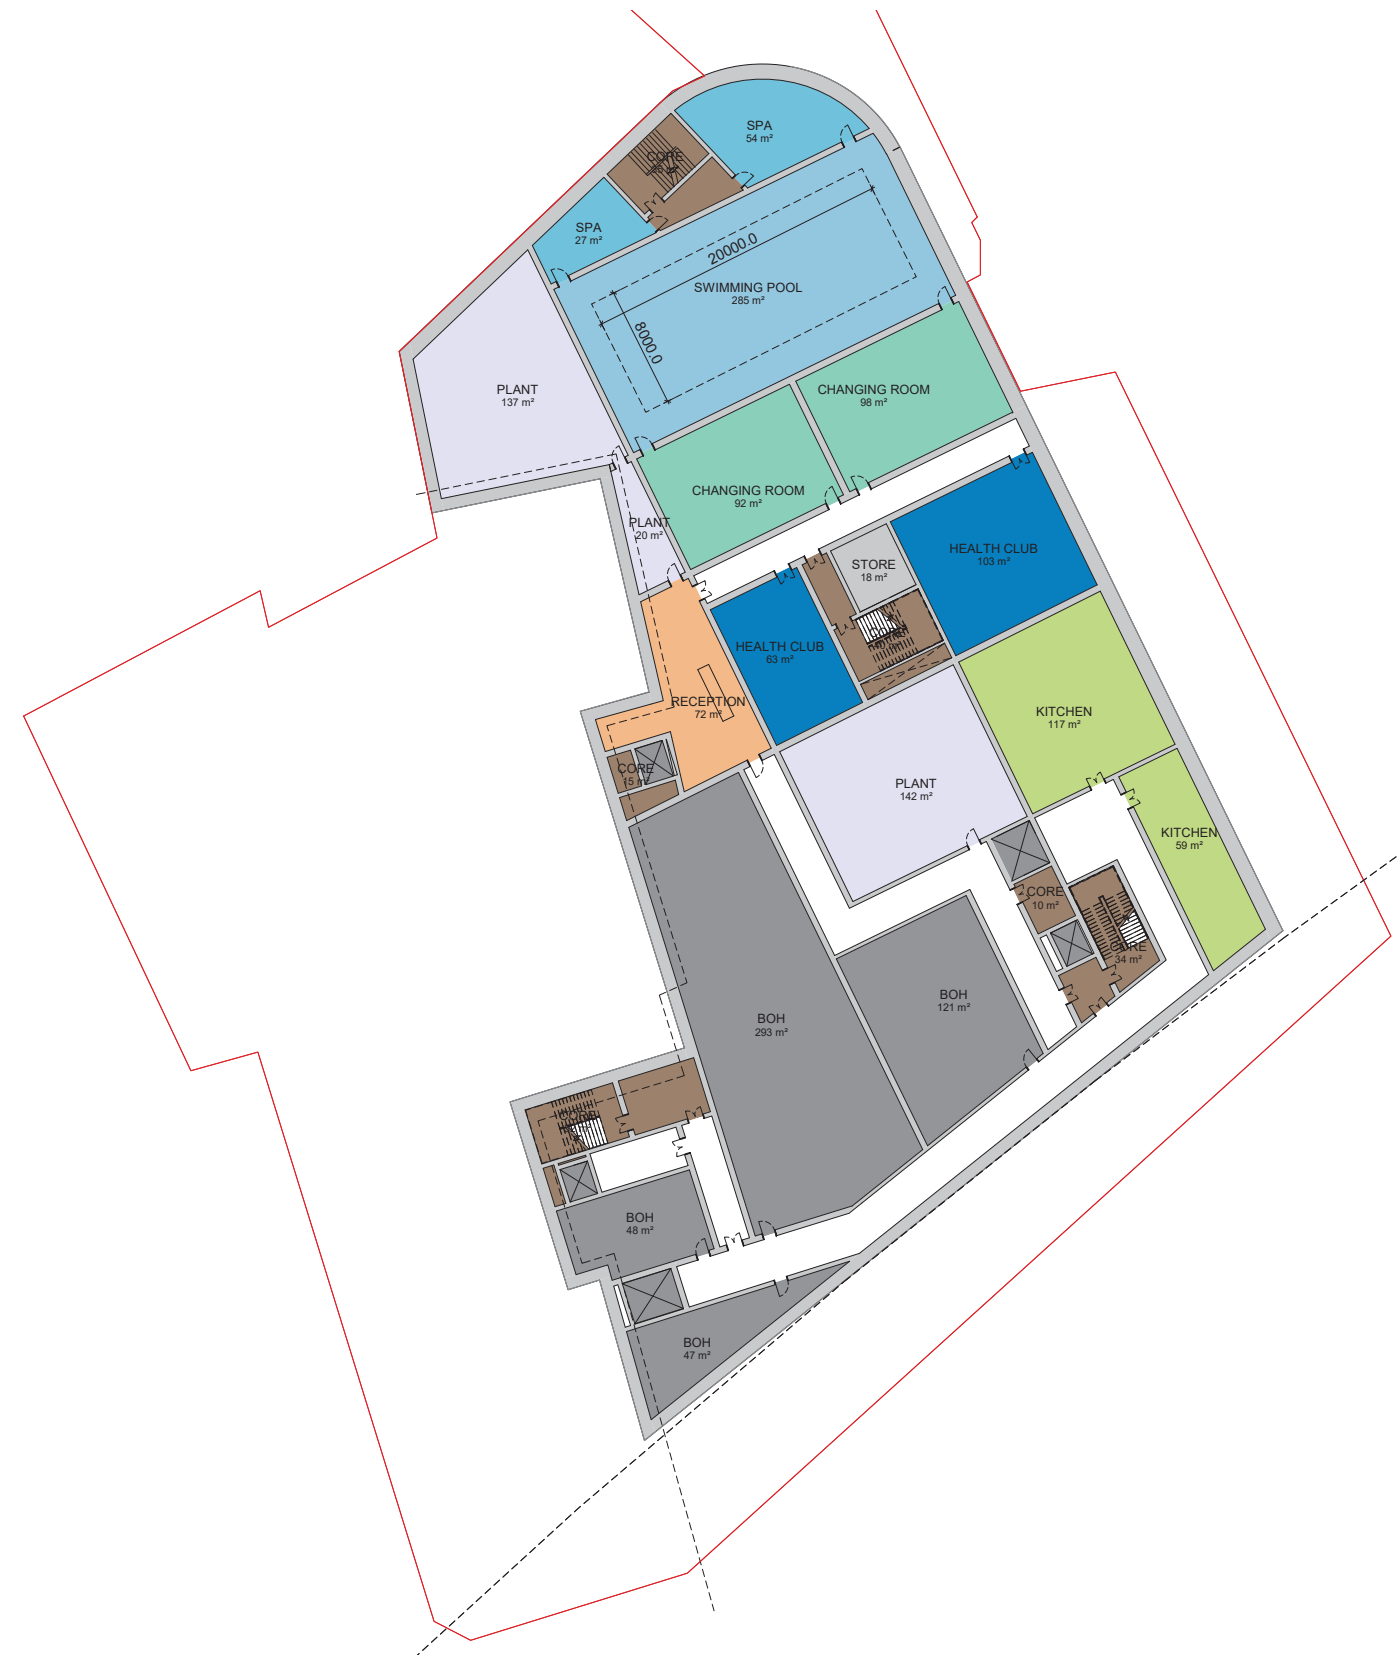
Basement 3 Plan

----- 1.4m offset

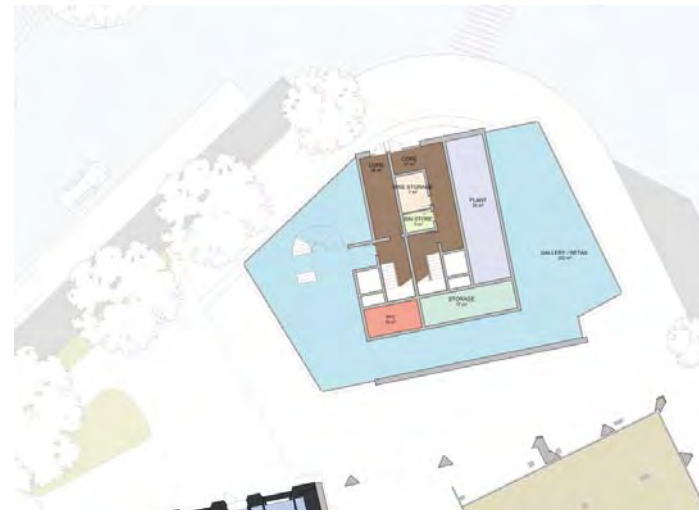
Ground Floor Plan

- Total GIA = 3,600m² / 39,000ft²
- Cultural GIA = 1,000m² / 11,000ft²
- Resi. GIA = 2,500m² / 28,000ft²
- Total number of apartments: 24
- 25% Apartments of 1b 2p (6)
- 37.5% Apartments of 2b 4p (9)
- 37.5% Apartments of 3b 6p (9)

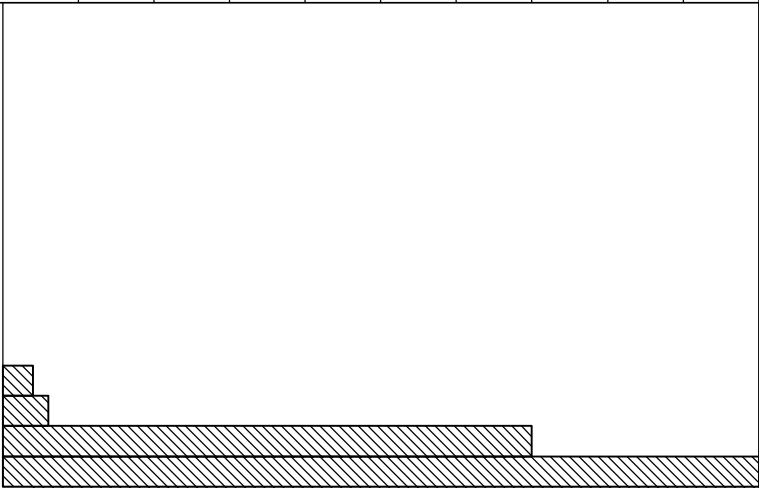
Contract: Grange Central Saint Martins			Client: Grange St. Martins Hotel Ltd		Probe ref: WS3
Contract Ref: 372042	Date: 26.02.20	Ground Level (m AOD): ---	Co-ordinates: ---		Sheet: 1 of 1

DEPTH (m)	READING (Blows/100mm)	DIAGRAM (N100 VALUES)	TORQUE ON RODS (Nm)	REMARKS
0.5				
1.0				
1.5	2 3 35 50

2.0		Dynamic probe hole terminated at 1.60m depth.		
2.5				
3.0				
3.5				
4.0				
4.5

Equipment Information: Type of cone used: **Disposable**. Type of anvil used: **Loose**.
