40 Leighton Road, London, NW5 2QE

Arboricultural Report, Tree Constraints Plan
&
Impact Assessment

Survey Date: Tuesday, 30 March 2021

Report Date: Wednesday, 31 March 2021

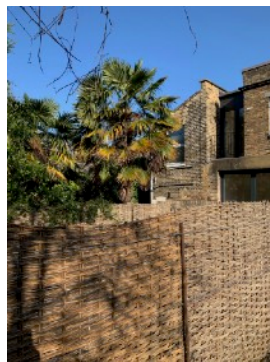
| Ref | Species | H/T | Stems | Dia | Canopy | | | | First | Crown | Age | Yrs | Cat | Observations | Recommendations | RPA (r) | RPA (a) | TPO/CON |
|---|---|---|---|---|---|---|---|---|---|---|---|---|---|---|---|---|---|---|
| T4 | Palm | 5 | S | 250 | 1 | 1 | 1 | 1 | 3N | 2.5 | Early Mature | 40 | C | Good overall condition, within neighbouring property | None | 3 | 28.3 | CON |
