## Arboricultural assessment & method statement

146-150 Royal College Street, Camden, London

28<sup>th</sup> April 2021

19268-AA-3-DC

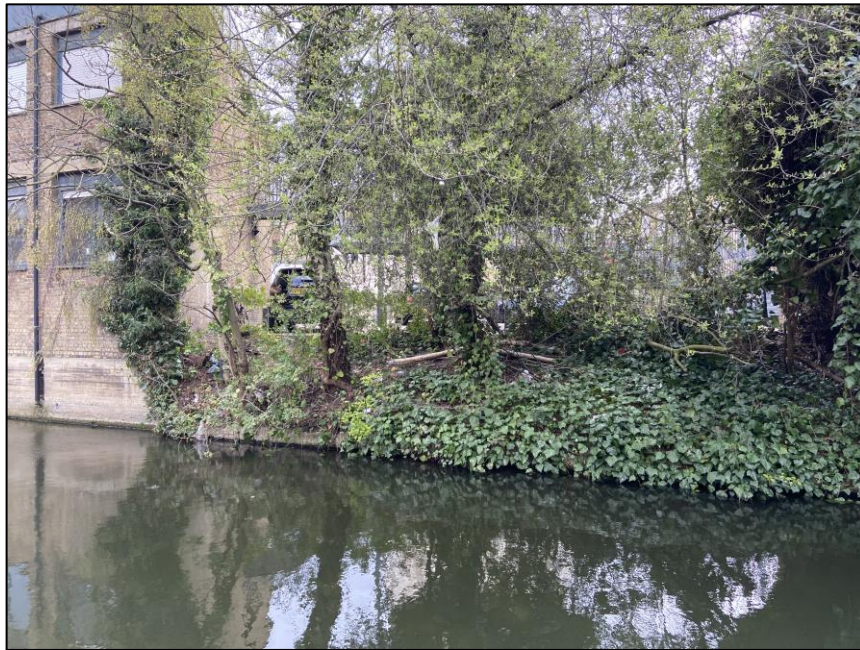
**Photo 2:** A closer view of group G1 and tree T2. The general quality is poor with little potential to improve.

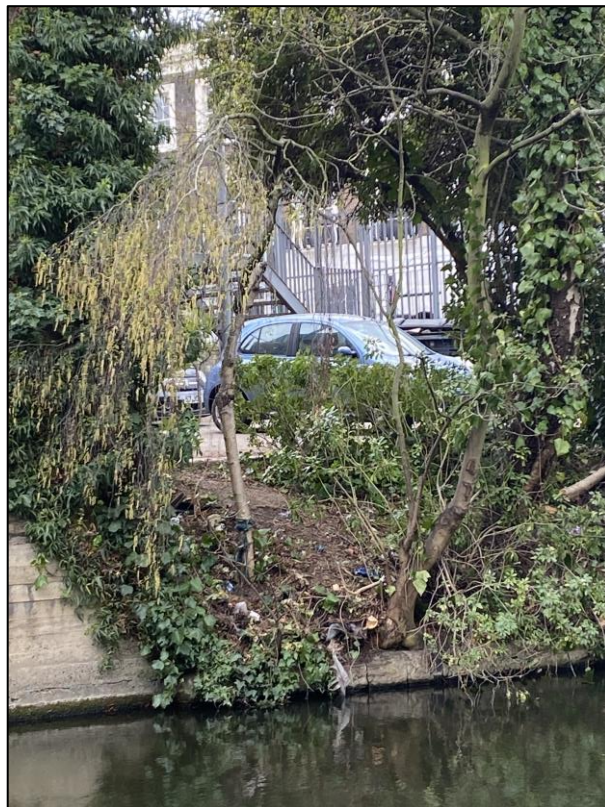
**Photo 3:** A closer view showing the poor form of group G1 growing close to the bank of the canal.

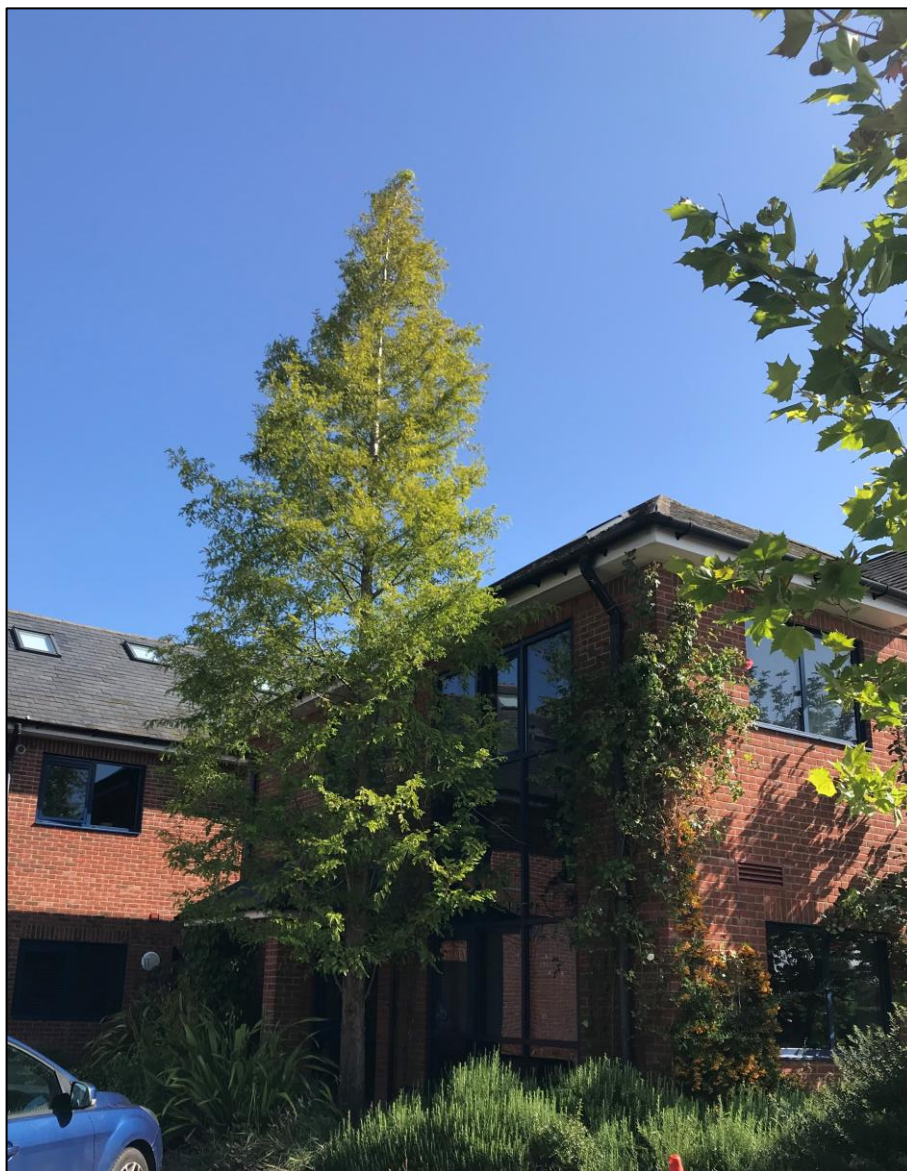
**Photo 4:** This shows an example of a dawn redwood (*Metasequoia glyptostroboides*) which was planted in front of Barrell Tree Consultancy's office in 2008. This species is particularly well suited to grow close to buildings due to its upright architectural form and light foliage. It can reach a height which can contribute to the wider amenity without creating an unreasonable relationship with the new building.

As part of the scheme, a comprehensive landscape design has been submitted by Gluckmansmith to include the new specimen dawn redwood as a direct replacement for tree T2. In addition, extensive new shrub planting to mitigate the removal of group G1 and provide a more sustainable and enhanced green strategy. All new trees will be specified and planted in accordance with the recommendations in BS 8545 (2014) *Trees: from nursery to independence in the landscape – Recommendations*.
