GEO-ENVIRONMENTAL & GEOTECHNICAL ASSESSMENT (GROUND INVESTIGATION) REPORT

146-150 ROYAL COLLEGE STREET, LONDON NW1 0TA

Report Title: Geo-environmental & Geotechnical Assessment Ground Investigation Report for 146-150 Royal College Street, London NW1 0TA

Job No: P2478J1837/AJH

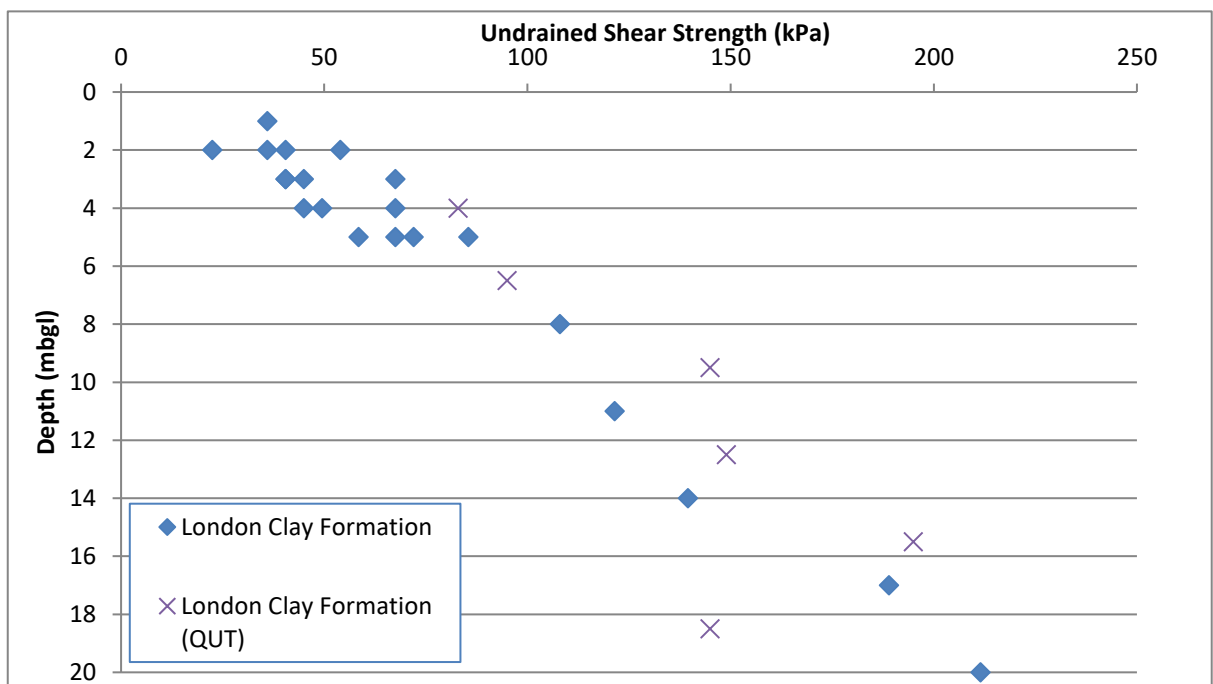
Figure 9.1: Undrained Shear Strength v Depth

9.4.3 The graph below shows the shear strength profile of the London Clay Formation encountered at the site, based on the SPT to shear strength correlation described above, as well as the results of undrained triaxial tests on undisturbed samples taken from the boreholes.

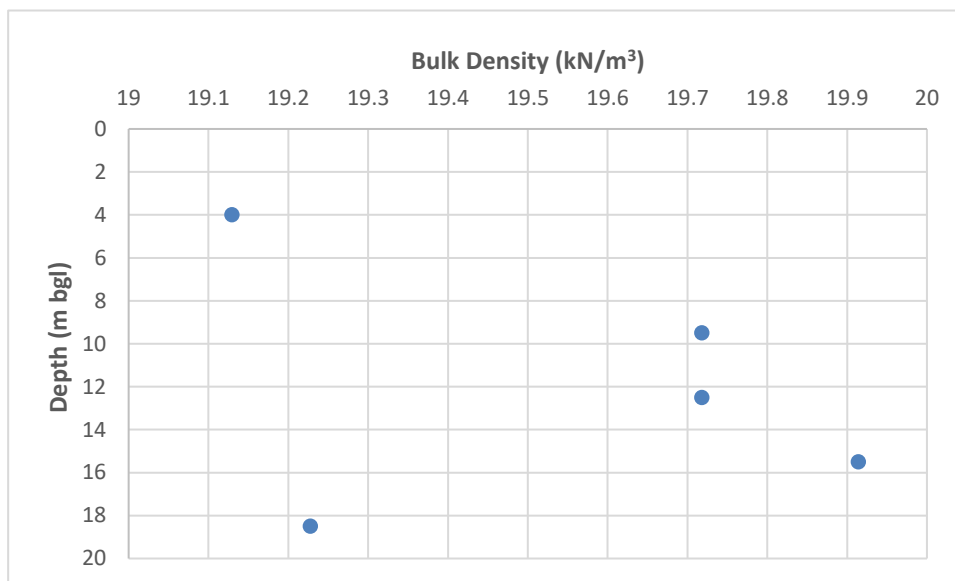
Figure 9.2: Bulk Density of the London Clay Formation v Depth

9.5.1 In order to calculate the undrained shear strength using the quick undrained triaxial methodology the bulk density of the materials has to be calculated. These values are provided on the quick undrained triaxial testing certificates provided in Appendix 4. These results are summarised in the figure below.

9.5.2 As can be seen on the graph above there appears to be two separate trendlines of bulk density v depth. It should be noted that the two lines are approximately parallel and therefore it suggests that the noted differences in bulk density is likely to be due to varying quantities of secondary constituents and not variations in the primary constituent.

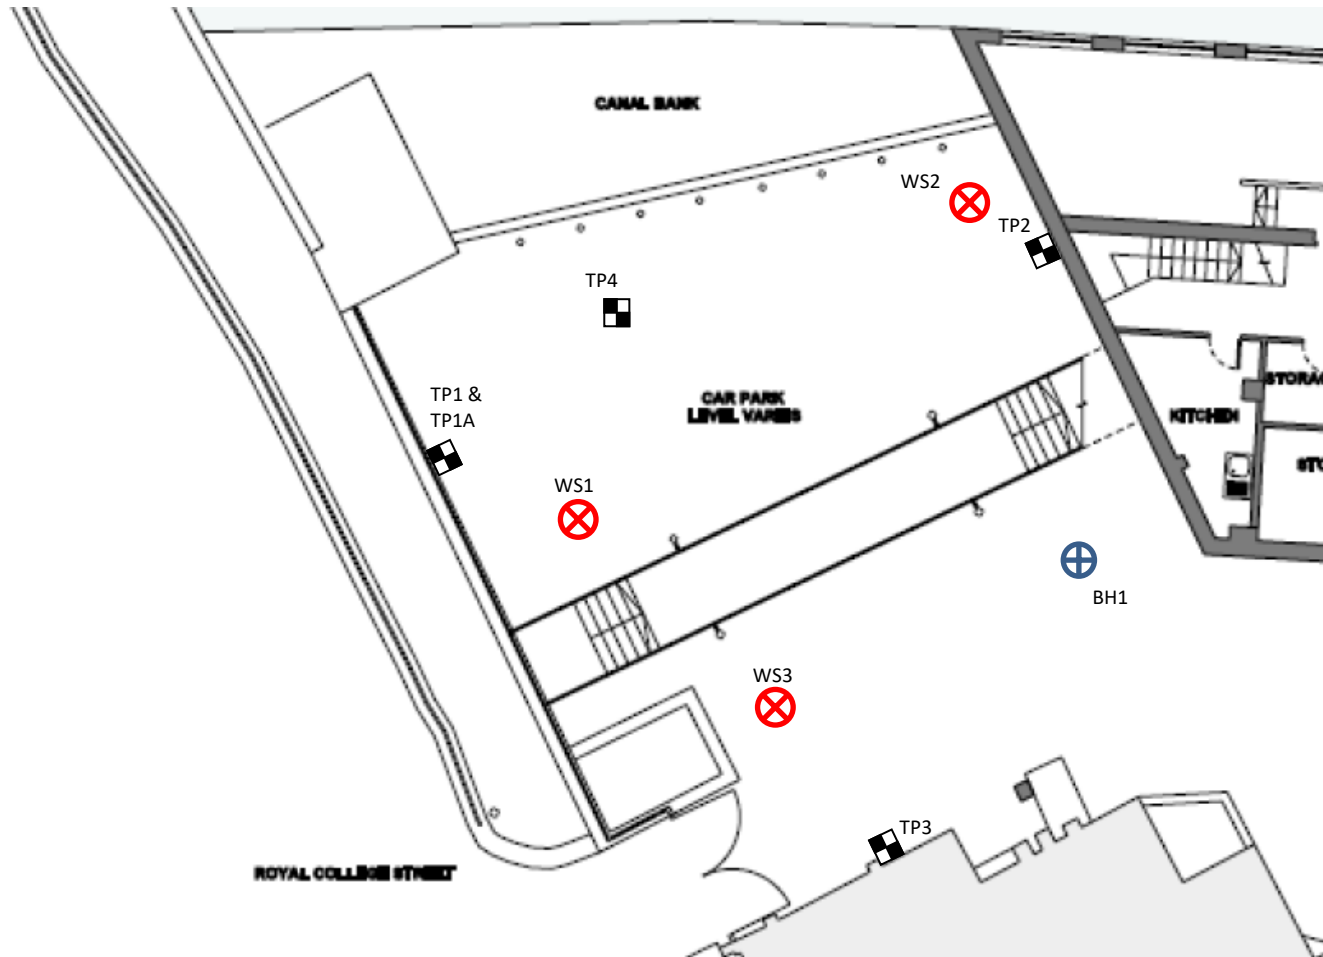
PROJECT NAME	146-150 Royal College Street, London NW1 0TA	CLIENT	Cumbræ Properties (1963) Limited
TITLE	Exploratory Hole Location Plan	PROJECT NO.	P2478J1837
DATE	February 2020	FIGURE NO.	2

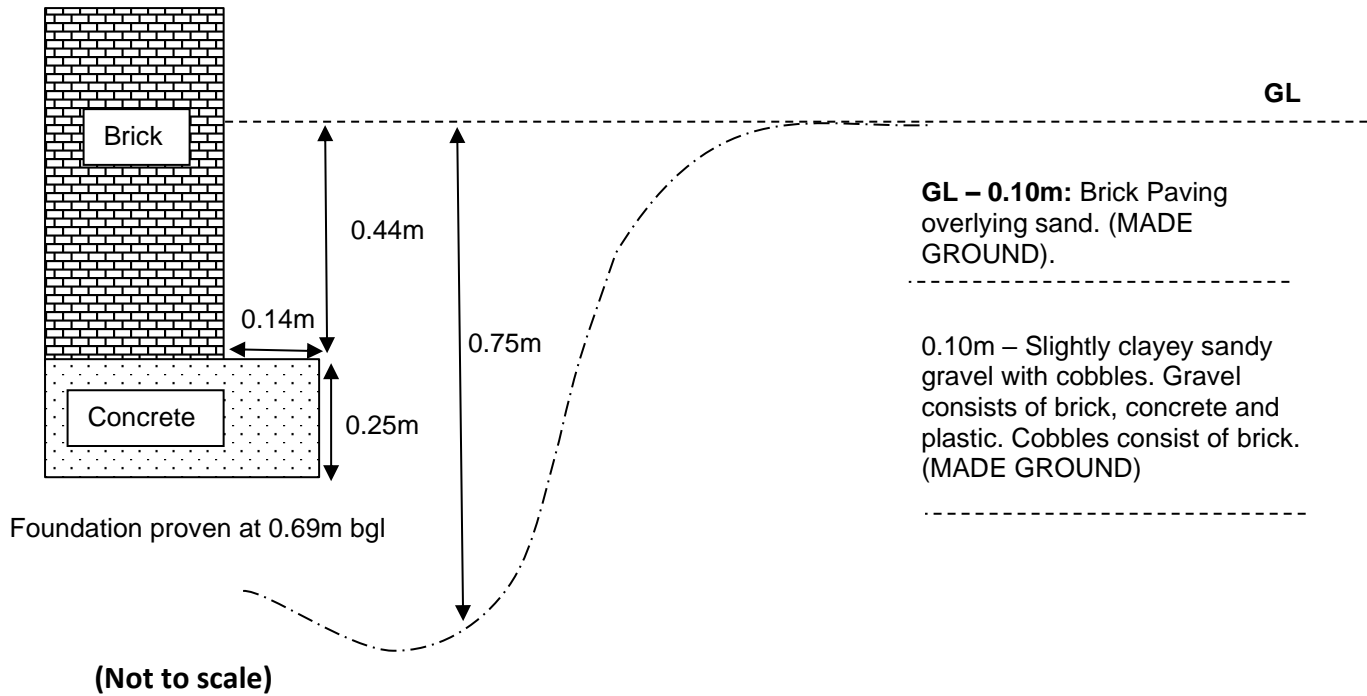
TP1A

Job No.:	P2478J1837	Issue Date:	January 2020
Project:	Royal College Street	Reference:	P2478J1837/AJH
Subject:	Foundation Inspection Pit Sketches	Prepared by:	JLW
