SITE AT THE UGLY BROWN BUILDING, LONDON

Thames Water Asset Assessment Report

Project no. 371654-03 (03)

Title:
 Thames Water Asset Assessment Report for Ugly Brown Building, London, NW1

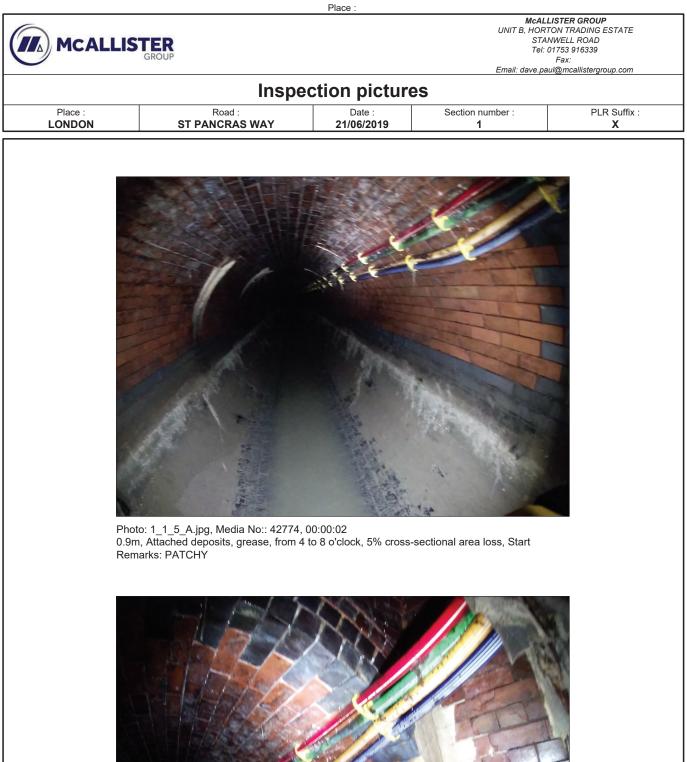
Photo: 1_1_6_A.jpg, Media No:: 42774, 00:00:02 0.9m, Other obstacles, external pipe or cable, from 2 to 3 o'clock, 5% cross-sectional area loss, Start Remarks: CABLES
