CALCULATION SHEET

Detailed Unexploded Ordnance (UXO) Risk Assessment

Project Name	The Ugly Brown Building (Ted Baker Head Office)
Client	RSK
Site Address	6a St Pancras Way London NW1 0TB
Report Reference	DA7410-00
Date	24 th October 2018
Originator	JMa

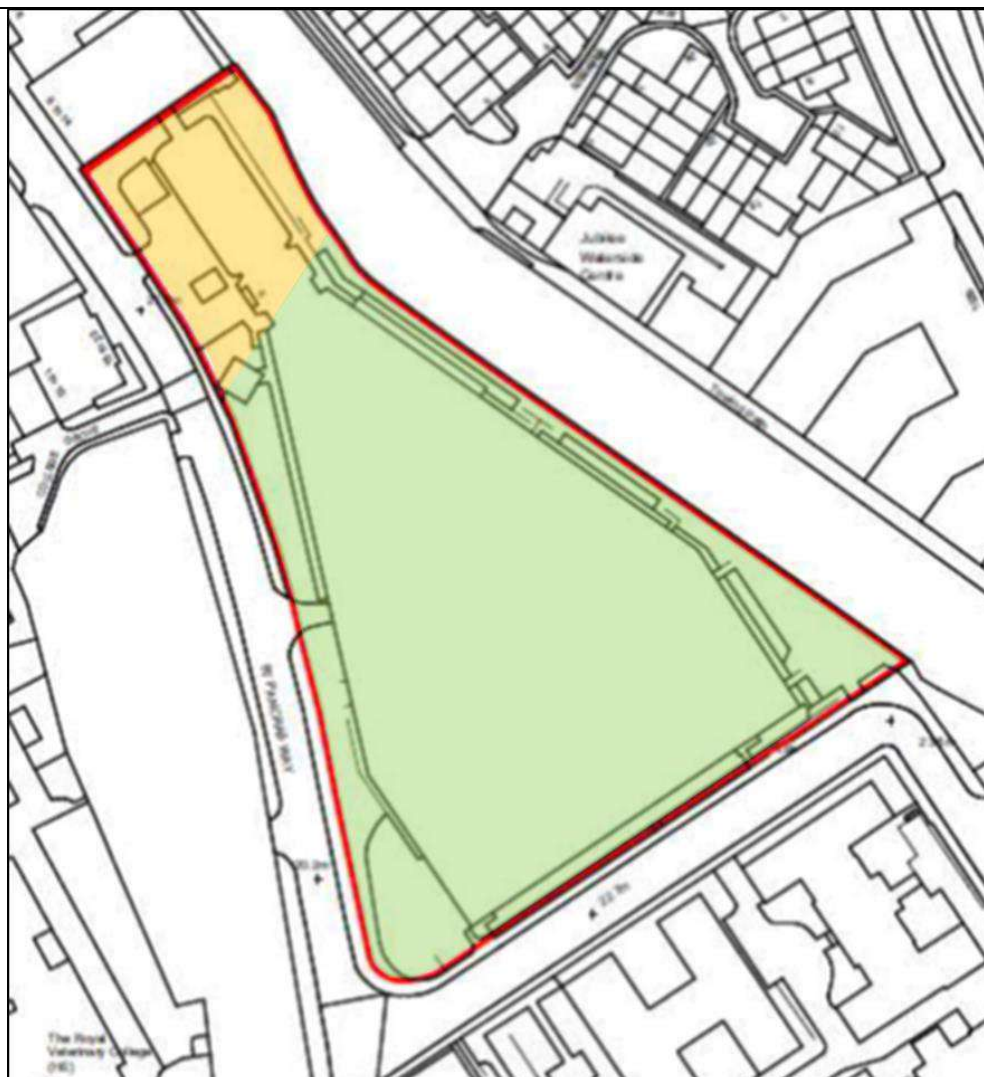
Risk Map

For indicative purposes – not to scale.

- Based on this criteria it has been possible to reduce the risk from UXO across the majority of the site area. This has not been the case within the northern section of the site due to its proximity to two bomb incidents and position directly adjacent to a dilapidated area. Furthermore, the open ground occupying the northern area (which was used for lorry repairs) is believed to have been less conducive to the inspection of UXO than the areas occupied by structures.

- Intrusive Magnetometer Survey of all borehole and pile locations/clusters down to maximum bomb penetration depth.

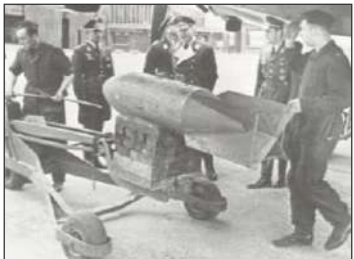
SC 250kg High Explosive Bomb

Bomb Weight	245-256kg (540-564lb)
Explosive Weight	125-130kg (276-287lb)
Fuze Type	Electrical impact/mechanical time delay fuze.
Bomb Dimensions	1640 x 512mm (64.57 x 20.16in)
Body Diameter	368mm (14.5in)
Use	Against railway installations, embankments, flyovers, underpasses, large buildings and below-ground installations.
Remarks	It could be carried by almost all German bomber aircraft, and was used to notable effect by the Junkers Ju-87 Stuka (Sturzkampfflugzeug or dive-bomber).

SC250 bomb being loaded onto German bomber

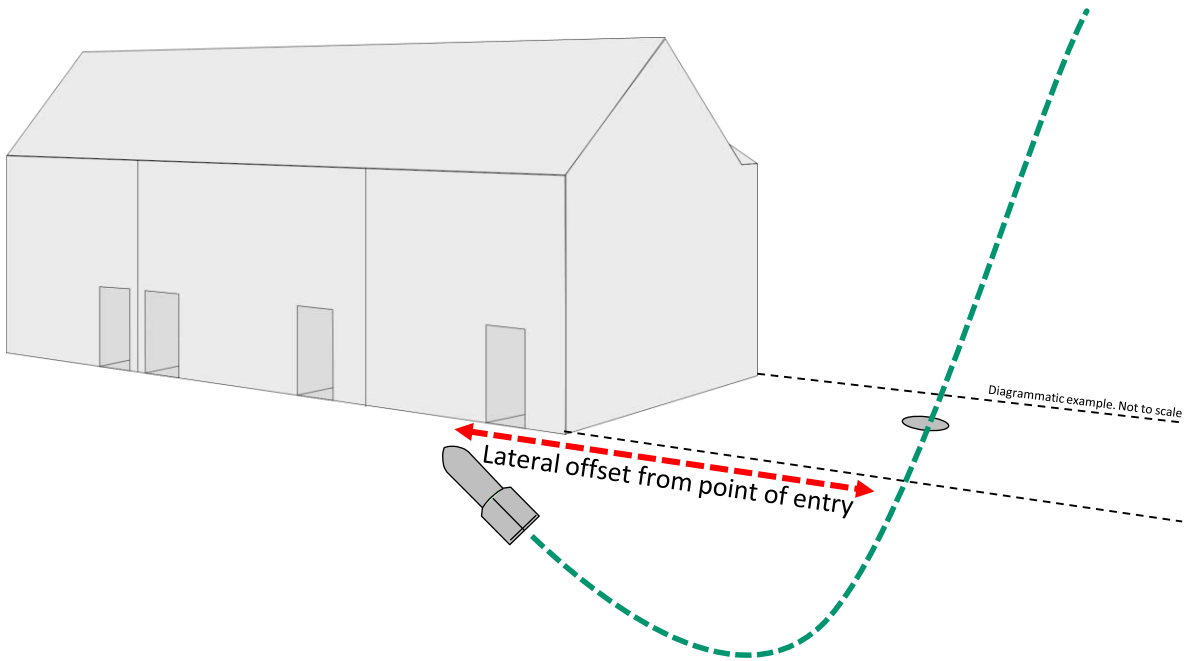
Diagram illustrating the J-curve effect. A dashed green line shows a projectile's path curving away from a building. A red dashed arrow indicates the 'Lateral offset from point of entry'. A dashed line from the building is labeled 'Diagrammatic example. Not to scale'.

Top: J-curve Effect - Due to angle of entry, unexploded bombs would often end their trajectory at a lateral offset from point of entry, often ending up beneath adjacent extant structures/sites.

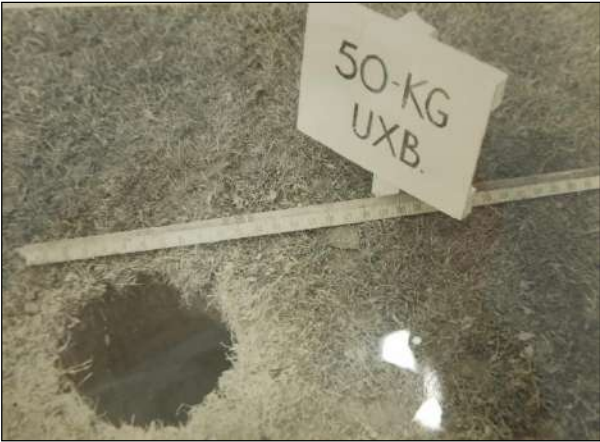
Bottom Left: A photograph of a small, dark, circular hole in the ground next to a sign that reads "50-KG UXB".

One of the most common scenarios for the above occurring was where a UXB fell into a 'bomb site' (such as the area shown **Top Left**), the entry hole of the bomb obscured by debris and rubble present. Note that the entry hole of a 50kg UXB could be as little as 20cm in diameter (**Left**).

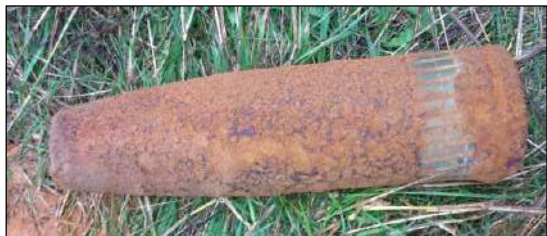
3.7 Inch QF Anti-Aircraft Projectile

Projectile Weight	28lb (12.6 kg)
Explosive Weight	2.52lbs
Fuze Type	Mechanical Time Fuze
Dimensions	3.7in x 14.7in (94mm x 360mm)
Rate of Fire	10 to 20 rounds per minute
Use	The 3.7in AA Mk 1-3 were the standard Heavy Anti-Aircraft guns of the British Army.
Ceiling	30,000ft to 59,000ft

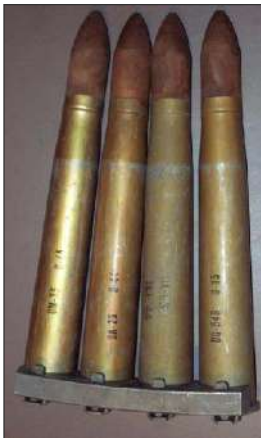
40mm Bofors Projectile

Projectile Weight	1.96lb (0.86kg)
Explosive Weight	300g (0.6lb)
Fuze Type	Impact Fuze
Rate of Fire	120 rounds per minute
Projectile Dimensions	40 x 180mm
Ceiling	23,000ft (7000m)
Remarks	Light quick fire high explosive anti-aircraft projectile. Each projectile fitted with small tracer element. If no target hit, shell would explode when tracer burnt out. Designed to engage aircraft flying below 2,000ft

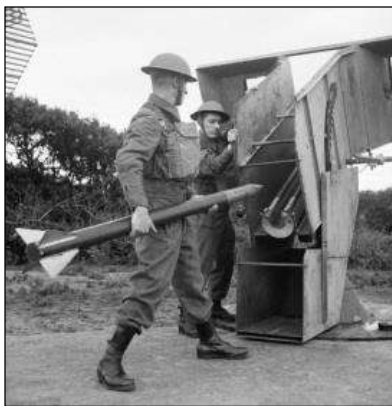
3in Unrotated Projectile (UP) Anti-Aircraft Rocket ("Z" Battery)

HE Projectile Weight	3.4kg (7.6lb)
Explosive Weight	0.96kg (2.13lb)
Filling	High Explosive – TNT. Fitted with aerial burst fuzeing
Dimensions of projectile	236 x 83mm (9.29 x 3.25in)
Remarks	As a short range rocket-firing anti-aircraft weapon developed for the Royal Navy. It was used extensively by British ships during the early days of World War II. The UP was also used in ground-based single and 128-round launchers known as Z Batteries. Shell consists of a steel cylinder reduced in diameter at the base and threaded externally to screw into the shell ring of the rocket motor

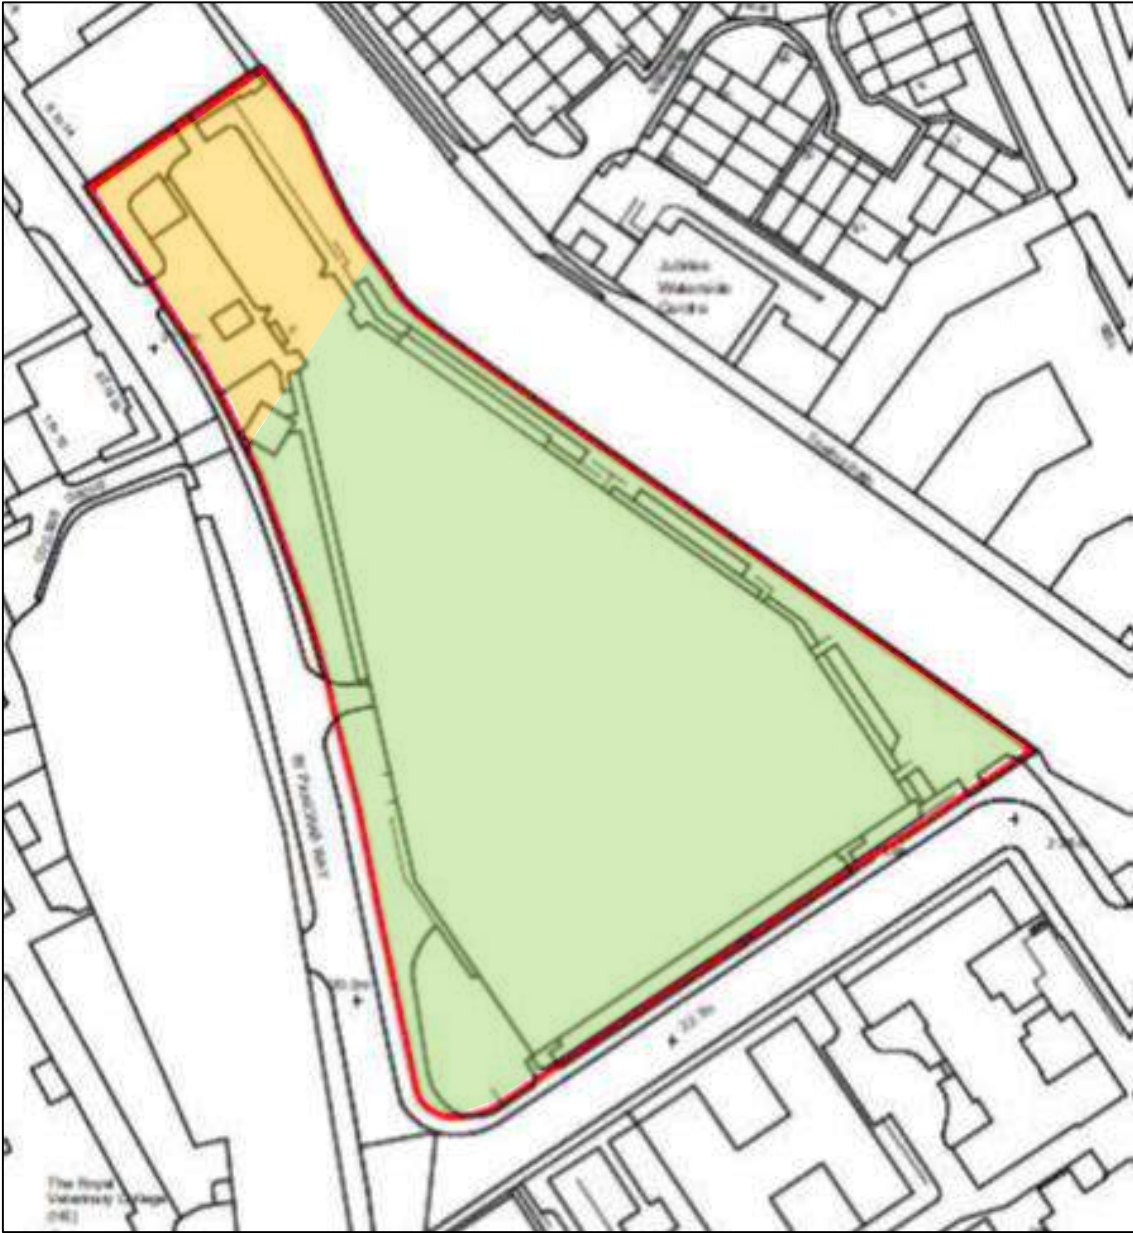
- Low Risk
- Medium Risk

- All Risk Areas:**
- Site Specific Unexploded Ordnance Awareness Briefings to all personnel conducting intrusive works
- Medium Risk Area:**
- Unexploded Ordnance (UXO) Specialist Presence on Site to support shallow intrusive works
 - Intrusive Magnetometer Survey of all Borehole and pile locations down to a maximum bomb penetration depth

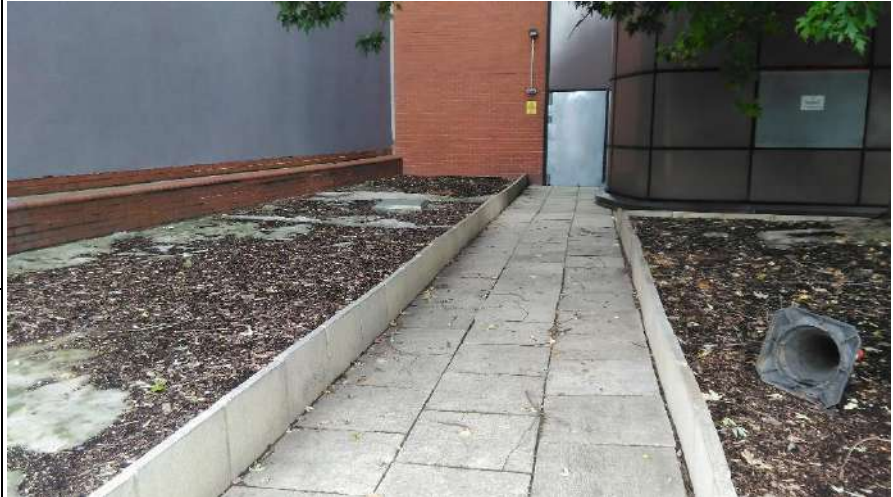
BH02 along northern boundary. Contiguous pile wall beneath plant bed on left

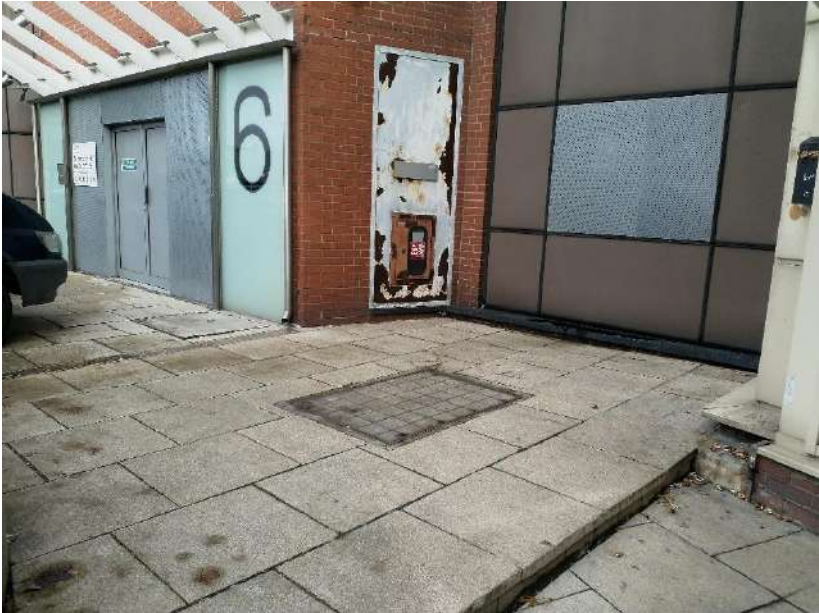
<p>Description:</p> <p>Thames Water sewer running beneath manhole (approximately) into the building at depth.</p>
