Original Total Water/Cement Ratio of Concrete BS 1881-124: 2015

1281066 Ugly Brown Building, 6a St Pancras Way, London, NW1 0TB

Chloride Content of Concrete

Petrographic Examination of Hardened Concrete - ASTM C856-18

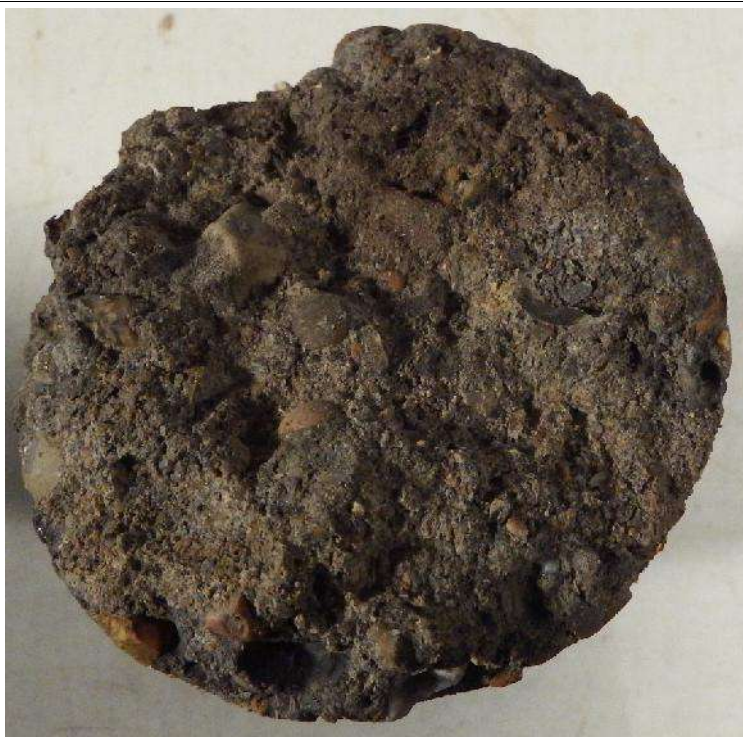
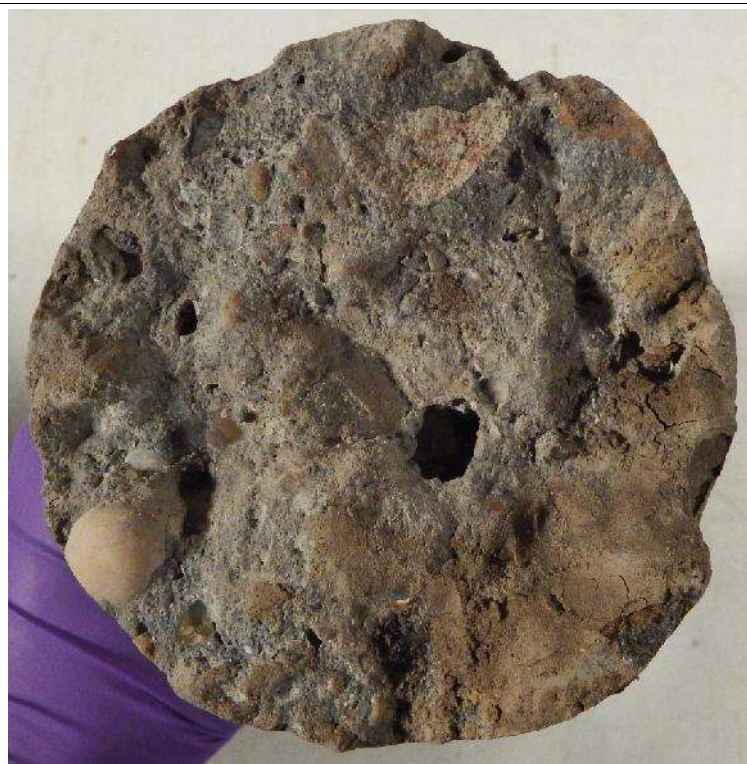
RECORD PHOTOGRAPH			
RSK Sample Ref.	18284/C1	Client Sample Ref.	Pile at B/H2
Description	Views of the upper and lower end surfaces of the core. Core diameter is 100 mm.

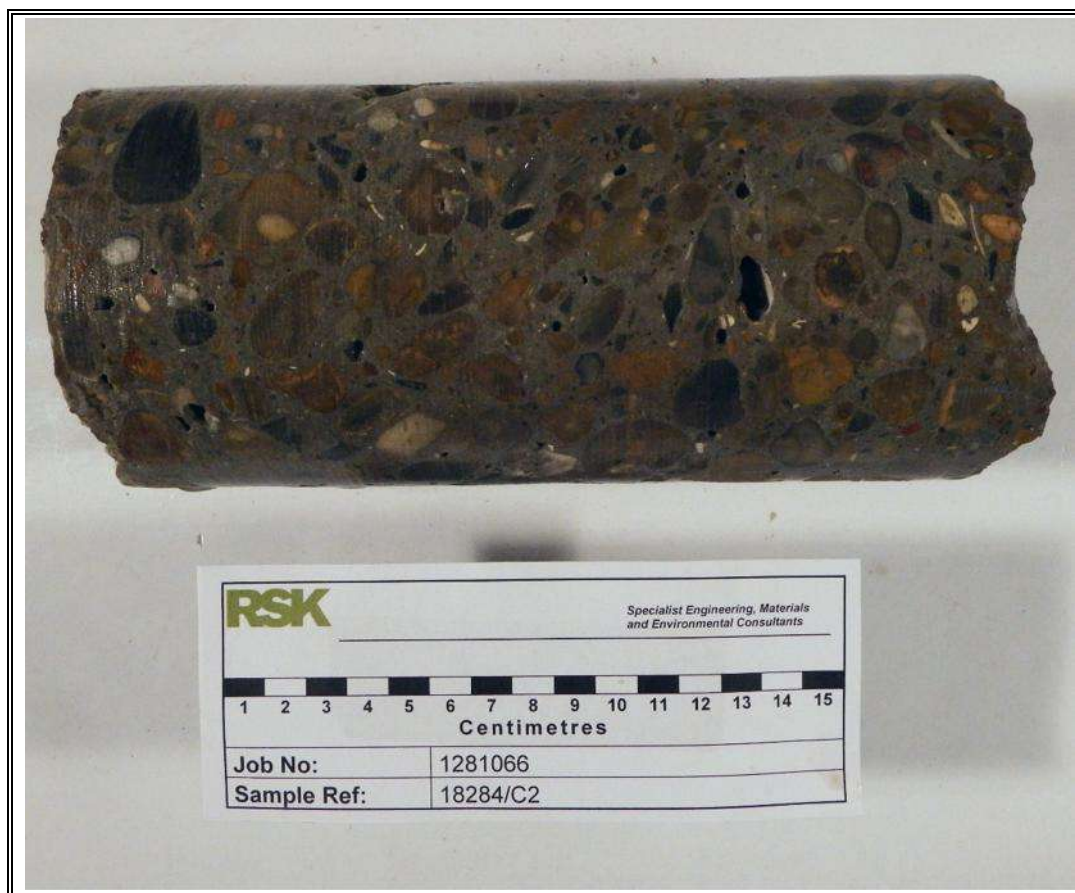
RECORD PHOTOGRAPH			
RSK Sample Ref.	18284/C2	Client Sample Ref.	Capping Beam at B/H 15
Description	View of the concrete as-received.

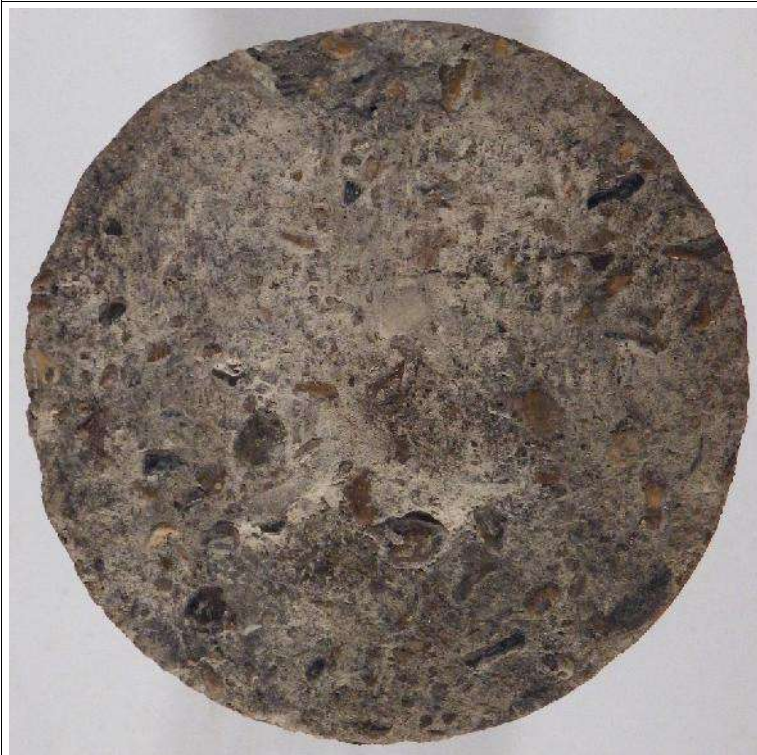
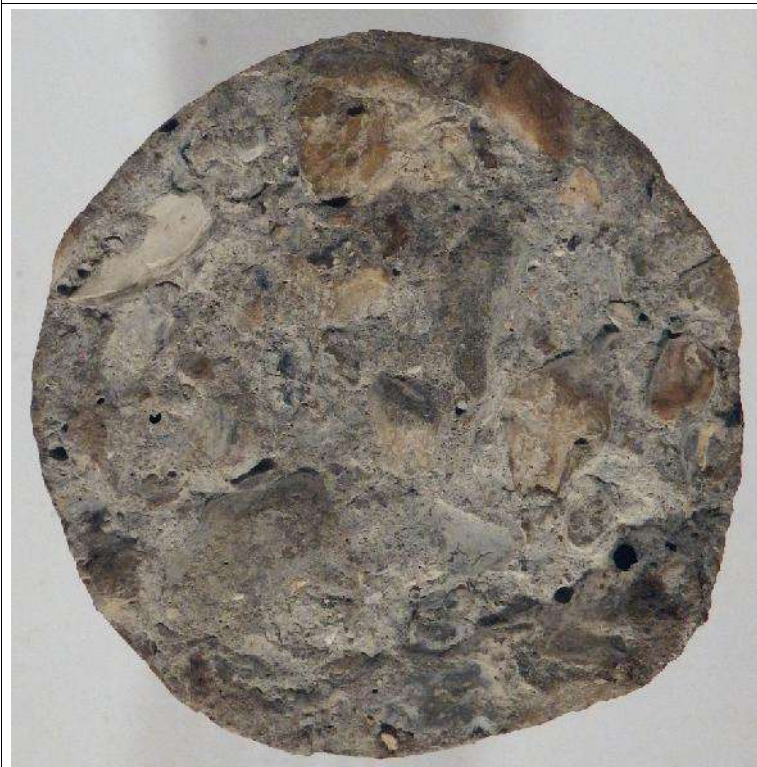
RECORD PHOTOGRAPH			
RSK Sample Ref.	18284/C2	Client Sample Ref.	Capping Beam at B/H 15
Description	Views of the upper and lower end surfaces of the core. Core diameter is 100 mm.

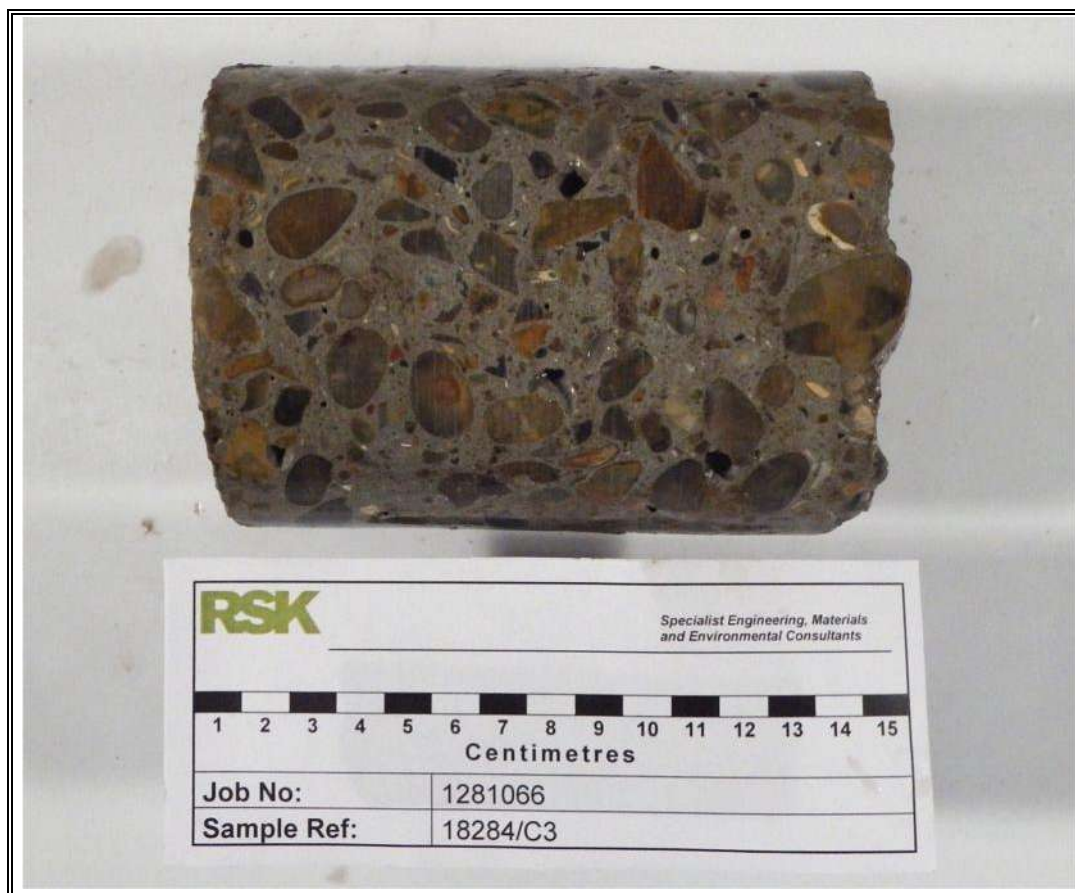
RECORD PHOTOGRAPH			
RSK Sample Ref.	18284/C3	Client Sample Ref.	Capping Beam at B/H 10
Description	View of the concrete as-received.

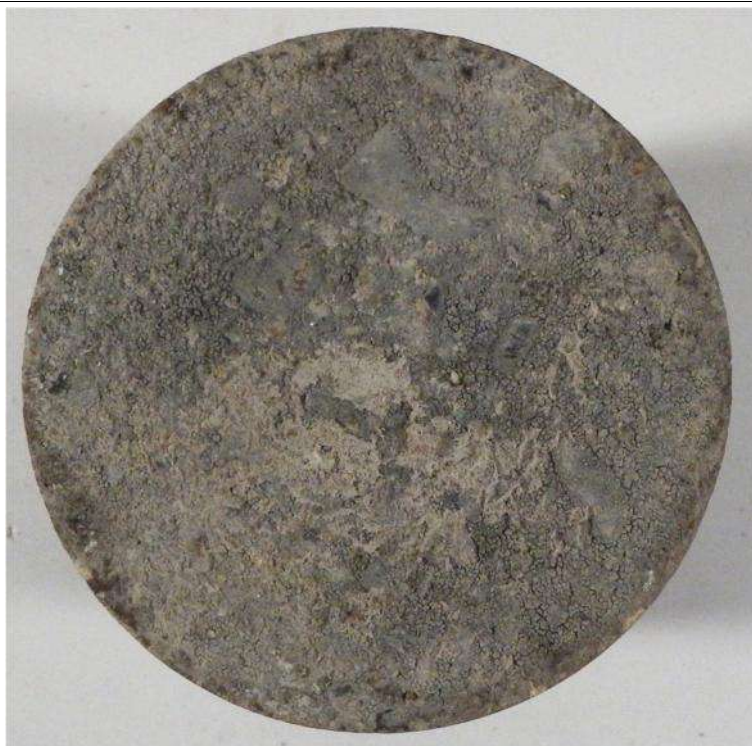
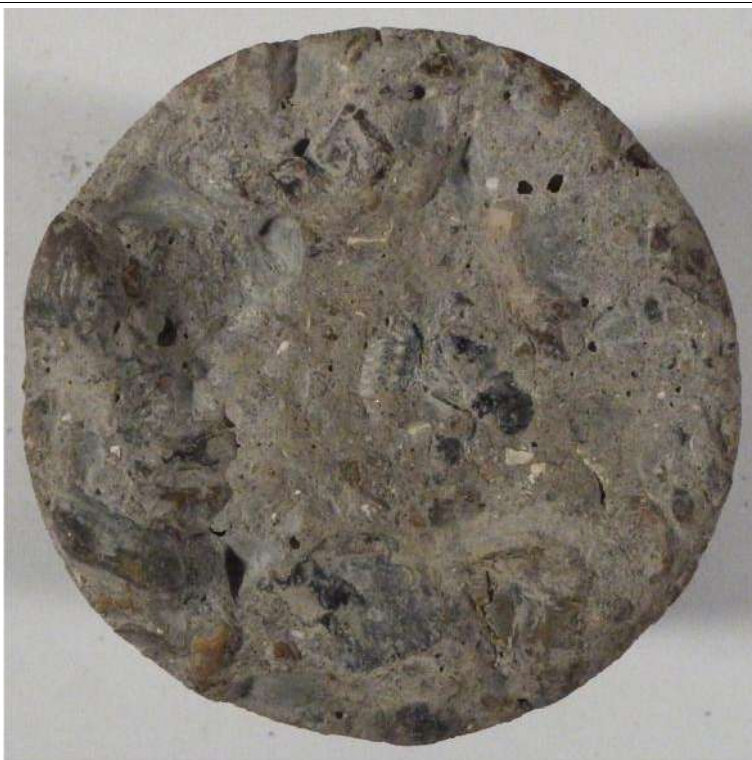
RECORD PHOTOGRAPH			
RSK Sample Ref.	18284/C3	Client Sample Ref.	Capping Beam at B/H 10
Description	Views of the upper and lower end surfaces of the core. Core diameter is 100 mm.

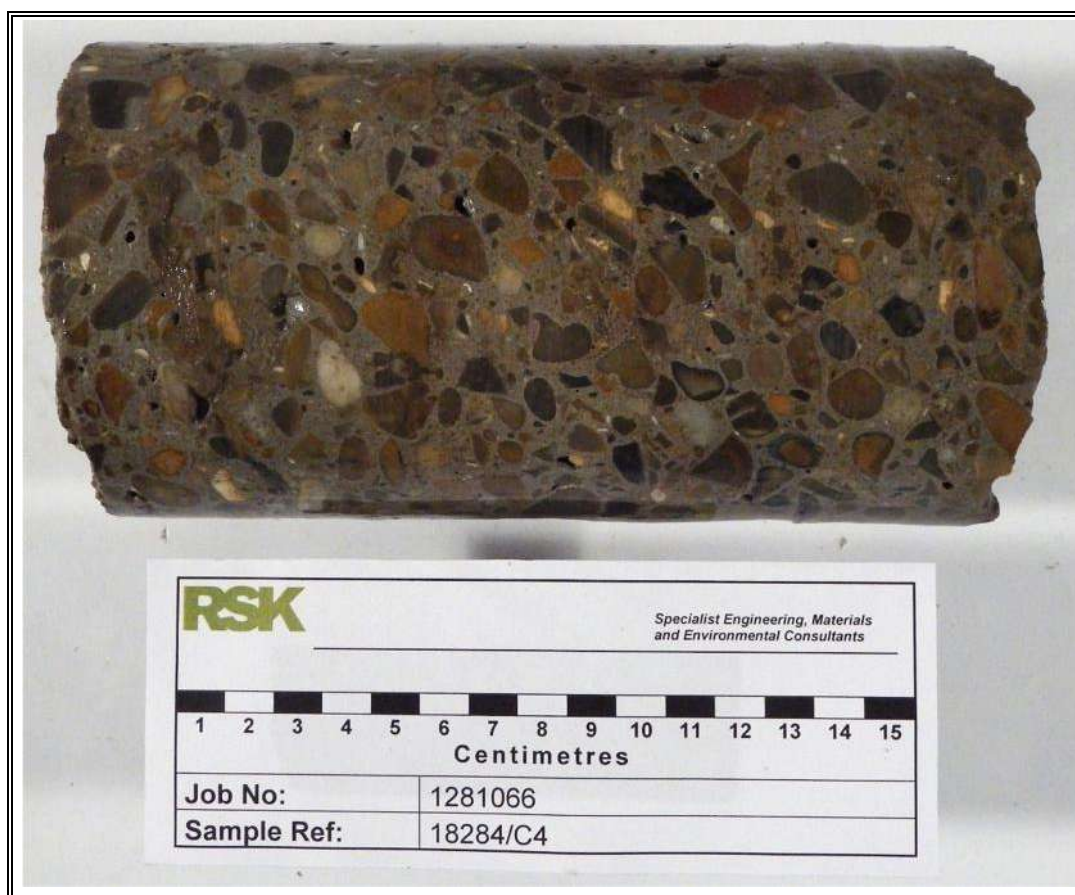
RSK Sample Ref.	18284/C4	Client Sample Ref.	Capping Beam at B/H 4
Description	View of the concrete as-received.

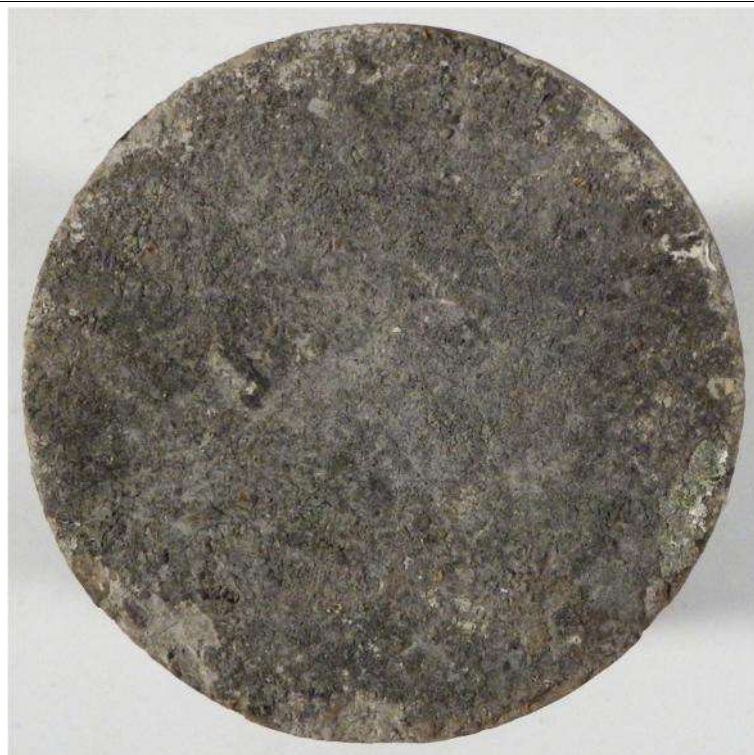
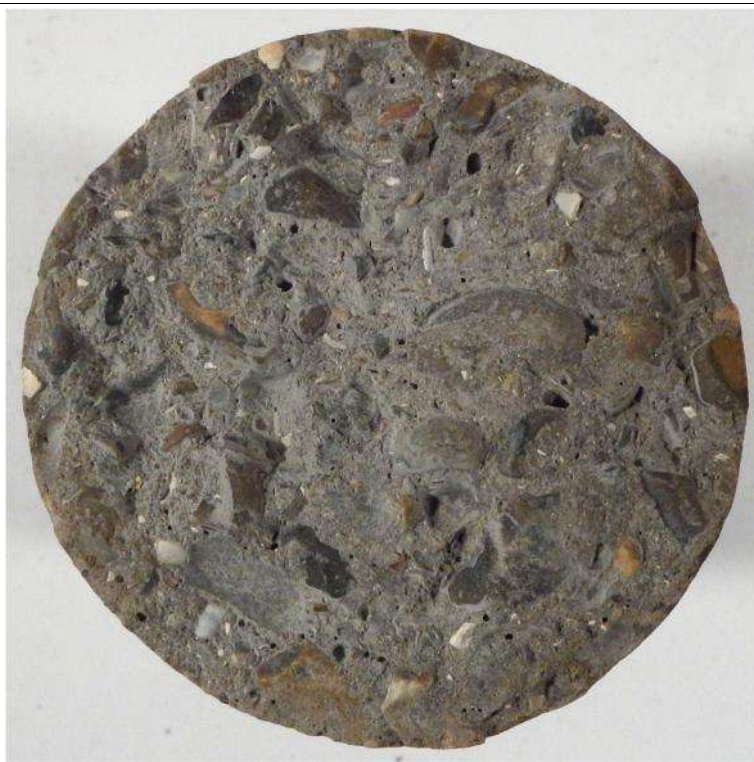
RECORD PHOTOGRAPH			
RSK Sample Ref.	18284/C4	Client Sample Ref.	Capping Beam at B/H 4
Description	Views of the upper and lower end surfaces of the core. Core diameter is 100 mm.

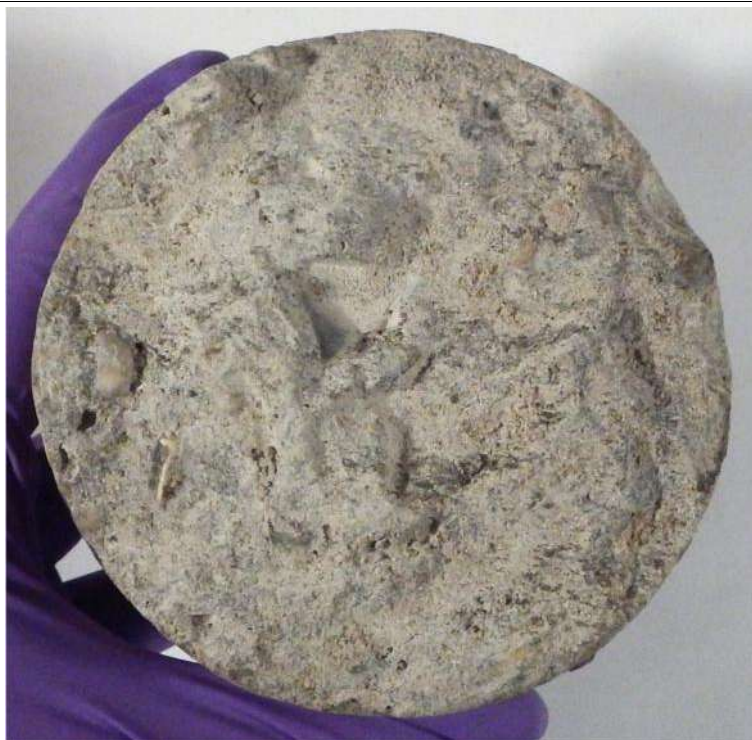
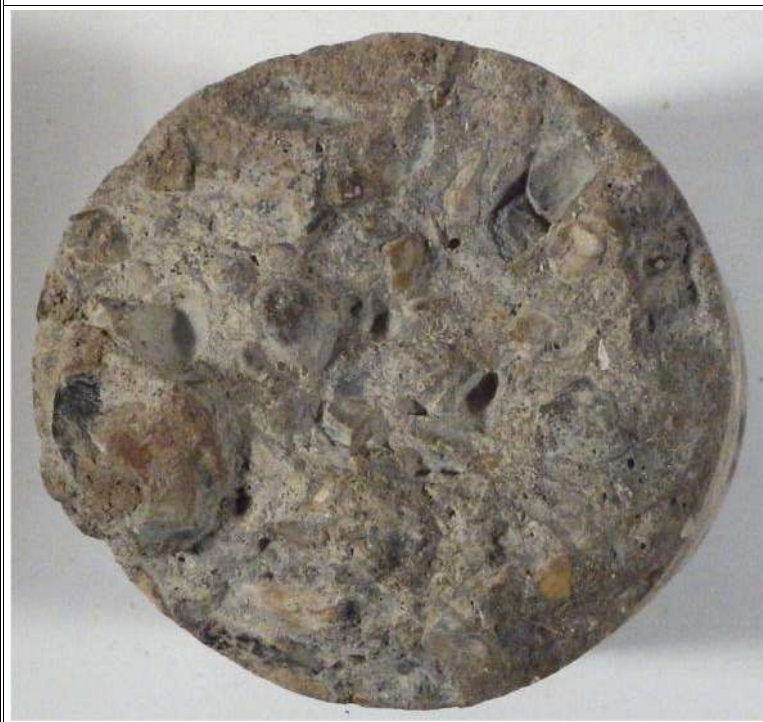
RECORD PHOTOGRAPH			
RSK Sample Ref.	18284/C6b	Client Sample Ref.	Pile at B/H 1
Description	Views of the upper and lower end surfaces of the core. Core diameter is 100 mm.
