Site at the Ugly Brown Building, London

Ground Movement and Building Damage Assessment Report

Project no. 371654-02 (01)

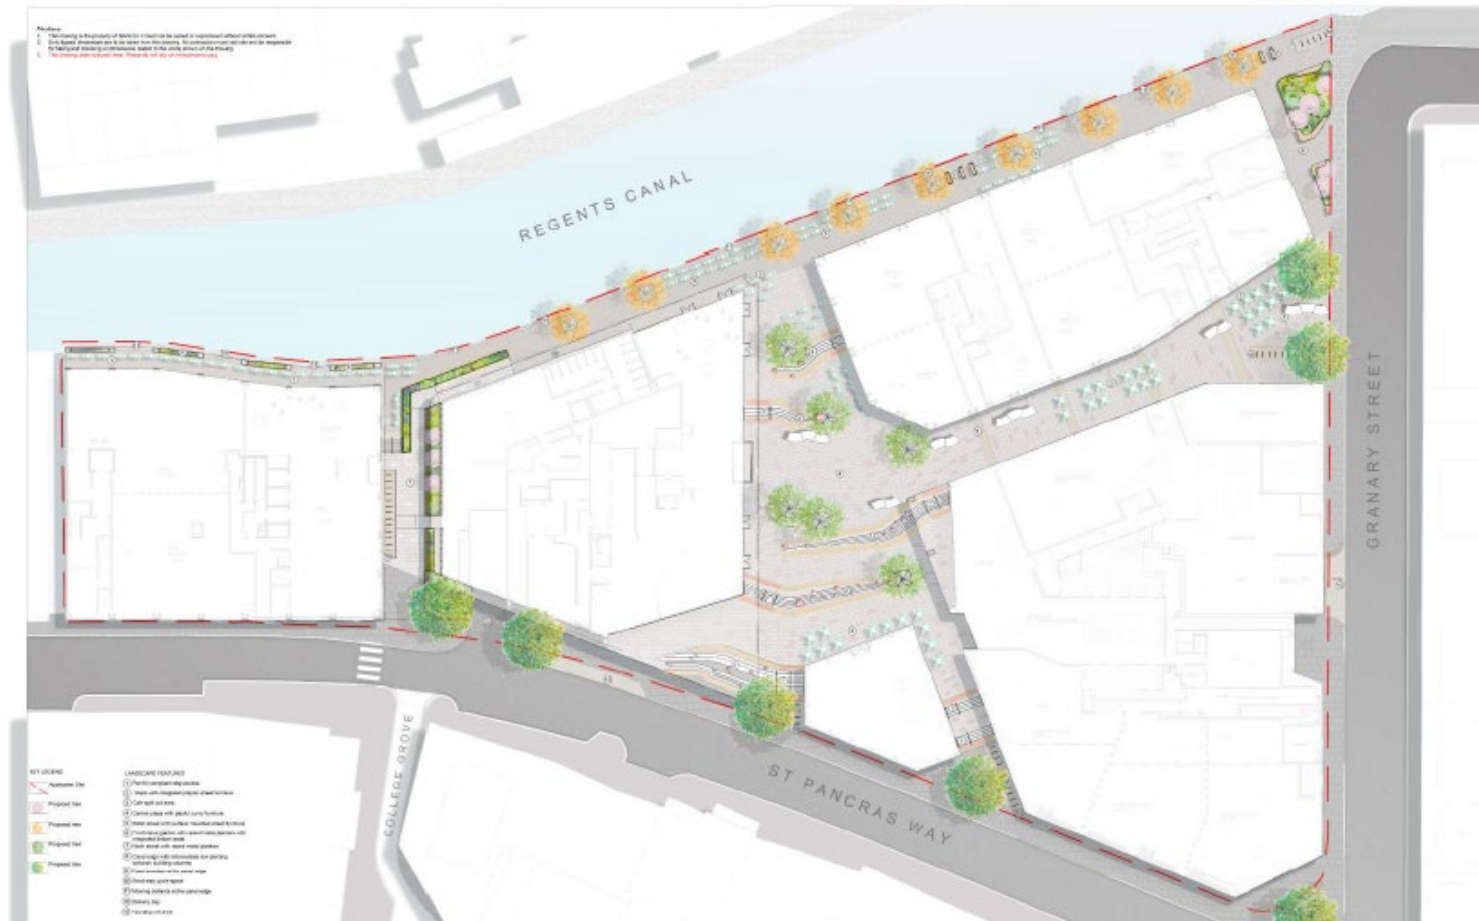
Plan Showing Proposed Building Configuration

The proposed redevelopment will involve the demolition of the existing UBB building and erection of 6 new buildings ranging in height from 2 storeys to 12 storeys above ground and 2 basement levels comprising a mixed-use business floorspace, residential, hotel, gym, flexible retail and storage space development with associated landscaping work. The new development comprises three plots A, B & C in which 'Plot A' will be offices, 'Plot B' will be the Ted Baker hotel & headquarters and 'Plot C' will comprise 4 major buildings for mixed-use offices, gym, residential & retail spaces.
