BS 5837 Arboricultural Report

& Impact Assessment

**Teil House
10D Kidderpore Avenue
London
NW3 7SU**

**Dated
26th May 2021**

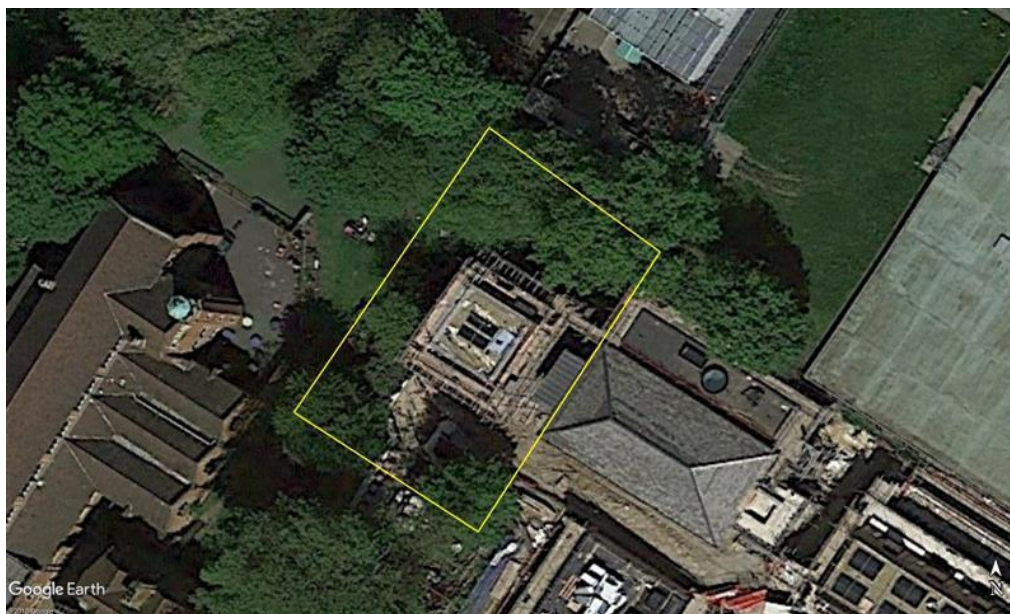
- 2.3.1. The area indicated below² shows the extent of the survey.

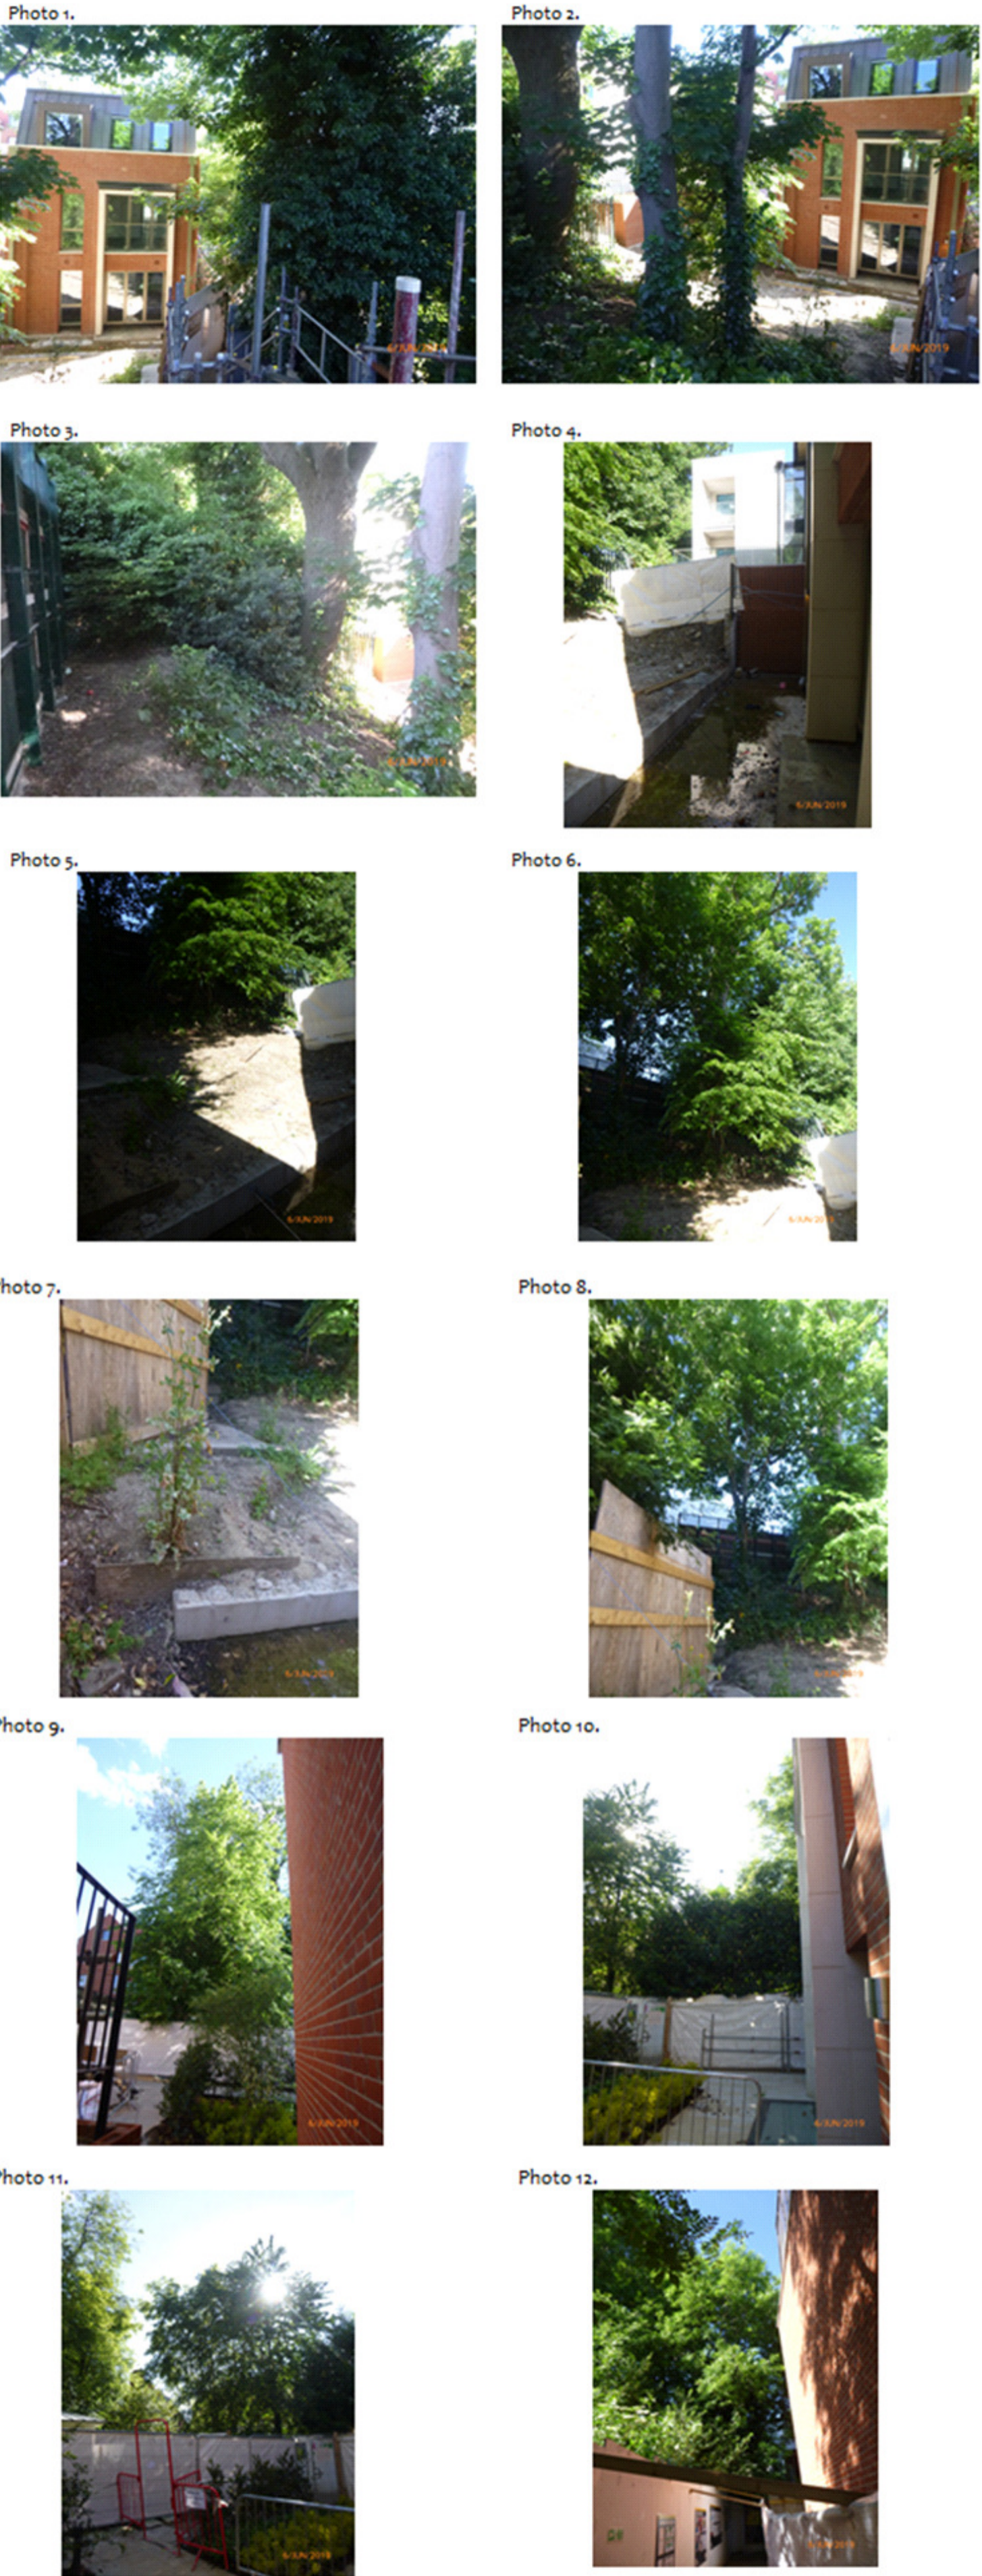
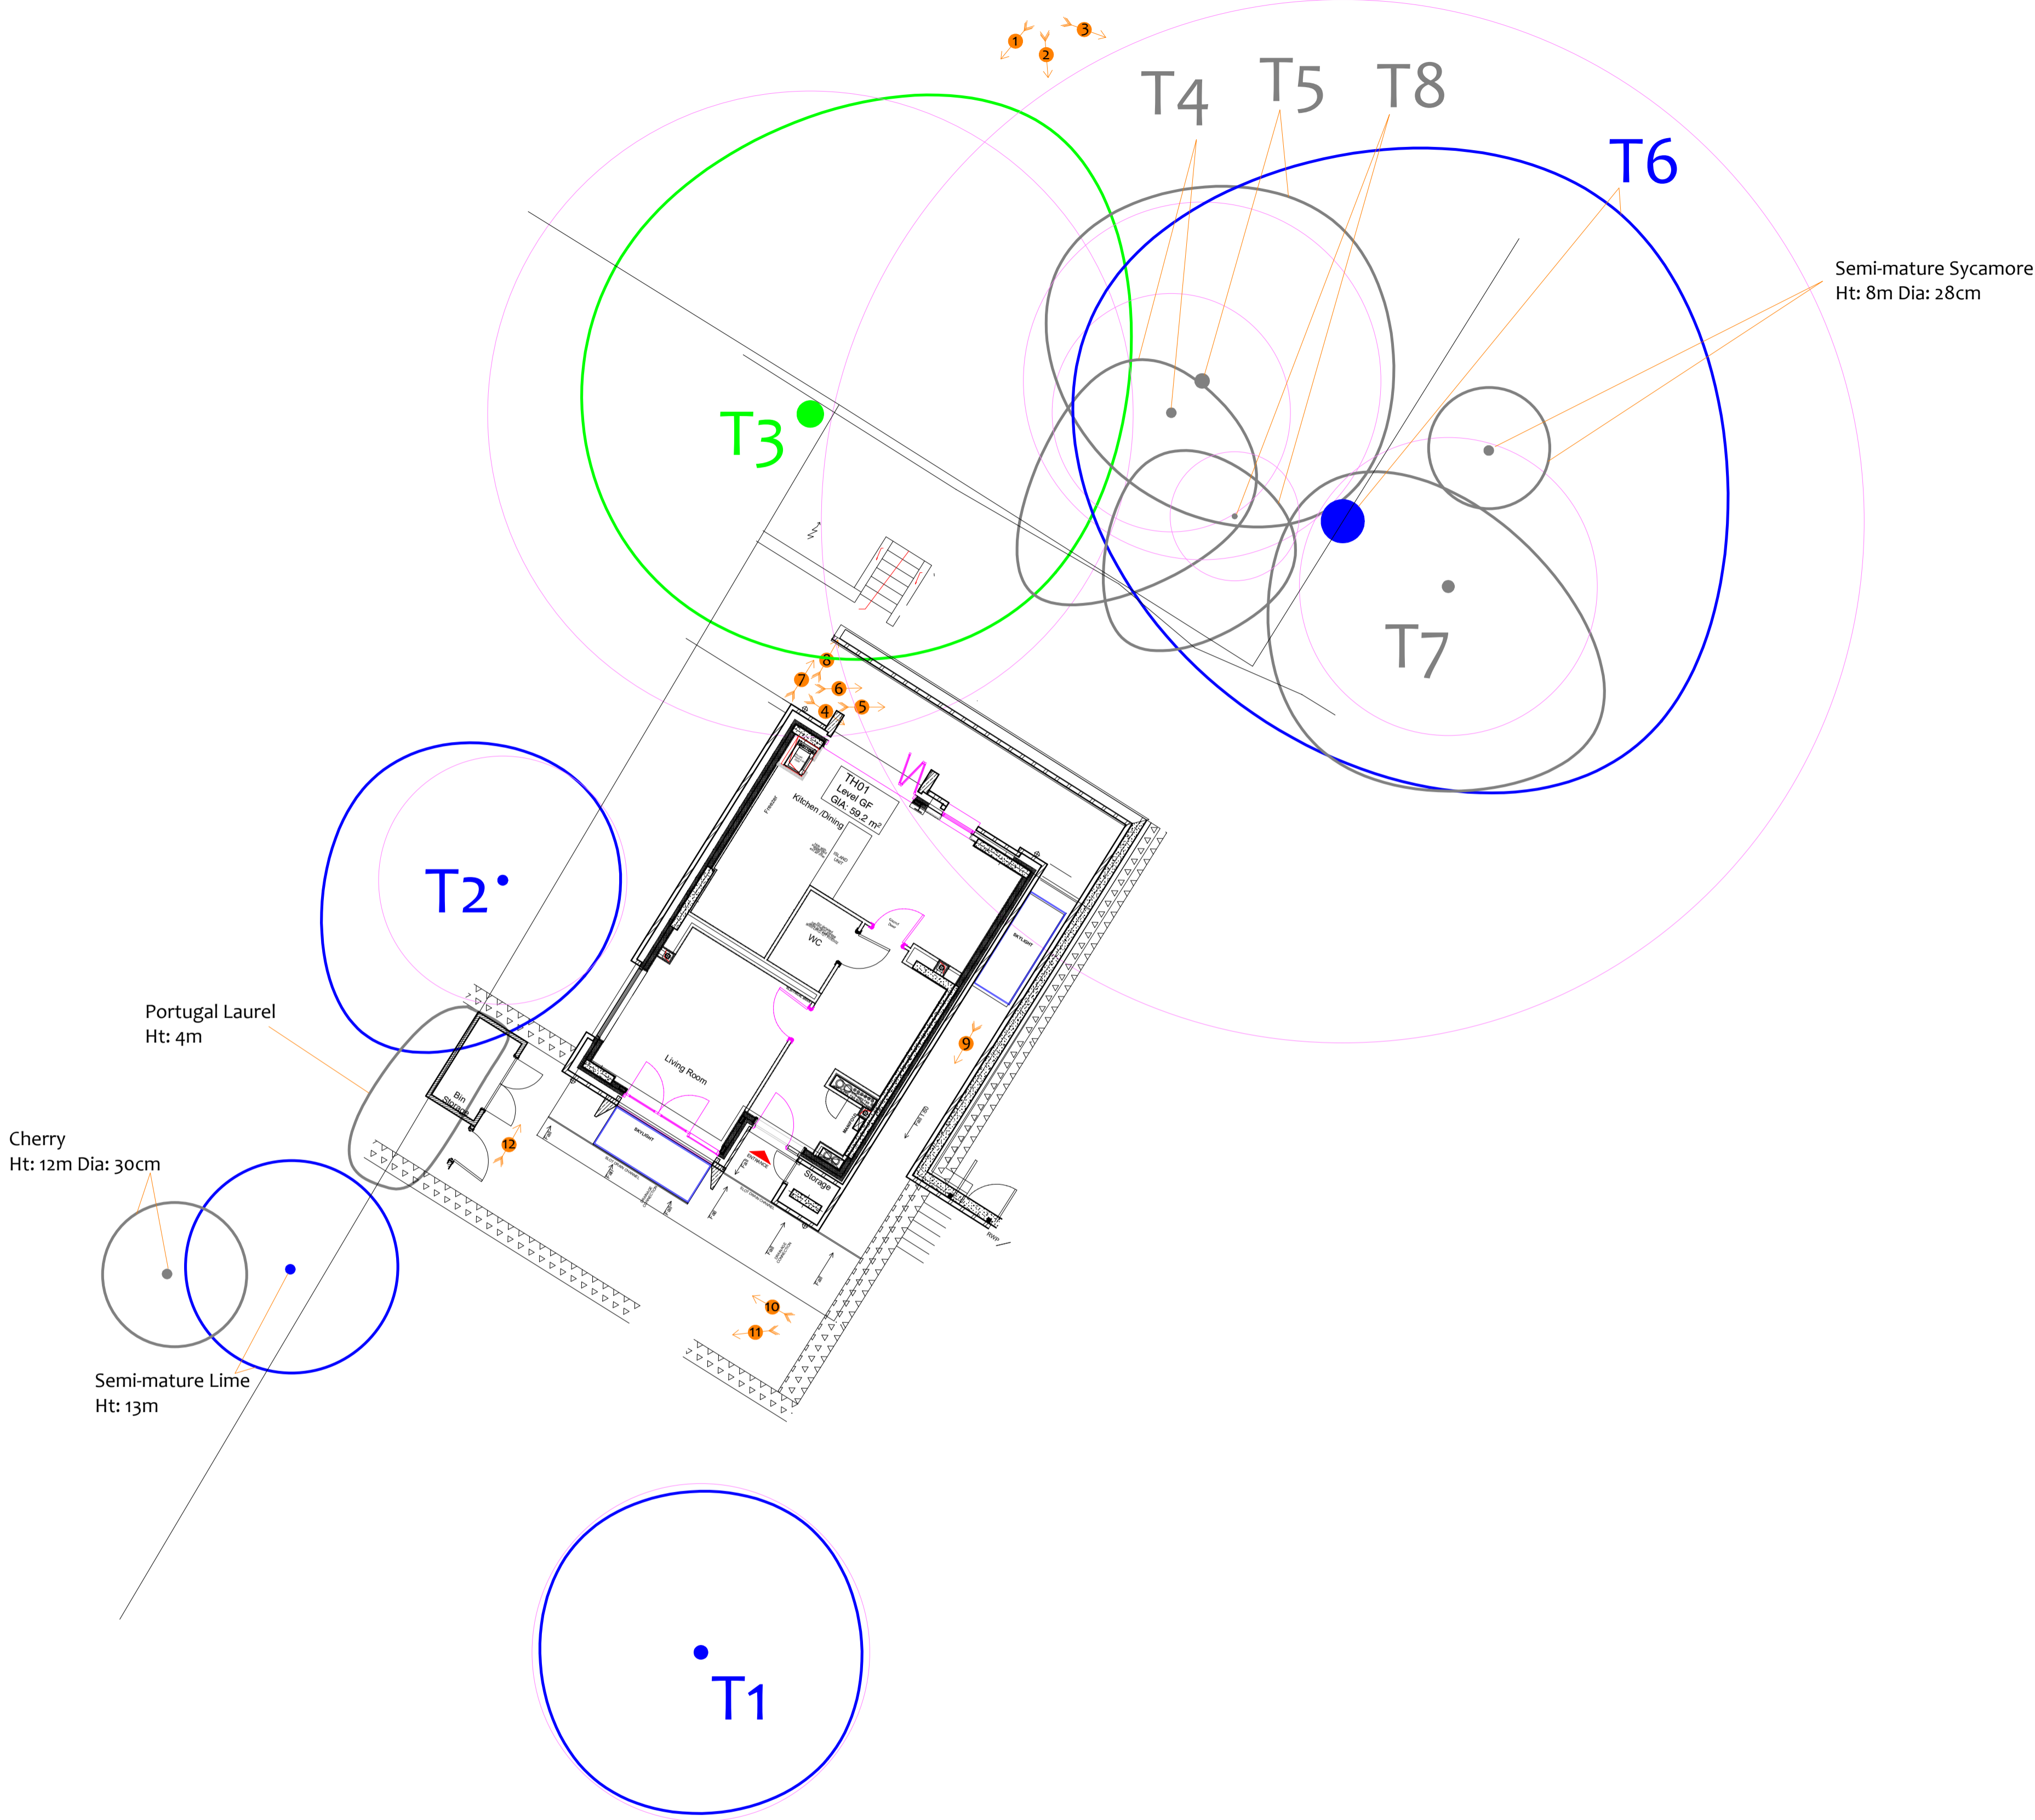
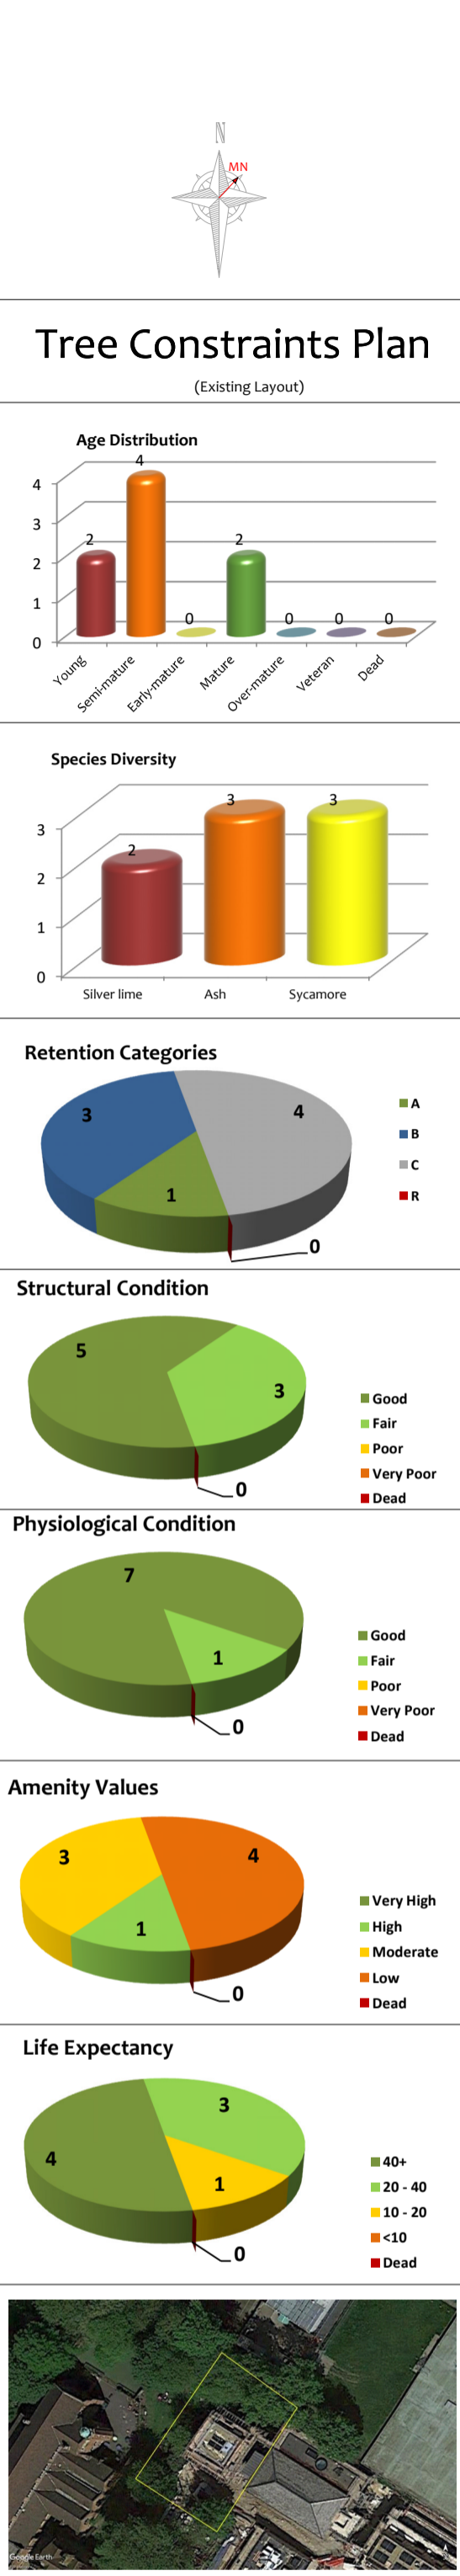
| Drawing No: | CCL 10332 / TCP Rev: 1 |

Tree Constraints Plan (TCP). This indicates the position, crown spread, Retention Category and Root Protection Area of each tree. It is used to inform where development may proceed without causing damage to trees.

| Title: | Tree Constraints Plan (Existing Layout) |

Refer to the Tree Constraints Plan for photo locations
