Rev	Date	Description	Initials
Client			
WORKING MEN'S COLLEGE			
Project Name			
WINDOW REPLACEMENT			
Drawing Title			
NORTH ELEVATION			
Issue Status			
PLANNING			
Scale & Paper Size	Date Originated	Drawn	
1:200@A3	April 2021	LR	
Project No.	Stage	No.	Rev.
P404	3	202	00

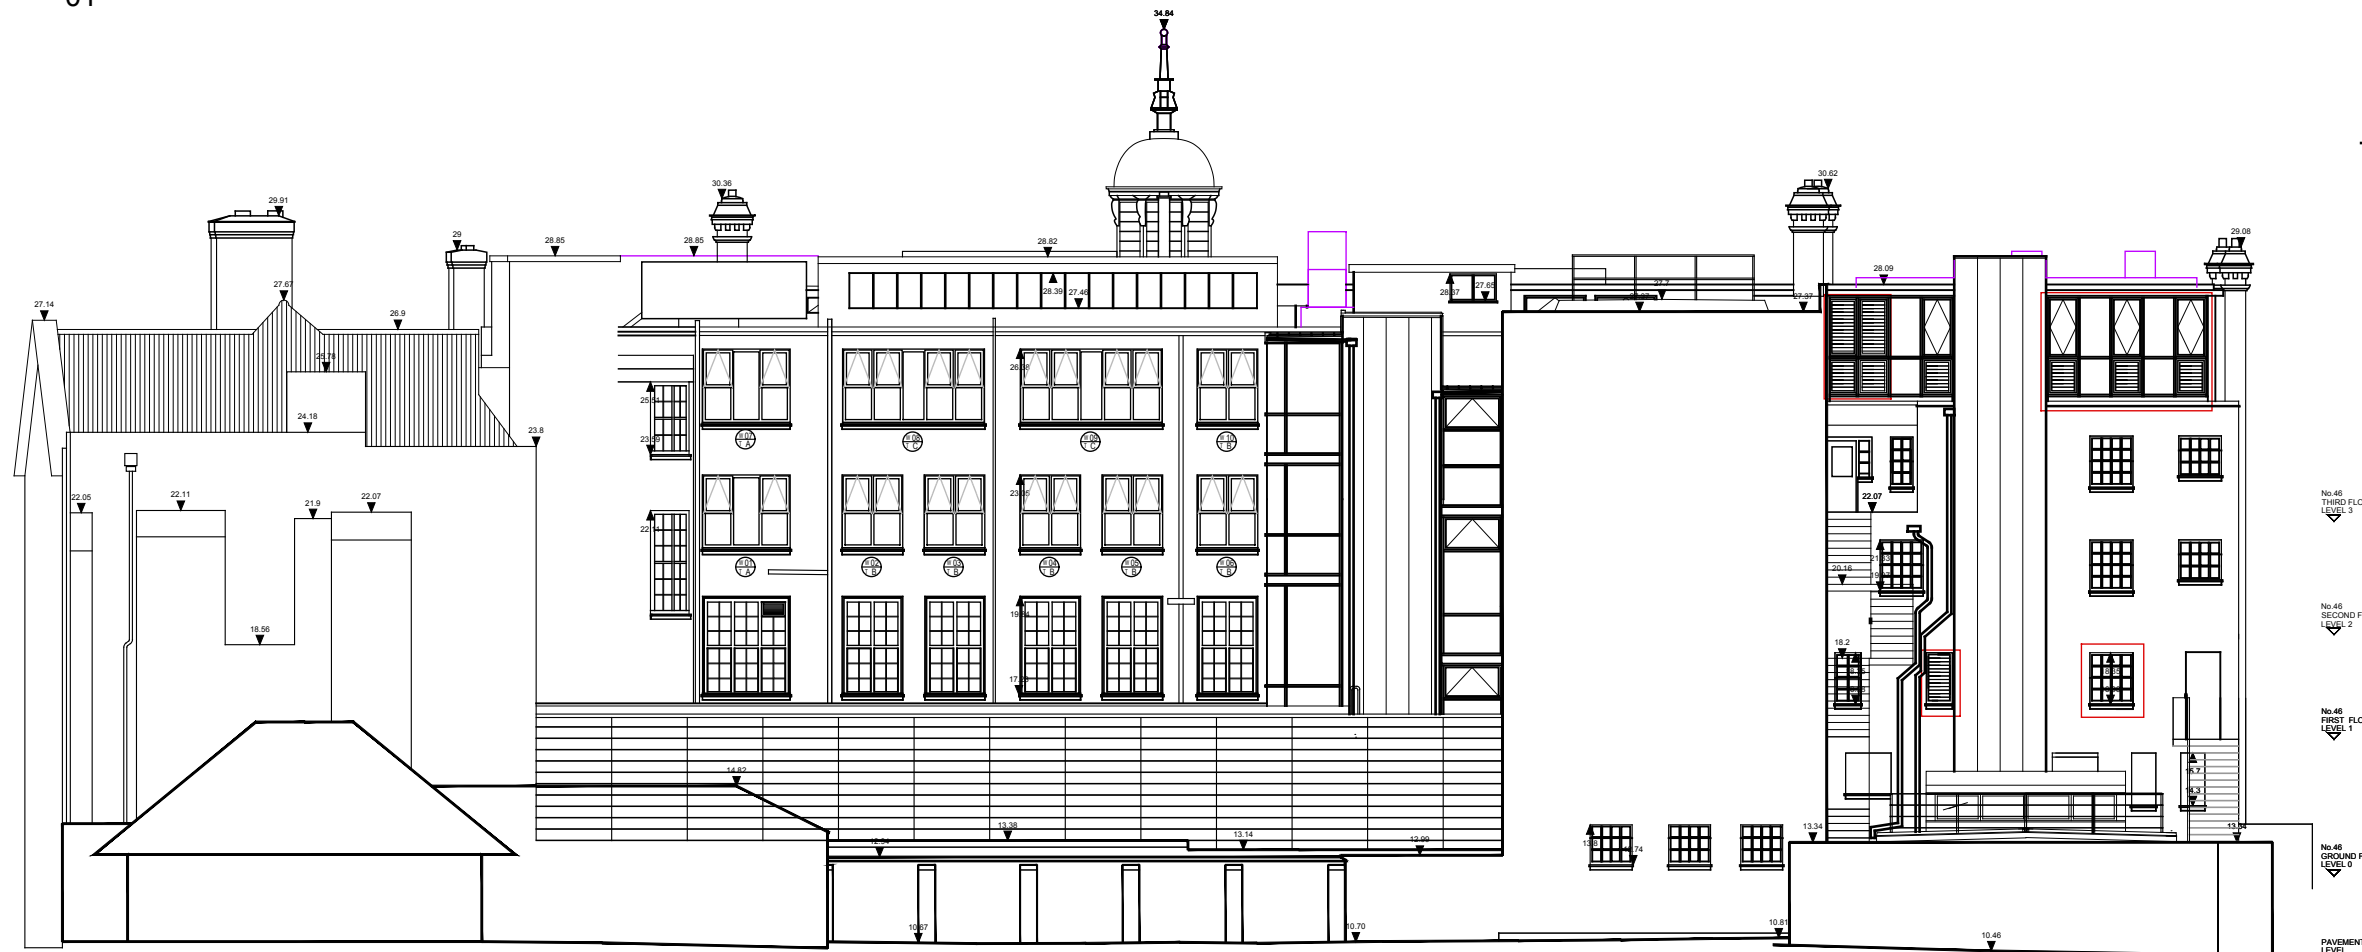
02 Proposed North Elevation

1. The dimensions shown for the window structural openings are based on record drawing information only and must be checked by the Window supplier prior to manufacture of the window units.
2. The existing window units to be replaced are the windows with reference tags only. They are Aluminium sash windows and are circa 40+ years old. They are beyond economic repair and they represent a health and safety risk to the building users (fall from height) due to lack of suitable opening restrictors.
3. The windows to be replaced are not original to the building and therefore their replacement should not adversely impact the heritage status of the external building appearance.
