GEOTECHNICAL DESK STUDY AND GROUND INVESTIGATION REPORT

62 Parliament Hill
London
NW3 2TJ

Report Title: Geotechnical Desk Study and Ground Investigation Report for 62 Parliament Hill, London, NW3 2TJ

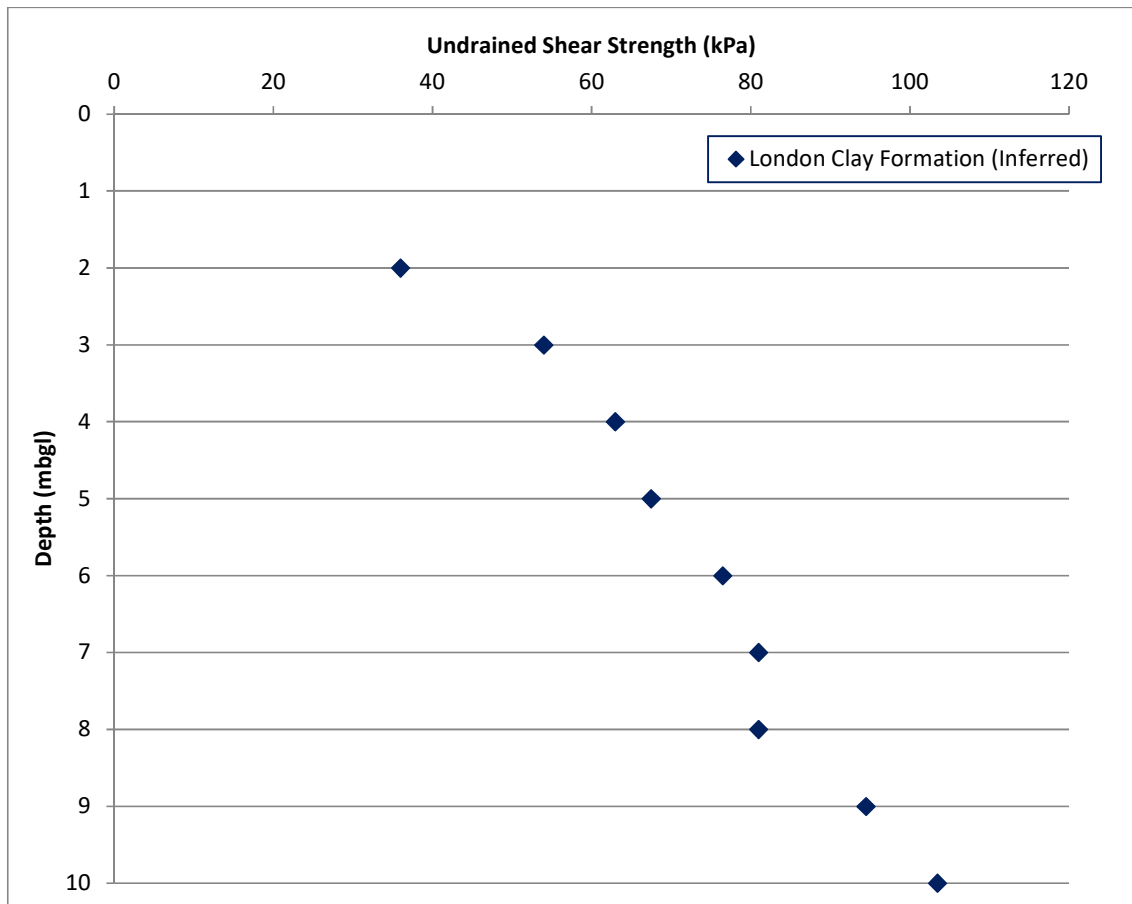
Figure 5.1: Inferred Undrained Shear Strength v Depth

5.4.3 As shown above there is a generally consistent increase in shear strength with depth throughout the London Clay Formation.

5.4.2 A value for f_1 of 4.5 has been adopted after Tomlinson (2001) to allow for a conservative assessment.

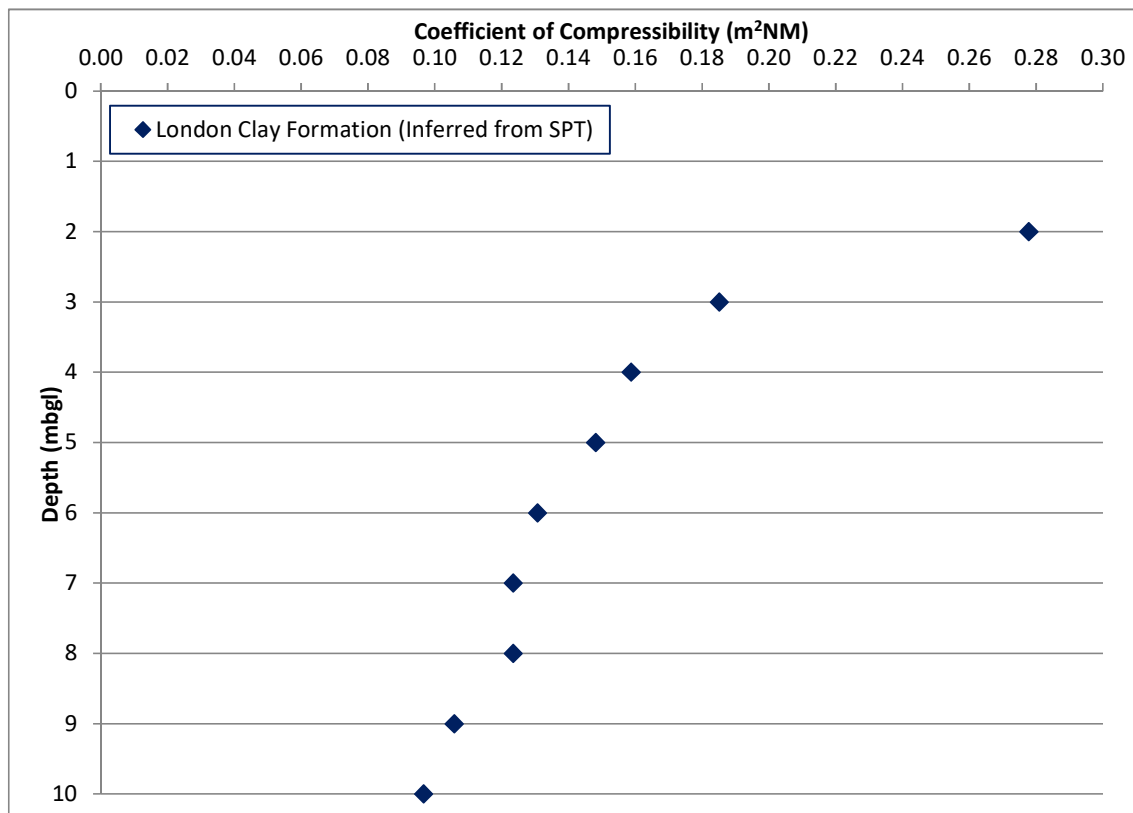
Figure 5.2: Inferred Coefficient of Volume Compressibility (m_v) v Depth

5.5.3 As would be expected the results reduce with depth as the clay increases in strength and the over burden increases, reducing the potential for compressibility.

5.5.4 The results from of the London Clay are generally of “low” to “medium” compressibility”.

5.5.2 Using the graphs provided in Tomlinson (2001) a value of f_2 of 0.45 has been taken and used with the SPT 'N' values to infer coefficient of compressibility (m_v). This allows for a conservative assessment.
