MURPHY'S YARD

BAT SURVEYS

Murphy Site, Kentish Town

Bat Surveys

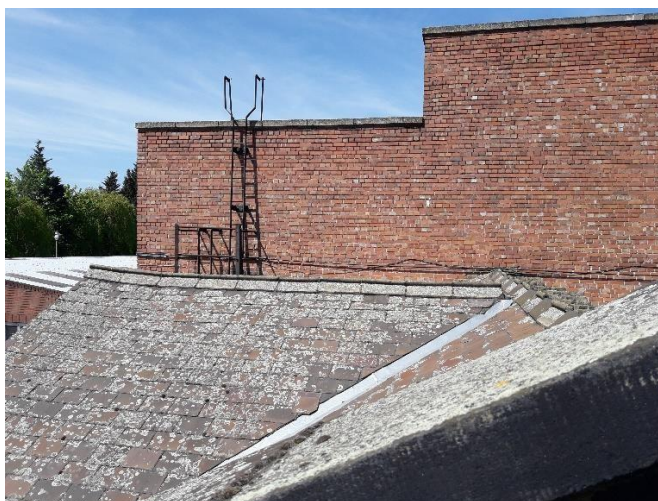
Photograph 1

View of roof structure of Building B4, as viewed from the east, with B5 behind.

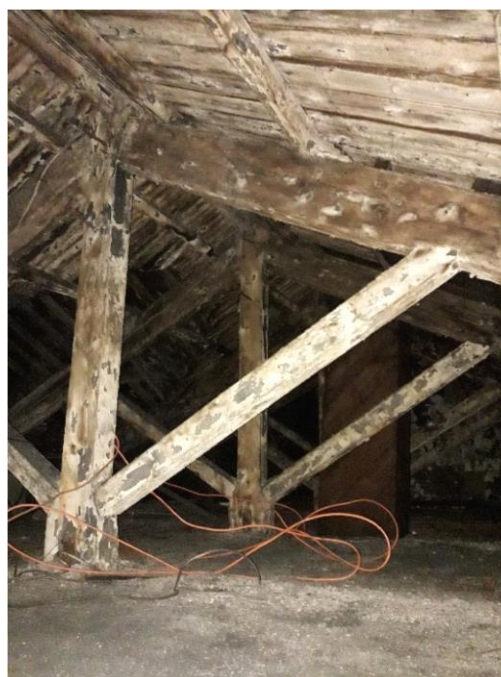
Photograph 2

of the loft void. A view was gained of the loft void, from atop a scaffolding tower where there was a gap in the timber floor of the void, adjacent to the eastern wall of the building. Timber boarding was present beneath the slates and the bitumen felt that lined the timber had completely degraded (Appendix 2, Photograph 2).

Representative view of interior of loft void of building B4, as viewed from atop a scaffold tower at the eastern end of the void.

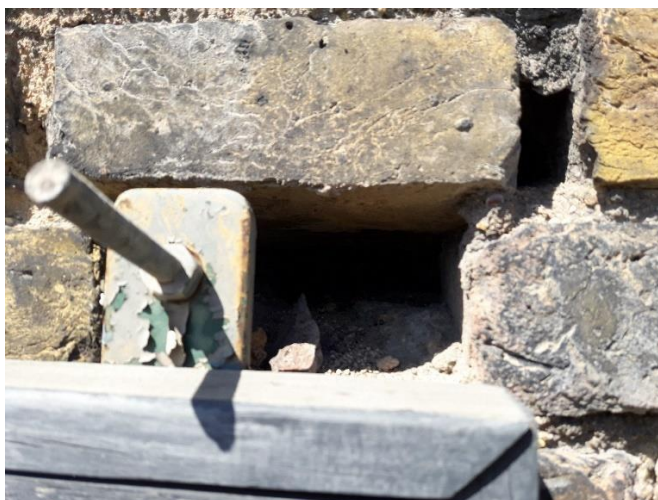
Photograph 3

- 3.12 *Building 4: Results.* The building was generally in good condition, with all roof tiles and ridge tiles noted to be tight. However, there were several gaps noted in the brickwork on the eastern elevation of the building, where the existing sign is bolted to the wall (Appendix 2, Photograph 3). There is also a brick that has twisted on the north-eastern corner of the building, and upon inspection was found to be an access point into a cavity within the wall and around the parapet wall (Appendix 2, Photograph 4). These gaps in the brickwork would provide potential roosting features for bats. There was also a gap in the brickwork at the apex of the parapet wall on the south-eastern elevation of the building, but this was large and exposed and considered unsuitable.

Holes within brickwork where sign has been fixed to south-eastern elevation of Building B4.

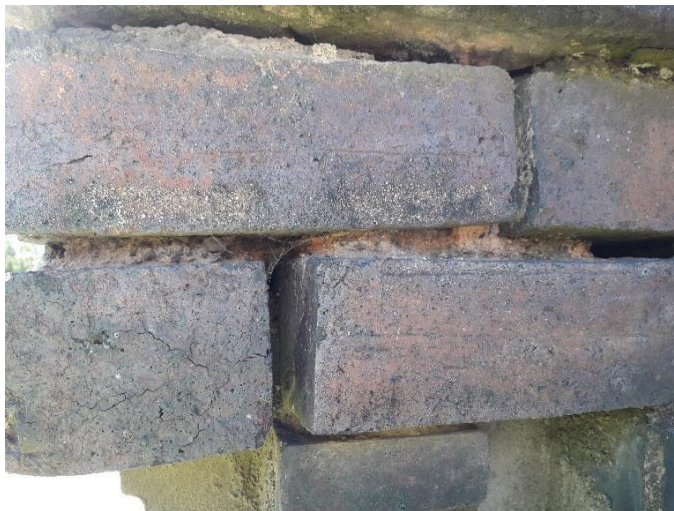
Photograph 4

Twisted brick on north-eastern corner of Building B4, creating an access point to cavity within parapet wall.

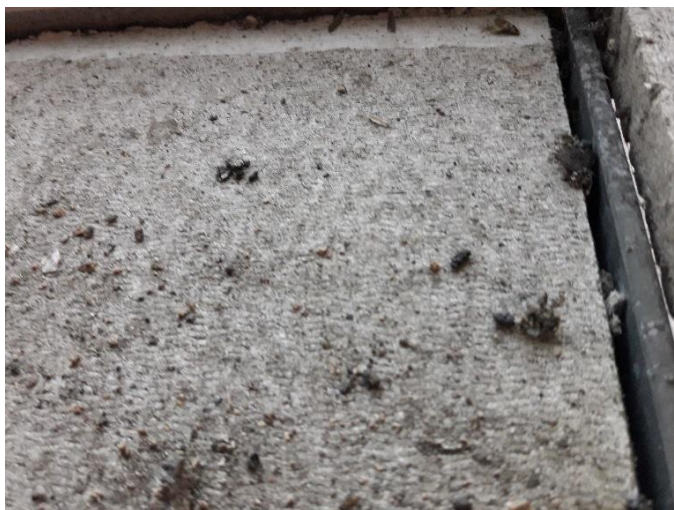
Photograph 5

- 3.13 The loft void was found to contain an abundance of cobwebs. There was no evidence of bats recorded within the loft void, on top of the suspended ceiling tiles or on the timber floor of the loft void. Mouse droppings were noted above the suspended ceiling at the eastern end of the building (Appendix 2, Photograph 5).

Mouse dropping on upper side of suspended ceiling in Building B4.

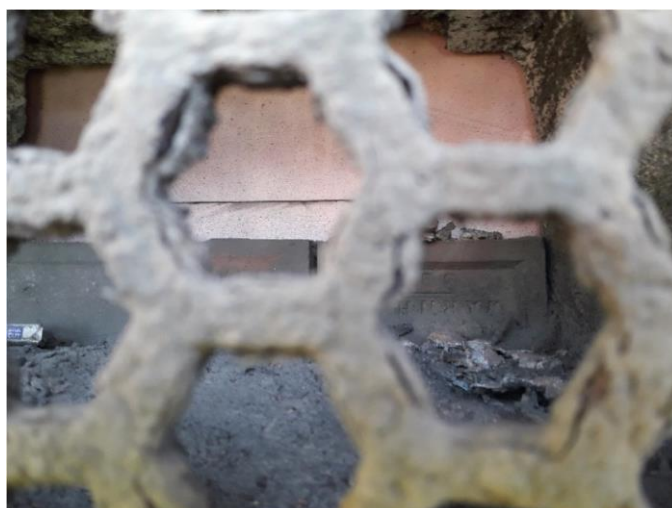
Photograph 8

3.19 *Building 6: Results.* The gaps within the stonework and the grill on the southern elevation were inspected using a MEWP. The cavity behind the grill, and the gaps within the stonework were found to be open and exposed and was considered to be unsuitable for roosting bats (Appendix 2, Photograph 9). No evidence of bats was noted within these features, and they were considered to have negligible potential for roosting. No further survey work is required on B6.

View into cavity behind grill on southern elevation of Building B6.

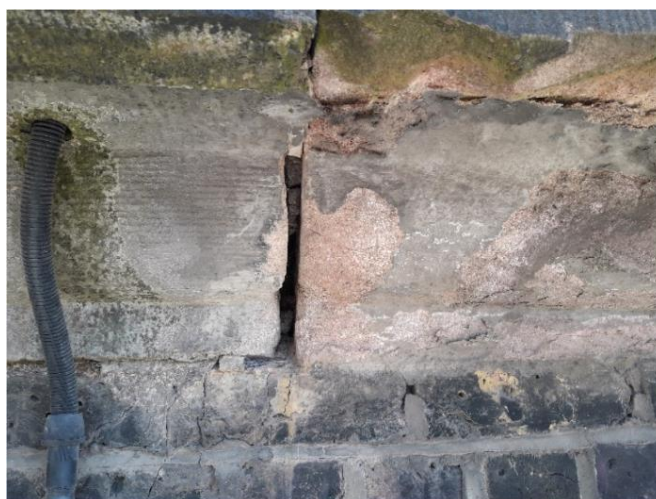
Photograph 9

View into cavity between stonework on southern elevation of Building B6.
