**TYBALDS ESTATE, CAMDEN,  
GREATER LONDON**

**PRELIMINARY BAT ROOST  
ASSESSMENT**

Report No: RT-MME-154667-05- Rev B

Date: June 2021

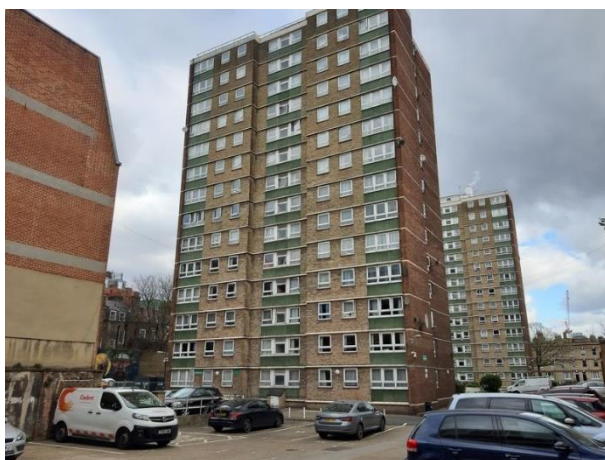
**Plate 4.1: Building B1 - Babington Court  
(Western Elevation)**

Babington Court (Building B1) and Chancellors' Court (Building B2) were of a similar design and construction and occupied the northern section of the site. These buildings were fourteen storeys high, post-war apartment blocks with flat concrete roofs (Plate 4.1 and 4.2). The buildings were brick-built with tightly fitted double glazed windows set in uPVC frames. Both buildings were in relatively good condition and were occupied at the time of the survey.

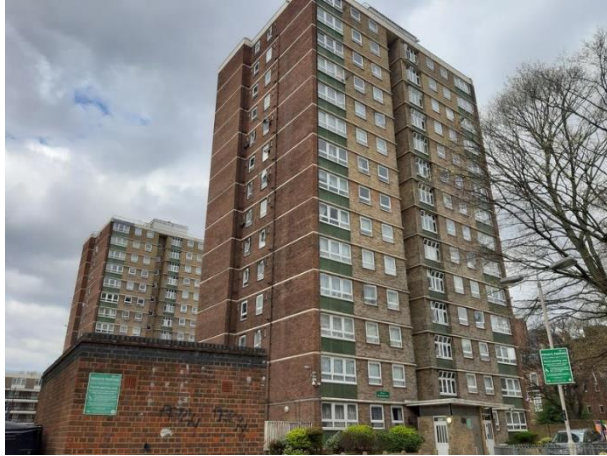
**Plate 4.3: Extent of Painted Fascia Board and Roof Storage Building (Eastern Elevation)**

A survey of the roofs of Buildings B1 and B2 was conducted from ground level. Due to the height of the buildings not all aspects of the roofs could be surveyed fully. The roofs were flat and constructed from concrete with a painted fascia board tightly fitted to each elevation of the building (Plate 4.3). A small, single-storey storage building was recorded on the roof of both buildings, surround by metal railings. Multiple open-ended pipes were also recorded on several aspects of the buildings across the site which provide potentially suitable crevices for roosting bats (Plate 4.4).

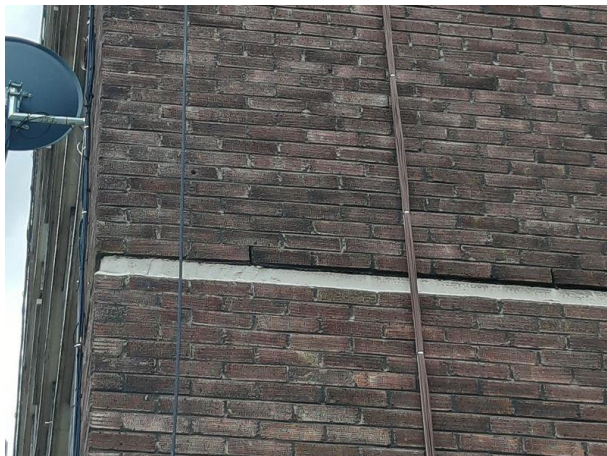
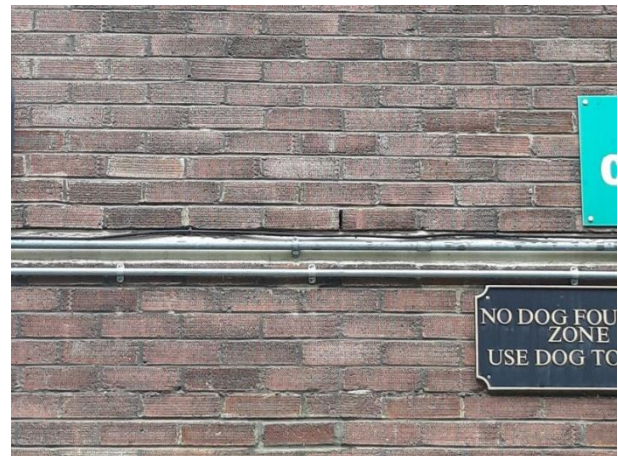
Weepholes were recorded on multiple aspects of the buildings (Plate 4.5 and Plate 4.6). These gaps provide potential ingress points into the internal structure of the buildings and create a suitable roosting crevice for bats. It was not possible to inspect these features due to the height at which they were located and as such it was not possible to establish if bats had used these features to enter a roost location at the time of surveying. No evidence of roosting bats, e.g. droppings, urine staining, feeding remains or scratch marks, was recorded within the features that could be fully inspected during the survey. Aspects such as windows and doors within the buildings did not contain any potential roosting features.

**Plate 4.5: Extent of Weepholes (Building B1 - Babington Court, Northern Elevation)**

**Plate 4.6: Extent of Weepholes (Building B2 - Chancellors' Court, Southern Elevation)**

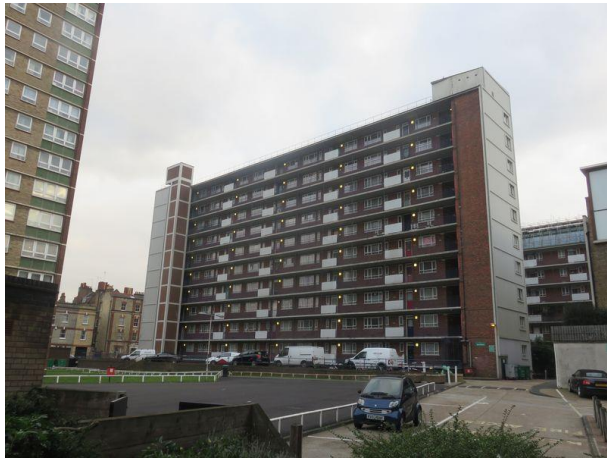
**Plate 4.7: Building B3 – Blemundsbury  
(Northern Elevation)**

Blemundsbury (Building B3) and Windmill (Building B4) were of a similar design and construction and occupied the eastern section of the site. These buildings were eight storeys high, post-war apartment blocks with flat concrete roofs (Plate 4.7 and 4.8). The buildings were predominantly brick-built with prefabricated metal stairwells present on the eastern and western elevations. Several concrete balconies were recorded on the northern and southern elevations. Tightly fitted double glazed windows were noted and sat in uPVC frames. Both buildings were in relatively good condition and were occupied at the time of the survey.

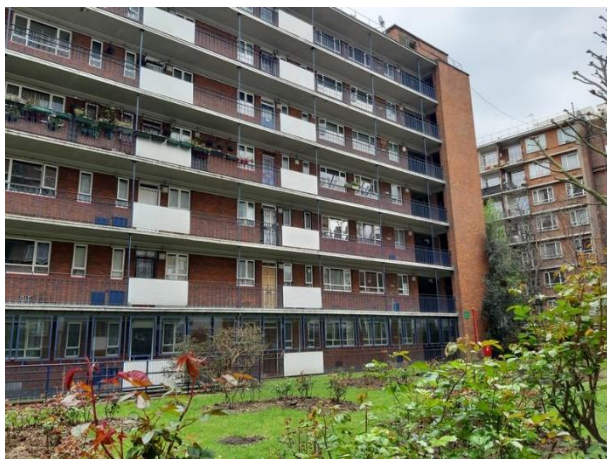
**Plate 4.9: Building B4 – Windmill (Northern  
Elevation)**

A survey of the roofs of Buildings B3 and B4 was conducted from ground level. Due to the height of the buildings not all aspects of the roofs could be surveyed fully. The roofs were flat and capped with concrete (Plate 4.9). An associated stairwell extension, constructed from brick and prefabricated metal was noted on the roofs of both buildings, surrounded by metal railings.

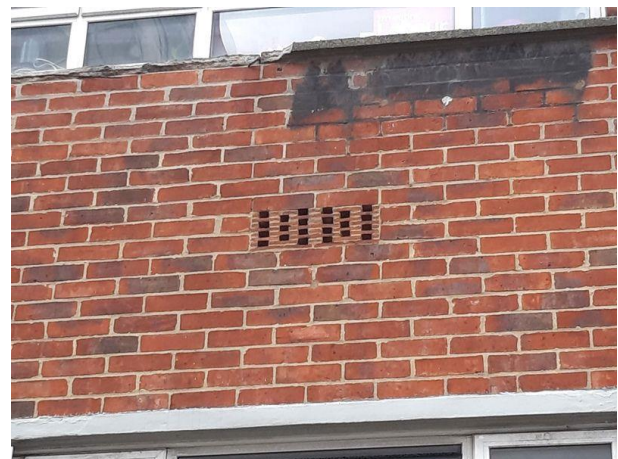
Multiple airbricks were also recorded beneath the suspended floors on the northern and southern aspects of the buildings which provide potentially suitable crevices for roosting bats (Plate 4.10). It was not possible to inspect these features due to the height at which they were located and as such it was not possible to establish if bats had used these features to enter a roost location at the time of surveying. No evidence of roosting bats, e.g. droppings, urine staining, feeding remains or scratch marks, was recorded within the features that could be fully inspected during the survey. Aspects such as windows and doors within the buildings did not contain any potential roosting features.

**Plate 4.10: Airbrick (Building B4 – Windmill,  
Southern Elevation)**

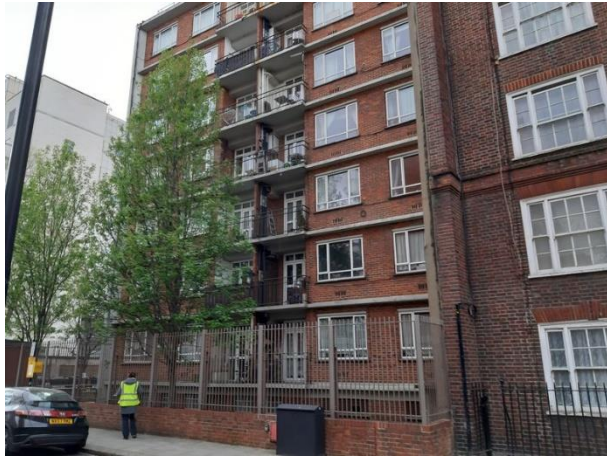
**Plate 4.11: Building B5 – Springwater (Eastern Elevation)**

Springwater (Building B5) and Richbell (Building B6) were of a similar design and construction and occupied the southern section of the site. These buildings were eight storeys high, post-war apartment blocks with flat concrete roofs (Plate 4.7 and 4.8). The buildings were predominantly brick-built with prefabricated metal walls present on the southern elevations. Several suspended concrete balconies were recorded on the eastern and western elevations. Tightly fitted double glazed windows were noted and sat in uPVC frames. Both buildings were in relatively good condition and were occupied at the time of the survey.

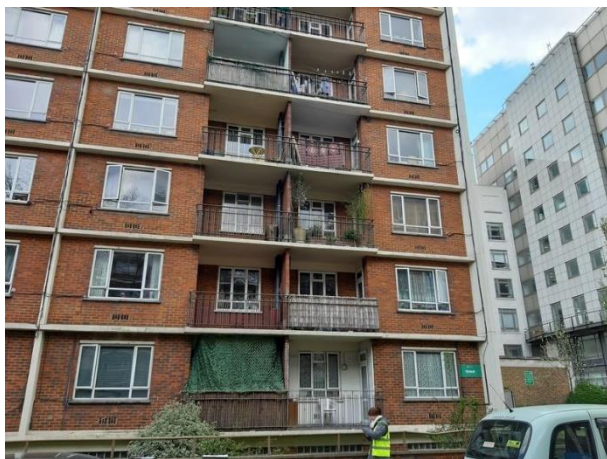
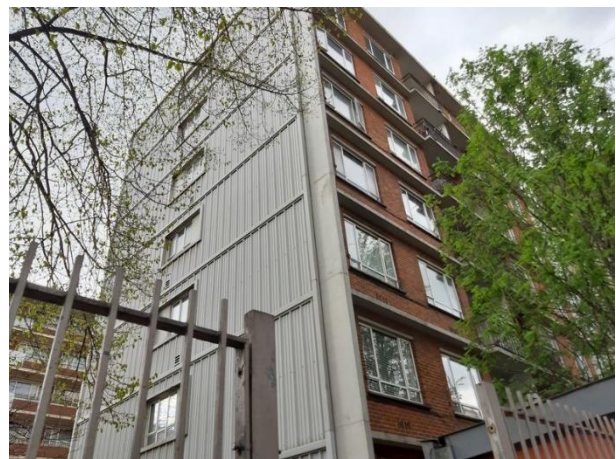
Multiple airbricks and vents were recorded beneath the suspended floors and amongst the prefabricated metal wall on the eastern, western and southern aspects of the buildings respectively; which provide potentially suitable crevices for roosting bats (Plates 4.13 and 4.14). It was not possible to inspect these features due to the height at which they were located and as such it was not possible to establish if bats had used these features to enter a roost location at the time of surveying. No evidence of roosting bats, e.g. droppings, urine staining, feeding remains or scratch marks, was recorded within the features that could be fully inspected during the survey. Aspects such as windows and doors within the buildings did not contain any potential roosting features.

**Plate 4.13: Extent of Airbricks (Building B6 – Richbell, Western Elevation)**

**Plate 4.14: Air Vents on Prefabricated Metal Wall (Building B5 – Springwater, Southern Elevation)**

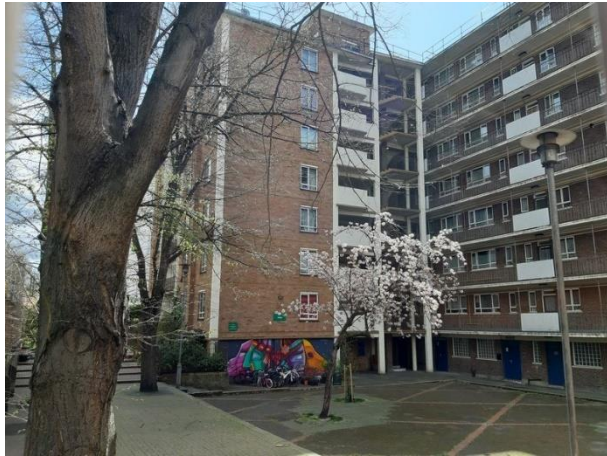
**Plate 4.15: Building B7 - Falcon (North-Eastern Elevation)**

Falcon (Building B7) was of a similar design and construction and occupied the south-western section of the site. This building was eight storeys high, post-war apartment blocks with flat concrete roofs (Plate 4.15). Several suspended concrete balconies were recorded on the eastern and western elevations. Tightly fitted double glazed windows were noted and sat in uPVC frames. The building was in relatively good condition and occupied at the time of the survey.

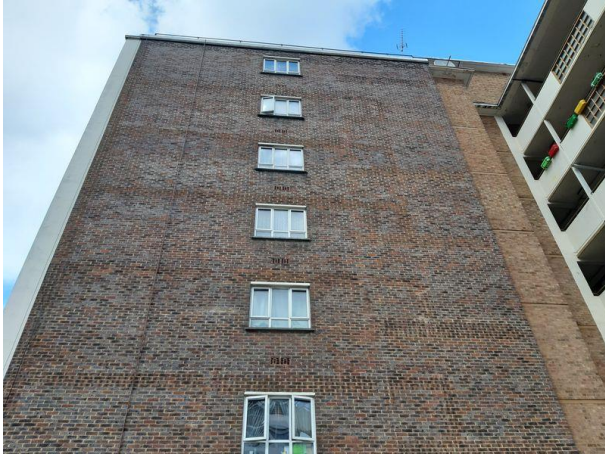
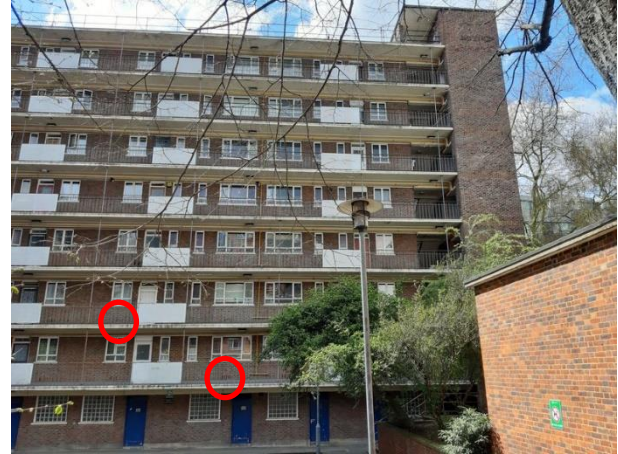
Multiple airbricks were also recorded beneath the suspended floors on the eastern and western aspects of the buildings which provide potentially suitable crevices for roosting bats (Plate 4.19 and 4.20). It was not possible to inspect these features due to the height at which they were located and as such it was not possible to establish if bats had used these features to enter a roost location at the time of surveying. No evidence of roosting bats, e.g. droppings, urine staining, feeding remains or scratch marks, was recorded within the features that could be fully inspected during the survey.

**Plate 4.19: Extent of Airbricks (Building B7, Southern Elevation)**

**Plate 4.20: Extent of Airbricks (Building B7, Eastern Elevation)**

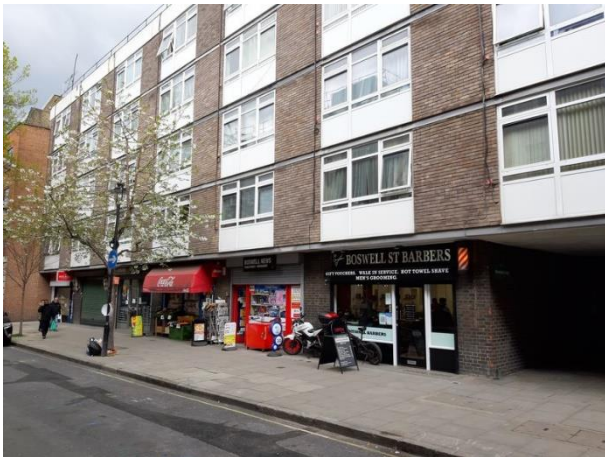
**Plate 4.21: Building B8- Devonshire Court (Southern Elevation)**

Devonshire Court (Building B8) was of a similar design and construction and occupied the north-western section of the site. This building was eight storeys high, post-war apartment blocks with flat concrete roofs (Plate 4.21 and 4.22). Several suspended concrete balconies were recorded on the eastern elevation. A stairwell extension adjoined the building to the south-east. Tightly fitted double glazed windows were noted and sat in uPVC frames. The building was in relatively good condition and occupied at the time of the survey.

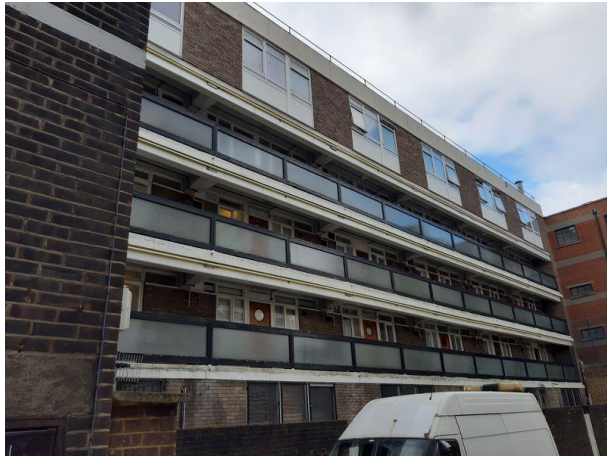
A survey of the roof of Building B8 was conducted from ground level. Due to the height of the building not all aspects of the roof could be surveyed fully. The roof was flat and constructed from concrete with a painted fascia board tightly fitted to each elevation of the building (Plate 4.23). A small, single-storey storage building was recorded on the roof of both buildings, surround by metal railings. Multiple open-ended pipes were also recorded on several aspects of the buildings across the site which provide potentially suitable crevices for roosting bats (Plate 4.24).

**Plate 4.23: Extent of Painted Fascia Board (Eastern Elevation)**

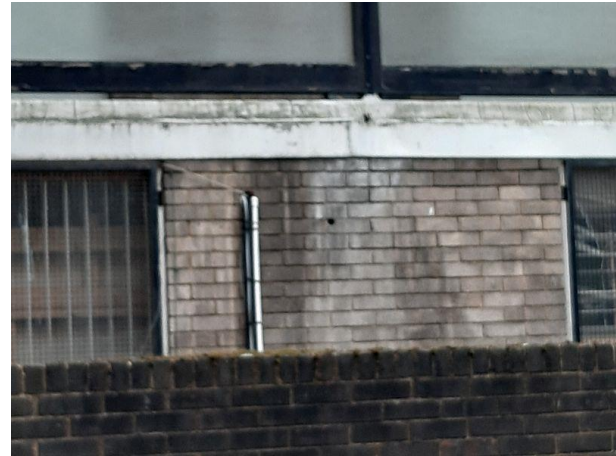
**Plate 4.24: Open-ended Pipework (Eastern Elevation)**

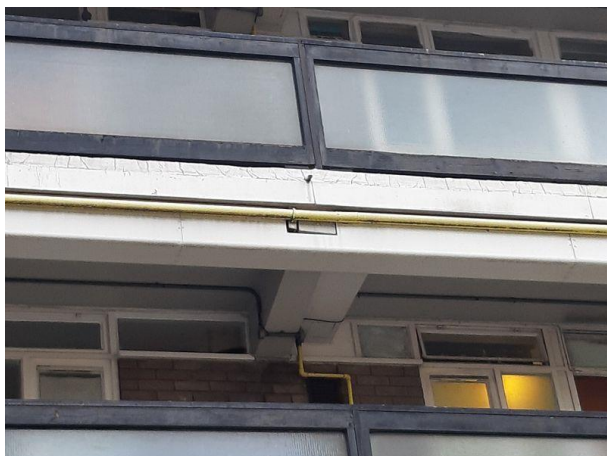
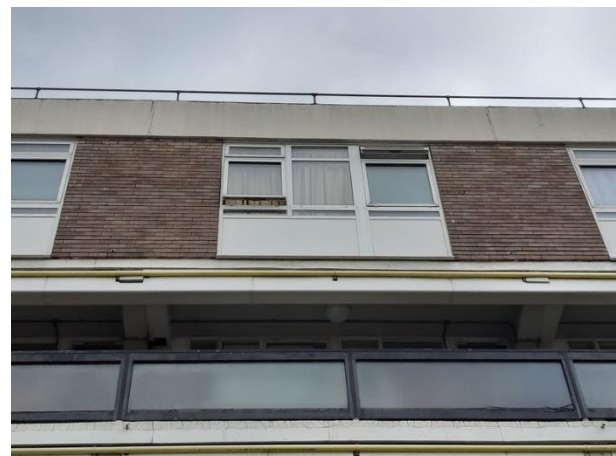
Gaps in the fascia board were recorded on the eastern elevation of the building (Plate 4.25 and Plate 4.26). These gaps provide potential ingress points into the internal structure of the buildings and create a suitable roosting crevice for bats. It was not possible to inspect these features due to the height at which they were located and as such it was not possible to establish if bats had used these features to enter a roost location at the time of surveying. No evidence of roosting bats, e.g. droppings, urine staining, feeding remains or scratch marks, was recorded within the features that could be fully inspected during the survey. Aspects such as windows and doors within the buildings did not contain any potential roosting features.

**Plate 4.25: Gaps in Fascia Board (Eastern Elevation)**

**Plate 4.26: Gaps in Fascia Board (Eastern Elevation)**

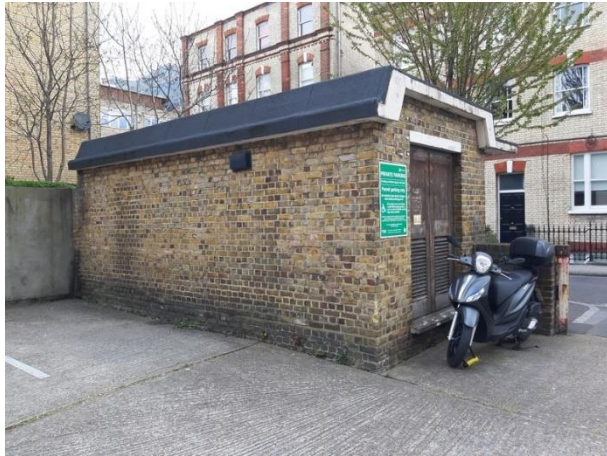
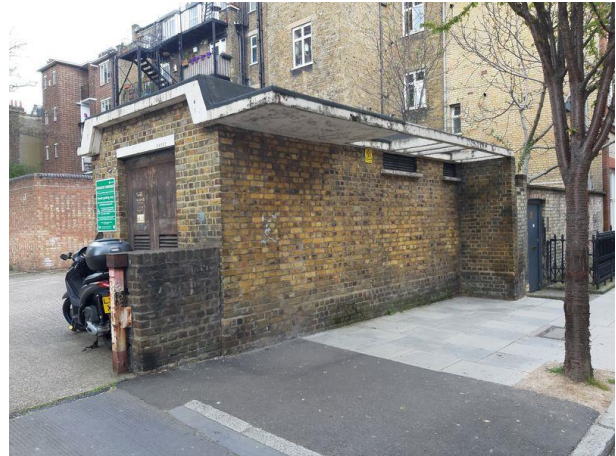
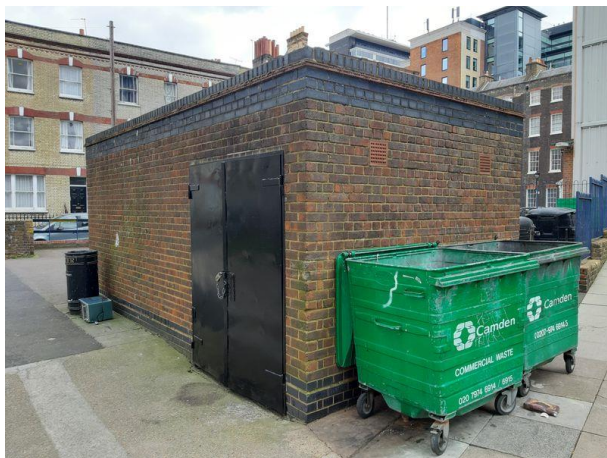
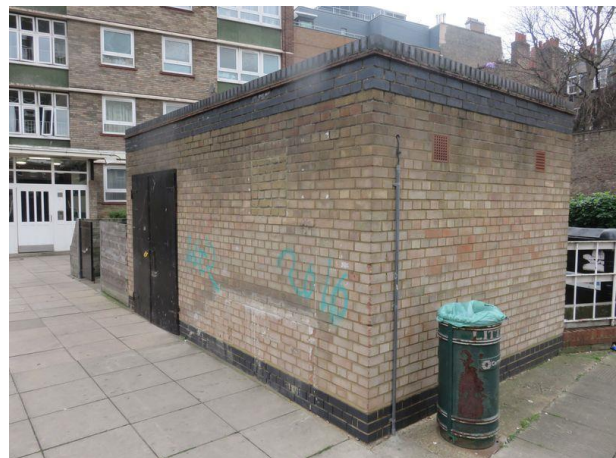
The three storage buildings were of a similar design and construction and comprised of single storey, brick-built structures with a combination of flat bitumen felt and concrete roofs (Plate 4.27, 4.28, 4.29 and 4.30). These buildings were in relatively good condition and operational at the time of the survey, with no gaps or cracks noted between the brickwork. The roofs were in overall good condition with no gaps or tears recorded. Wooden doors were fixed within wooden frames. The frames were of good condition and were tightly fitted to the external wall with no gaps recorded.

No features were recorded during the external assessment of the storage buildings which could be utilised by bats to gain entry into the internal areas of these buildings. In addition, no external features suitable for roosting bats were noted on the buildings. The buildings were in good condition and tightly sealed with no potential ingress/egress points or features for bats.

Plate 4.27: Storage Building (Western Elevation)

Plate 4.28: Storage Building (Eastern Elevation)

Plate 4.29: Storage Building (Northern Perspective)

Plate 4.30: Storage Building (Southern Elevation)

The storage buildings and sheds were fully inspected, and no bat roosts were identified. These structures had no potential for roosting bats. The survey data obtained for the site is valid for 12 months from the survey date. If development works to the surveyed structure have not commenced within this timeframe it will be essential to update the survey effort to establish if suitable features have developed and if bats have colonised the structures in the interim. In the unlikely event that a bat is found during demolition works all works must immediately cease and a suitably qualified ecologist should be contacted.

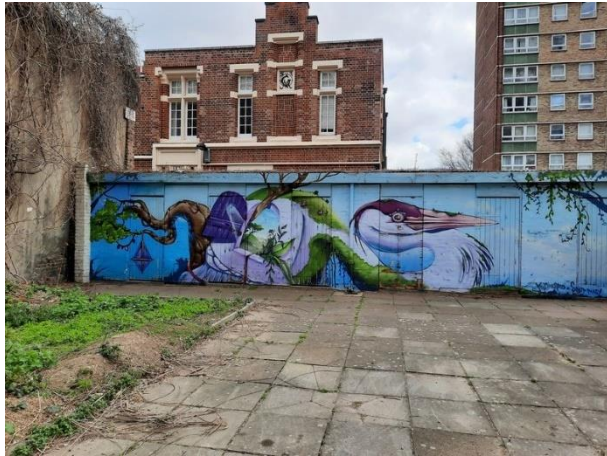
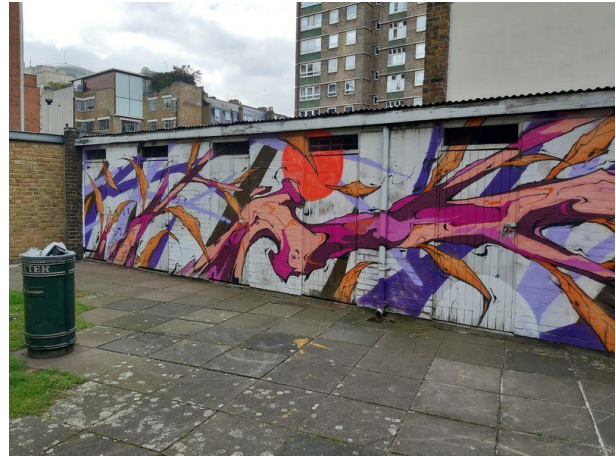
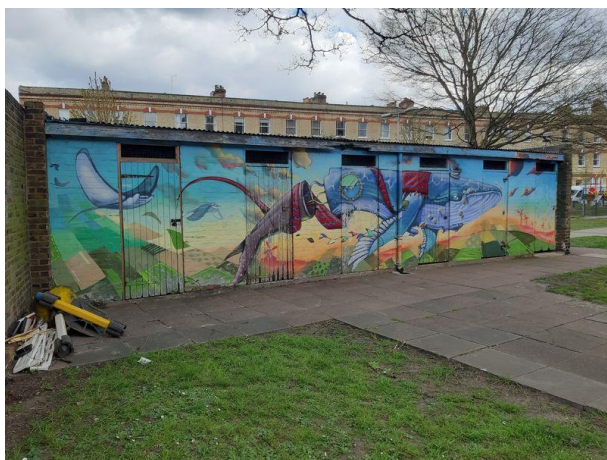
Three terraces of storage sheds were situated along the northern boundary of the site and were currently being used for private storage (Plates 4.31, 4.32, 4.33 and 4.34). The sheds had corrugated metal roofs, plastic guttering, brick walls and large wooden doors. Transom gaps above the door were meshed, preventing internal access to the shed spaces.

No features were recorded during the external assessment of the storage sheds which could be utilised by bats to gain entry into the internal areas of these buildings. In addition, no external features suitable for roosting bats were noted on the buildings. The buildings were in good condition and tightly sealed with no potential ingress/egress points or features for bats.

Plate 4.31: Storage Shed (Western Elevation)

Plate 4.32: Storage Shed (Eastern Elevation)

Plate 4.33: Storage Shed (Western Perspective)

Plate 4.34: Storage Shed (Western Elevation)
