30 Euston square. Design access statement.

Ref: Design Access statement for the Conservation, stabilisation and repair to the Ceramic faience Piers, The Royal college Of General Practioners.

Conservation Clean, stabilisation and repair to the Ceramic faience Piers.

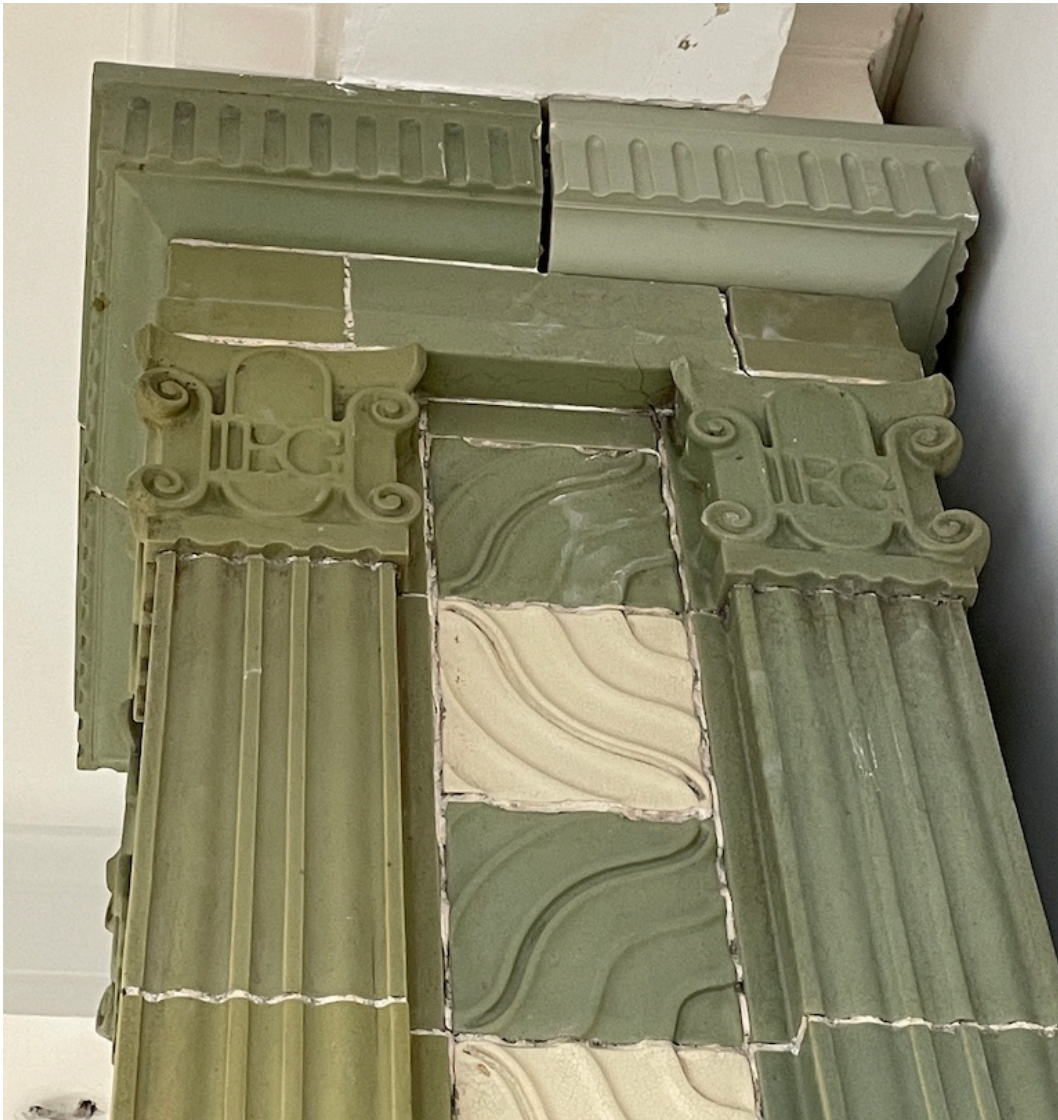
Insitu example of a 20th century replacement.

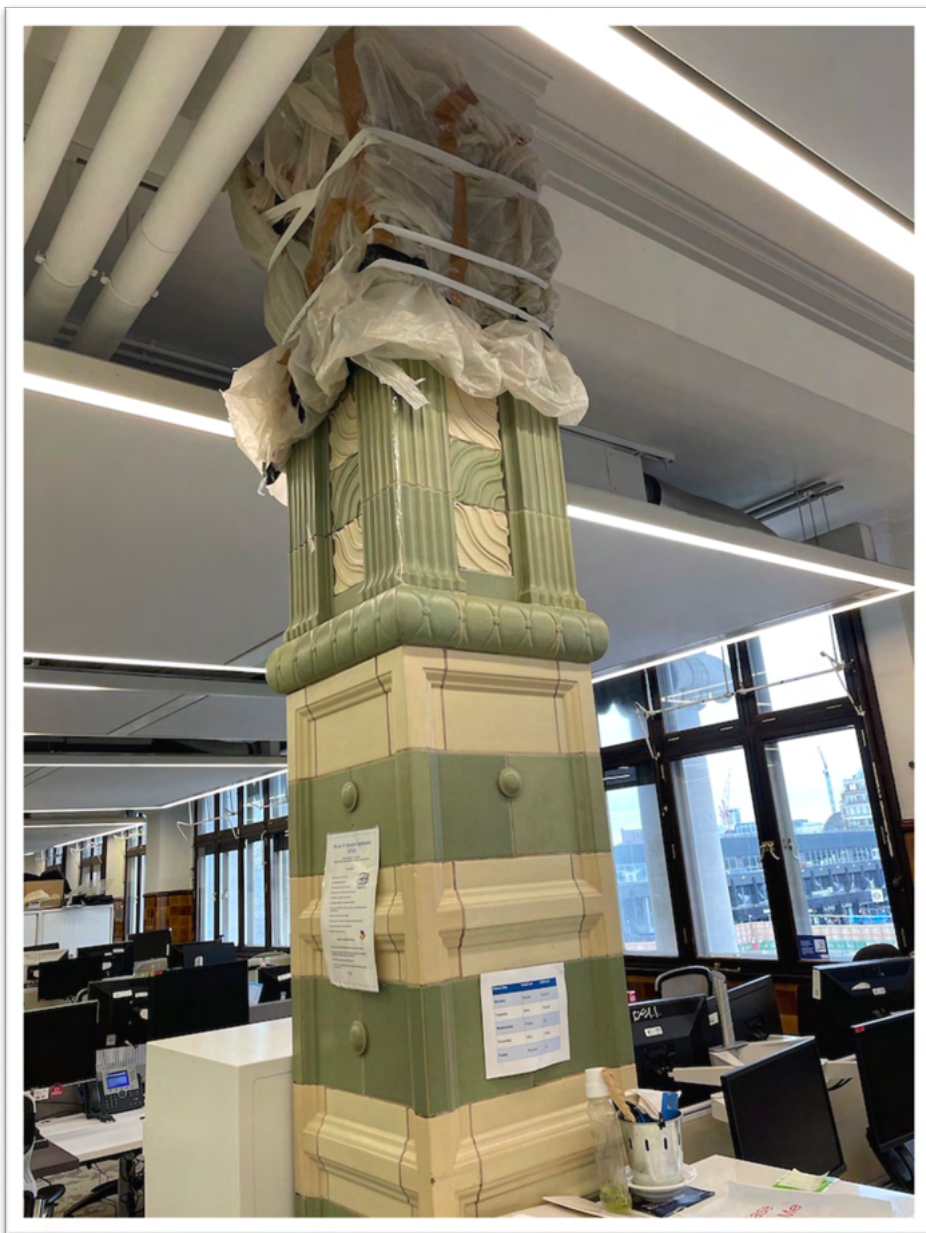
Column 5 level 2 situated above a workstation.

It is clear there is a bonafide need to undertake a facsimile replacement to provide the necessary support to column 5 (level 2) and provide lasting repairs limited to what is reasonably necessary to prevent the problems from escalating within the other columns and to maintain a safe working environment.

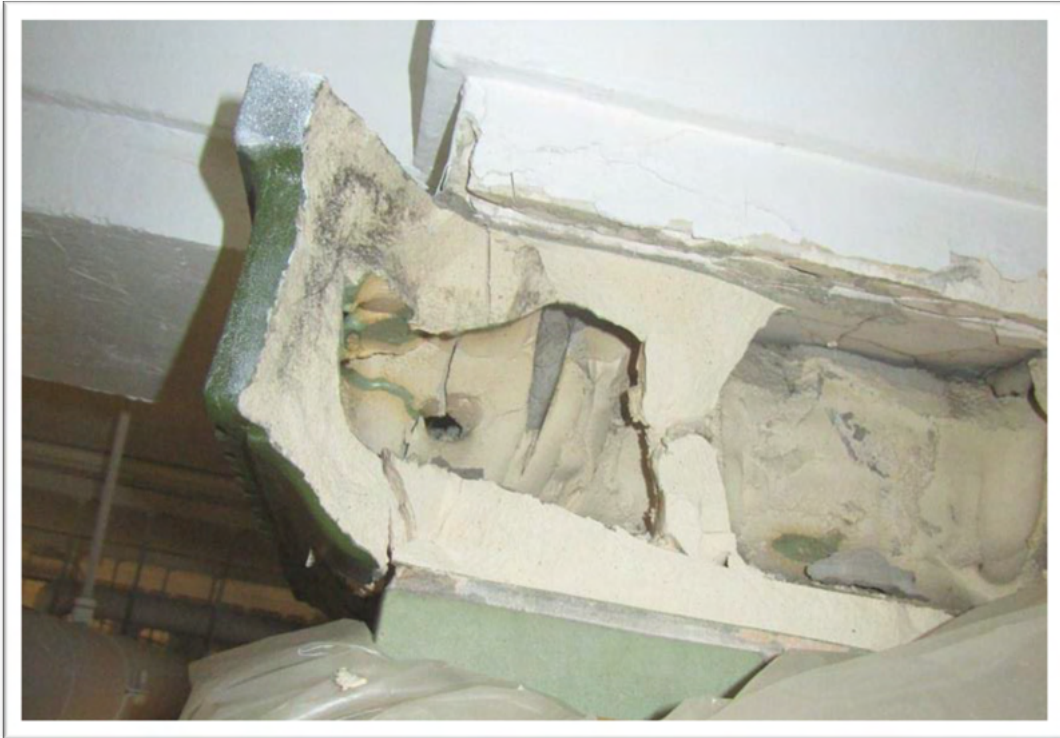
The structural inspection of one of the sections categorises the failure as 'an inadequate original fixing'.

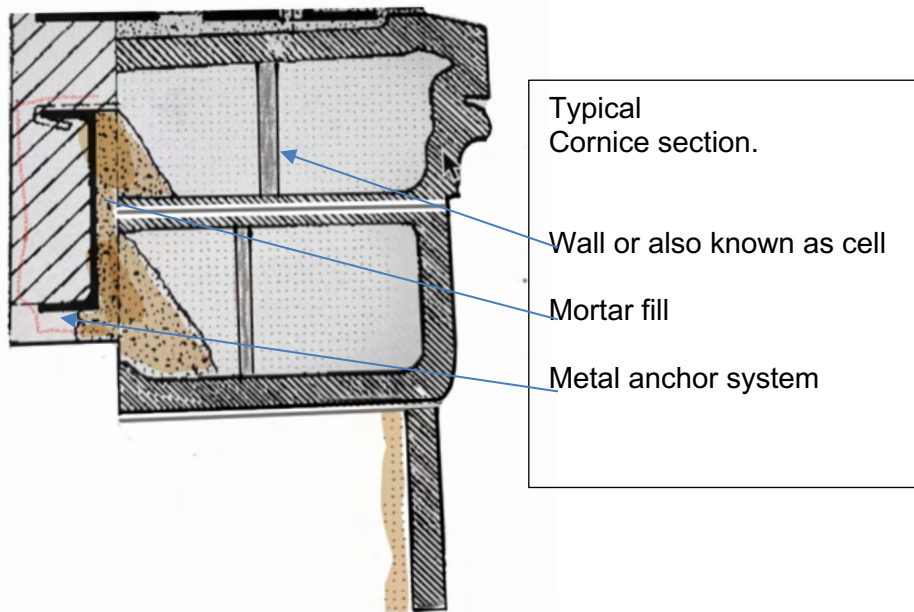
Fixing Arrangement: Metal detected at centre section, indicating limited anchor system. In compression with mortar.

Cross section of modular ceramic cornice and fixing arrangement.

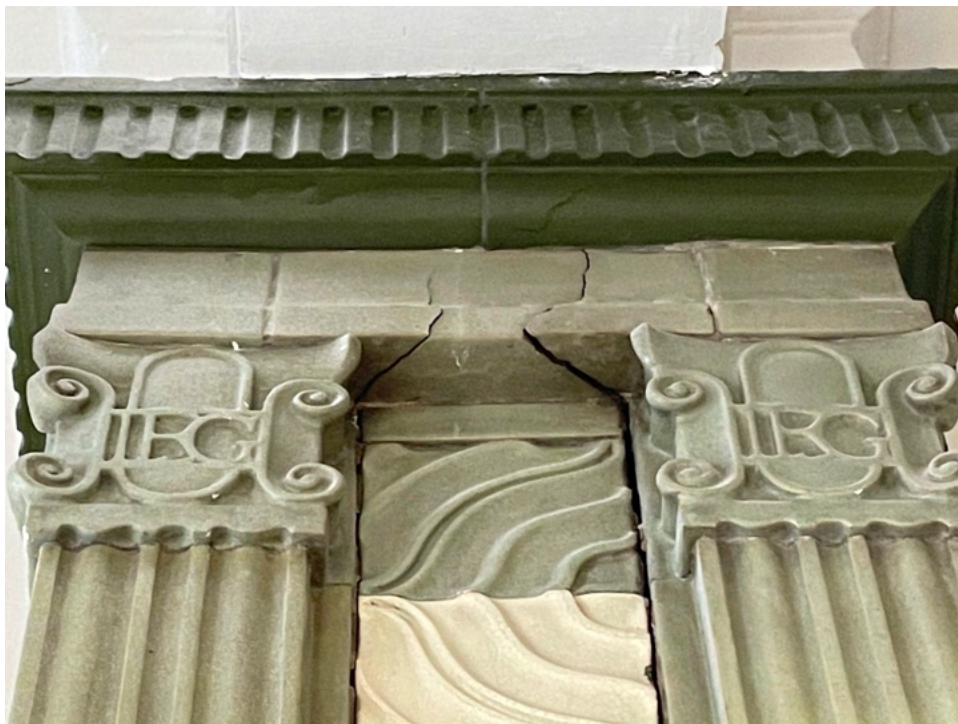
The mechanisms leading to the structural fissuring of the tiles and cornice has not yet been fully understood or explored precisely enough.

We can summate from the condition report and structural review that there is a general degree of stress and deterioration and it is conceivable for a modular section to detach in the future² and for a replica to become damaged.

Vertical fractures within the lower cornice.

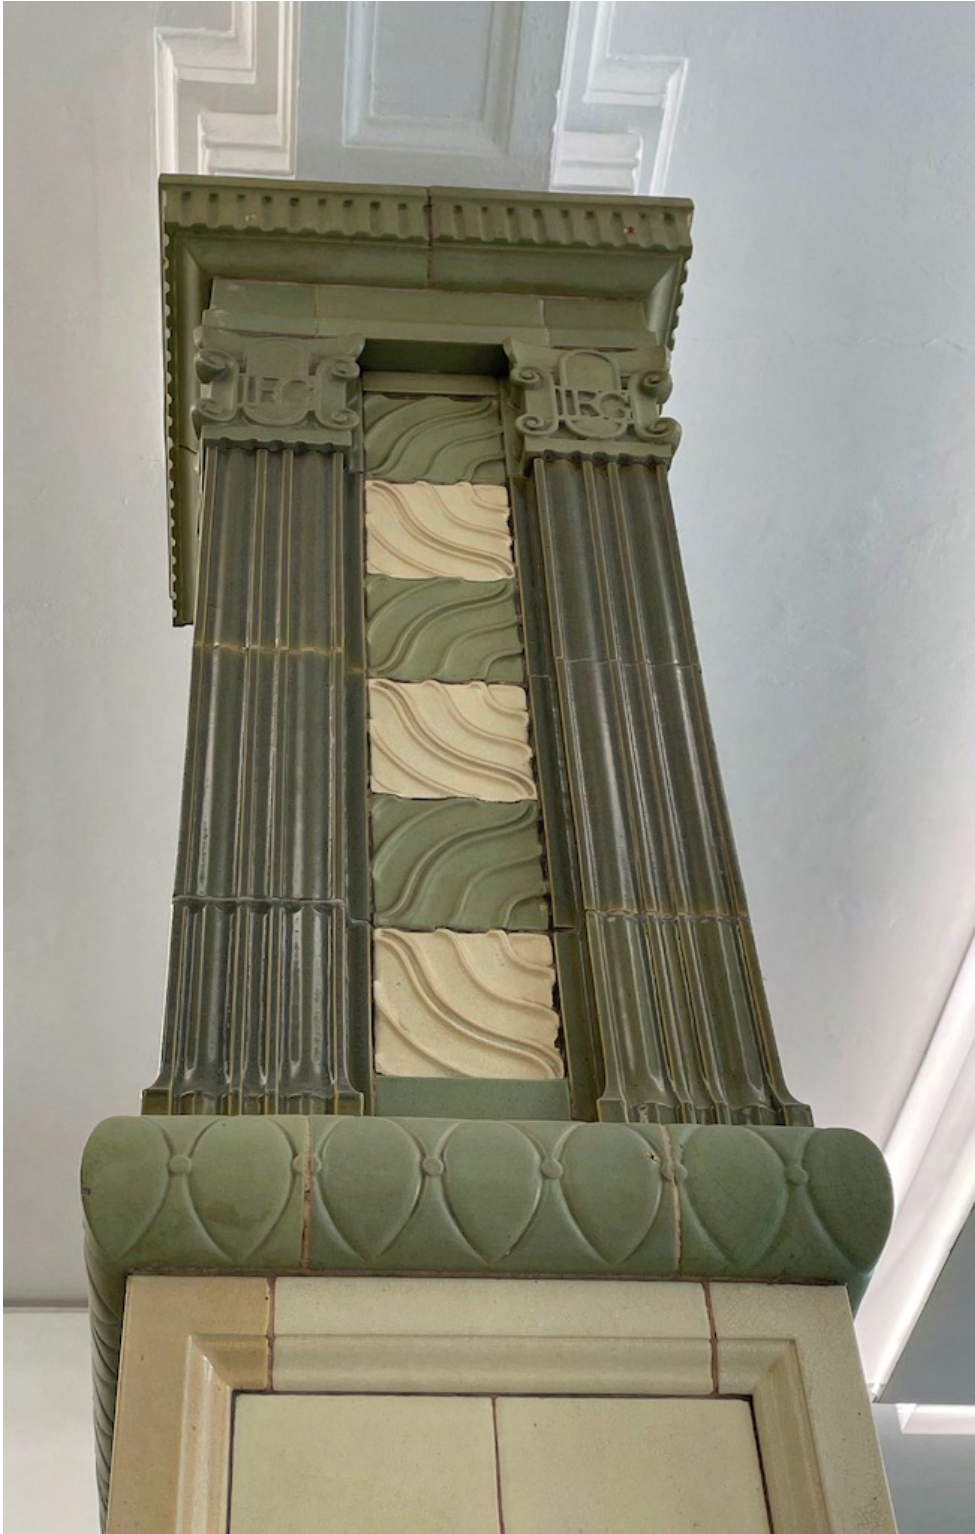
Example of undamaged column.
