# CONTAMINATED LAND RISK ASSESSMENT

# Phase 1 Desk Study Report

5 Brecknock Road London N7 0BL

PH1-2021-000079

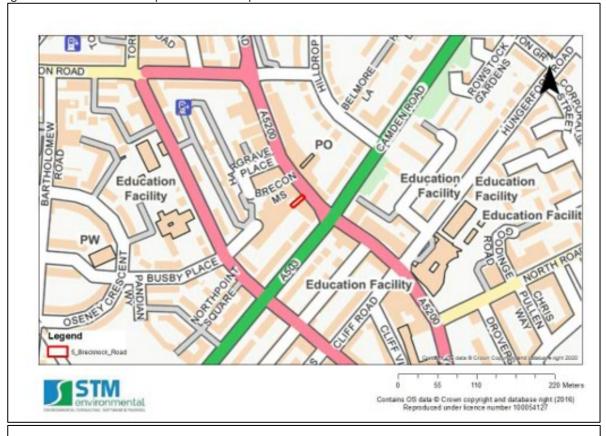
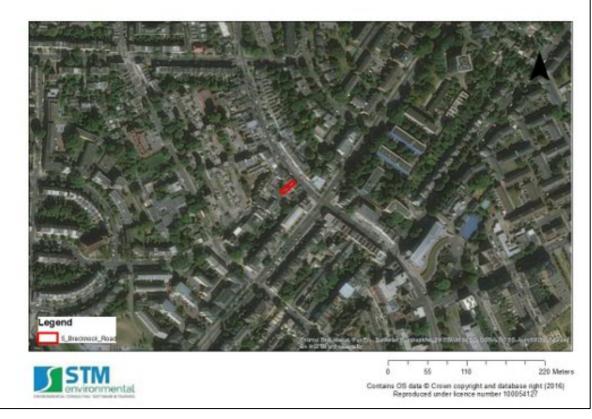
Figure 1: Site Location Map and Aerial Map

The site is located at 5 Brecknock Road, London, N7 0BL at grid reference is 529769, 185008. The site has an area of approximately 0.01 ha. See Figure 1 below for the Site Location and Aerial Maps.

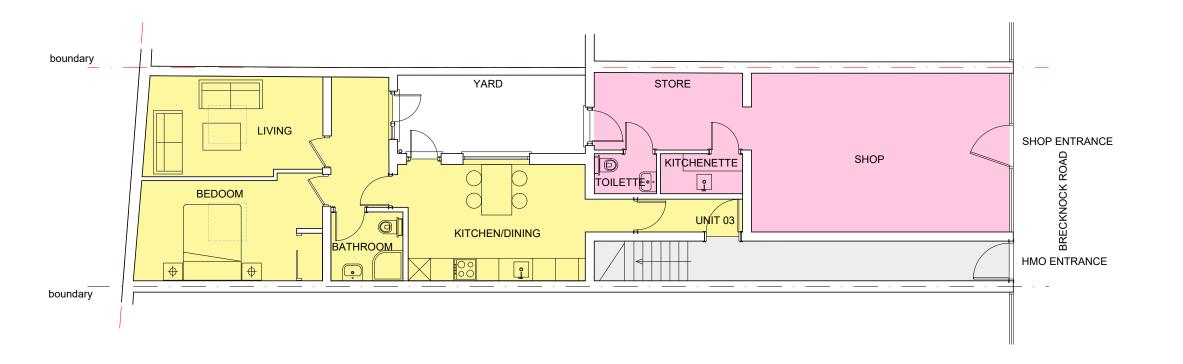
**GROUND FLOOR PLAN AS BUILT**

The development proposal is a conversion and change of use of the rear of the ground floor shop into a self-contained residential accommodation. It is understood that there are no proposals to include soft landscaping in the development.

The proposed development plans are contained in Appendix 1.
