GROUND INVESTIGATION AND BASEMENT IMPACT ASSESSMENT REPORT

30 Ferncroft Avenue
London
NW3 7PH

J20268

April 2021

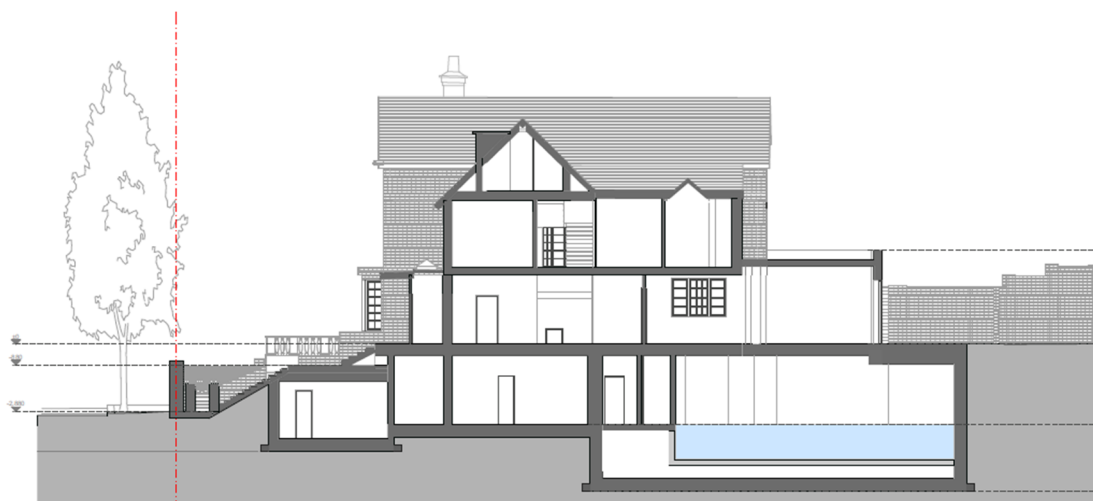
Within the northwestern portion of the basement, it is proposed to include a swimming pool, which will require a deepened excavation to approximately 6.30 m, a level of 93.75 m OD. A proposed cross section is shown below.

The new basement levels will extend to depths of between 0.70 m and 6.30 m and be founded at levels of between 96.00 m OD and 93.75 m OD, such that formation levels will be within the stiff silty sandy clay of the Claygate Member.

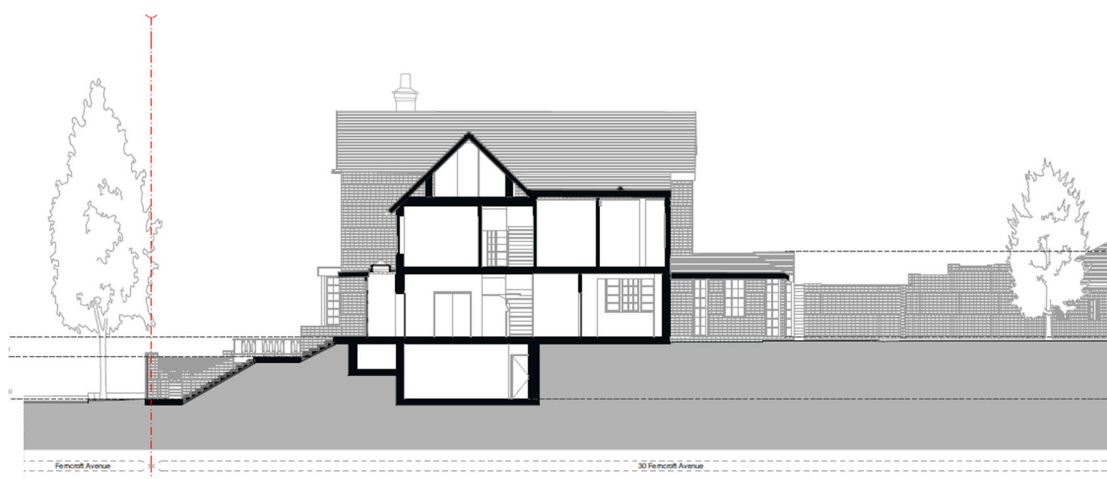
The topography of the site follows that of the general area, which slopes up to the north / northwest and to a lesser extent, to the west. As such, the southern boundary of the site is at a level of circa 97.50 m OD, approximately 4 m below the northern boundary, which is at a level of around 101.50 m OD. The general slope gradient is approximately 4°, although the site has been terraced and levelled. The ground floor level of the house is at a level of approximately 100 m OD, with a terraced level constructed at the front of the house and the rear garden partly cut into the slope to form a level area, as shown by the existing cross-section below.

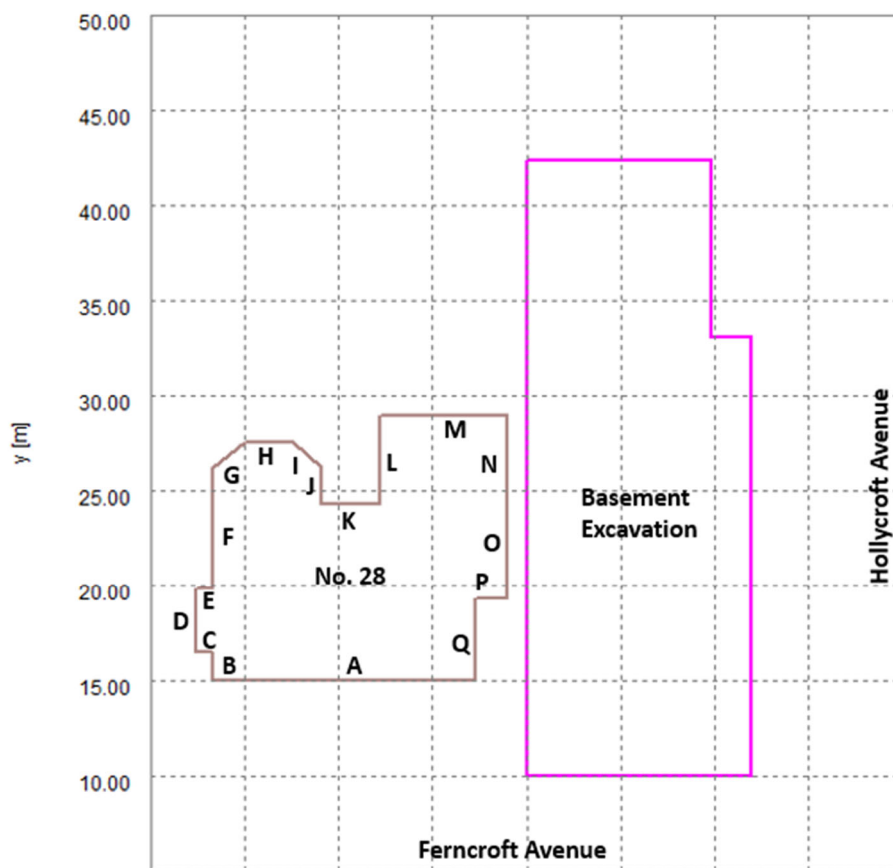
The only sensitive structure relevant to this assessment is considered to be the neighbouring property of No 28 Ferncroft Avenue to the west and the plan below indicates the locations and references of the individual elevations assessed as part of the analysis.

The planning records for No 28 indicate that it includes a lower ground floor level, although no levels are provided on the drawings. A trial pit excavated adjacent to the southeastern elevation indicated a foundation level of 98.09 m OD and therefore this has been adopted as the level for the majority of the building footprint, whilst a trial pit excavated adjacent to the single storey rear extension did not prove the foundation extent at 1.30 m, although a foundation level of 98.50 m OD has been adopted. Both these levels are likely to be conservative but are considered to be a sensible approach. The heights and foundation levels of each of the sensitive elevations are summarised in the table below.

Structure Reference	Foundation level (m OD)	Height of building above ground level (m)
28A to 28K	98.09	7
28L to 28N	98.50	4
28O to 28Q	98.09	7
