MARIA FIDELIS SCHOOL,
NORTH GOWER STREET,
LONDON, NW1 2LY

Appendix C1: Ground Engineering ground investigation report

Project : Maria Fidelis Lower School,
London NW1
Client : Camden Council

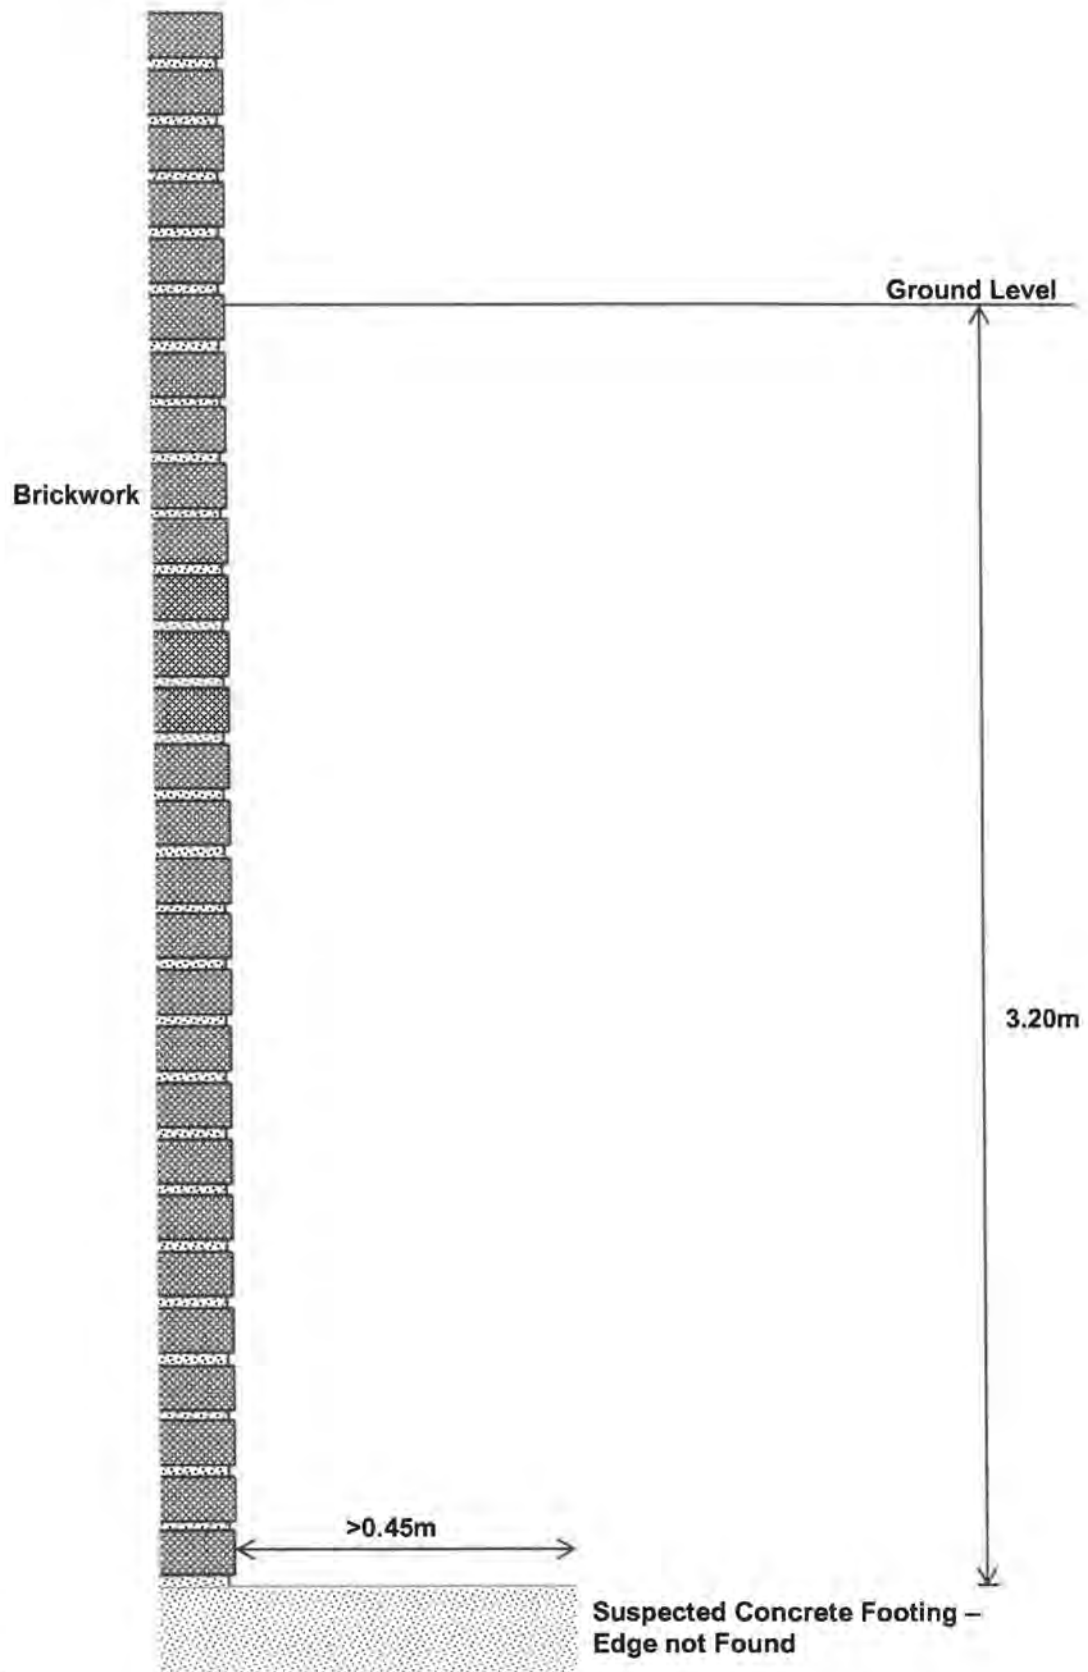
Trial Pit TP 3 Cross Section A-A

In TP 3, the brickwork wall rested at 3.20m depth upon a suspected concrete footing, the edge and base of which were not found.
