CLIENT
Schroders UK Real Estate Fund

PROJECT NAME
North Crescent

DOCUMENT TITLE
Security Needs Assessment

DOCUMENT REFERENCE NUMBER
 QCIC-03096-01001d

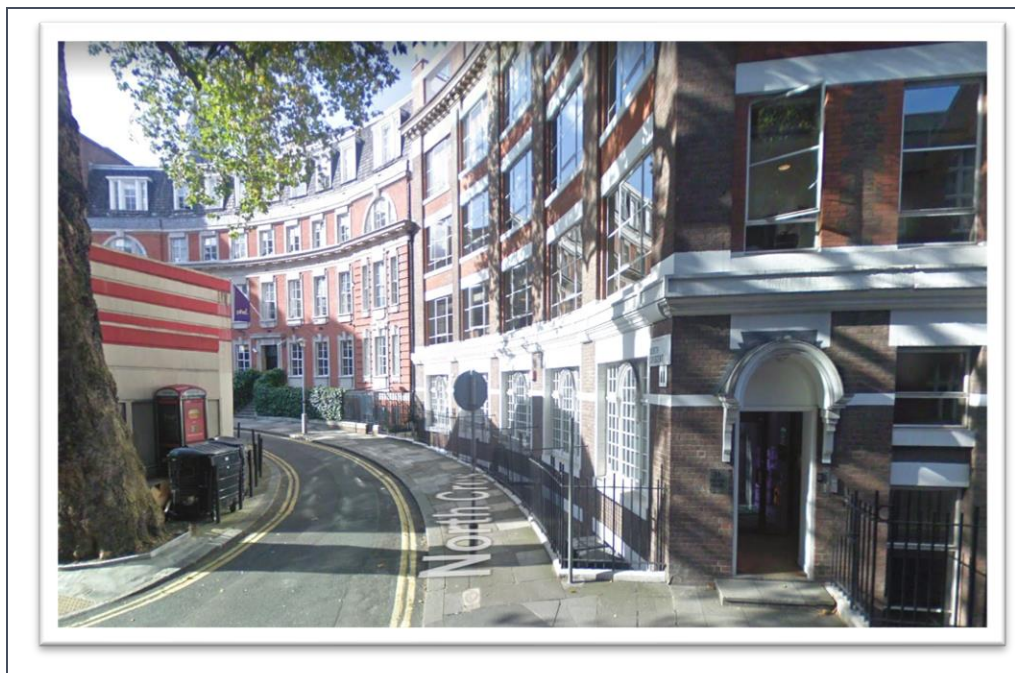
Figure 2: North Crescent North Crescent (Source: Google Maps)

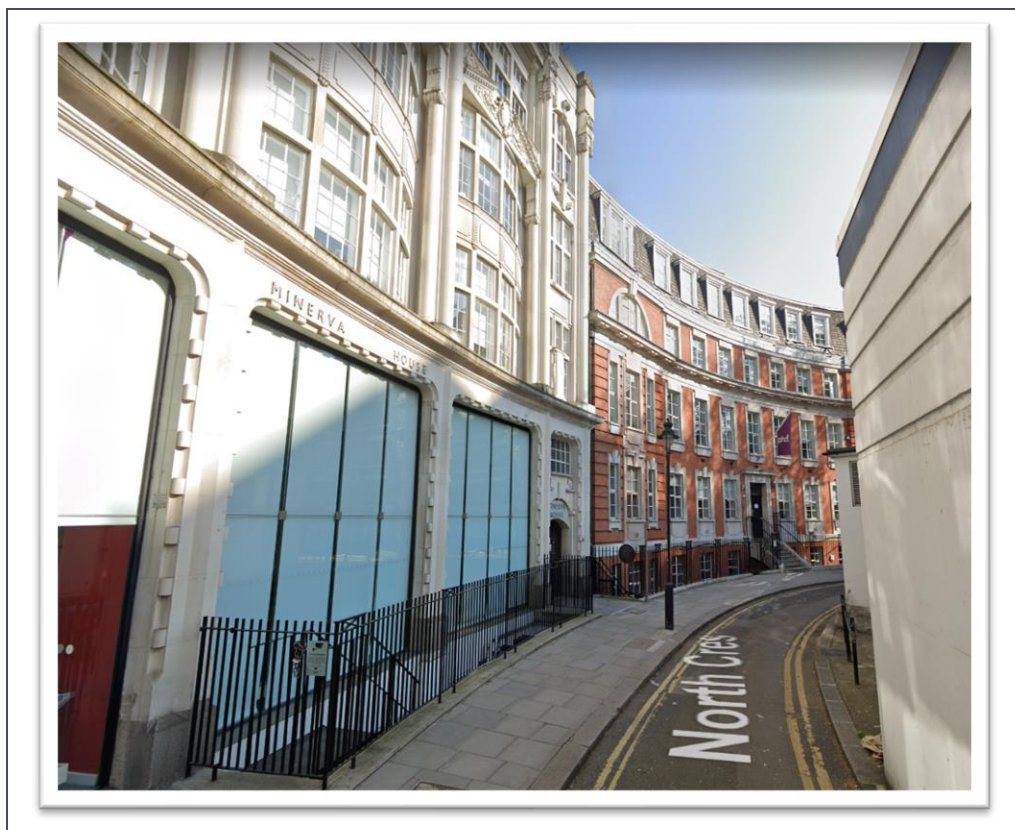
Figure 3: North Crescent (Source: Google Maps)

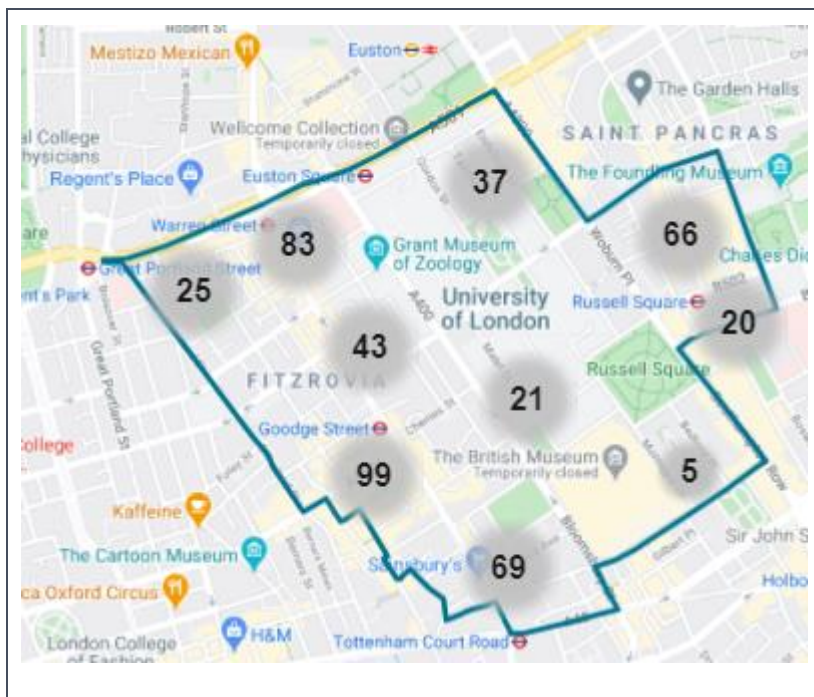
Figure 17: Selected crime map of the immediate area for the month of October 2020

From the crime statistics, it is assessed that the volume of pedestrians is proportional to the number of crimes committed, with many crimes committed in areas where there is a higher.

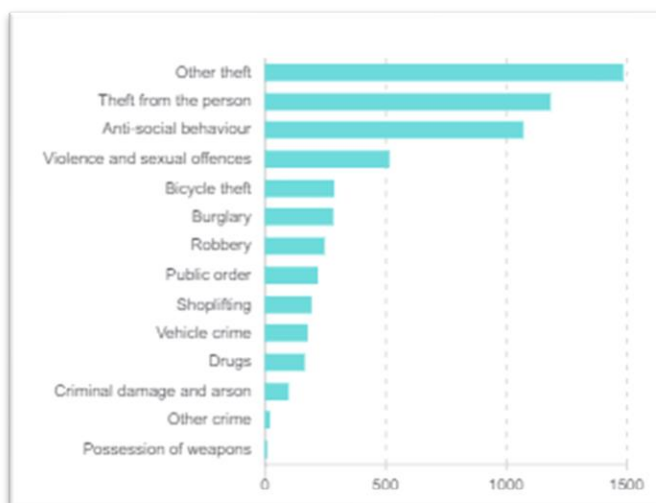
Figure 18: Number of crimes committed within the Bloomsbury area

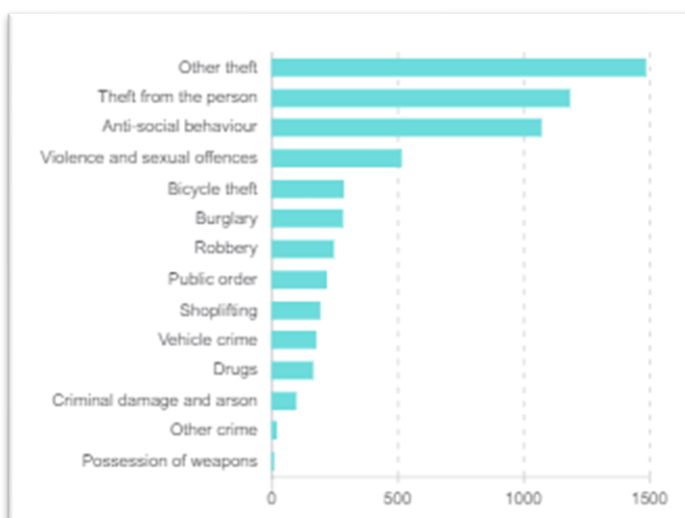
Comparison of crime types in this area between October 2019 and September 2020

Type	Total	Percentage
Anti-social behaviour	1076	17.9%
Bicycle theft	291	4.8%
Burglary	287	4.8%
Criminal damage and arson	102	1.7%
Drugs	169	2.8%
Other theft	1491	24.8%
Possession of weapons	13	0.2%
Public order	223	3.7%
Robbery	251	4.2%
Shoplifting	197	3.3%
Theft from the person	1189	19.8%
Vehicle crime	181	3%
Violence and sexual offences	520	8.6%
Other crime	25	0.4%

QCIC has assessed that **Other Theft 24.8%** as well as **Theft from the Person 19.8%** directed towards the development and its occupants are the most prevalent threat as well as the potential for **Anti-Social Behaviour 17.9%** and **Violence and Sexual Offences 8.6%**.

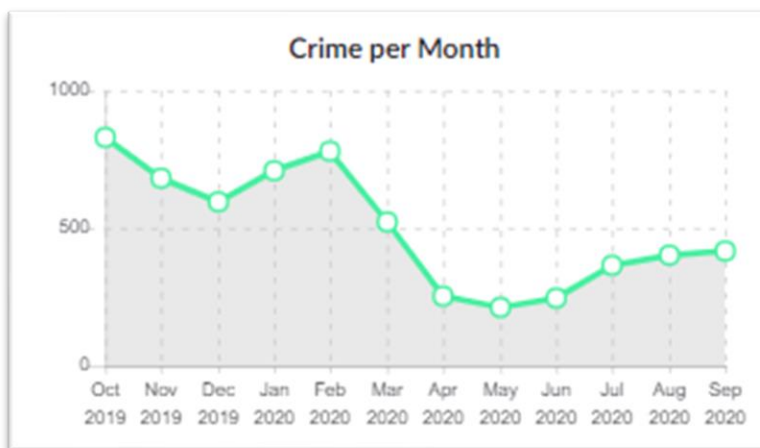
Crime levels in this area between October 2019 to September 2020

Month	Total	Percentage
Oct 2019	830	13.8%
Nov 2019	682	11.3%
Dec 2019	596	9.9%
Jan 2020	709	11.8%
Feb 2020	780	13%
Mar 2020	523	8.7%
Apr 2020	253	4.2%
May 2020	212	3.5%
Jun 2020	246	4.1%
Jul 2020	365	6.1%
Aug 2020	402	6.7%
Sep 2020	417	6.9%

Crime rates within the local area between the periods of **October 2019** and **September 2020** present abnormal fluctuation in levels of reported crime. Although the underlying reasoning for the level of variable change are unknown this could be attributed to two possible factors:
