21009 100

Basement Floor Plan

Ground Floor Plan

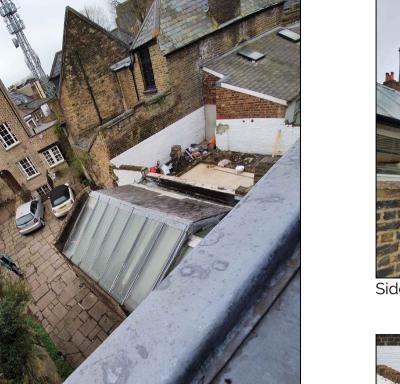
View looking out at rear roof

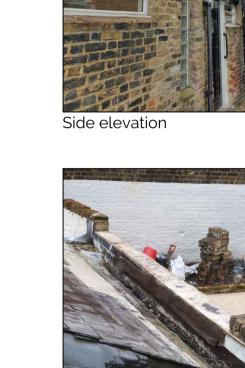
Rear roof

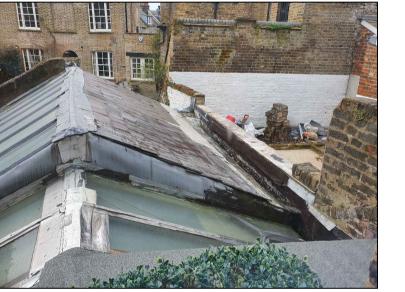
Rear roof in state of adhoc repairs

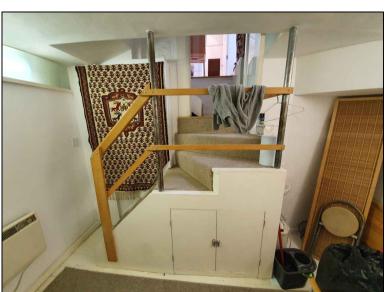
Restricted access to basement with staircase down

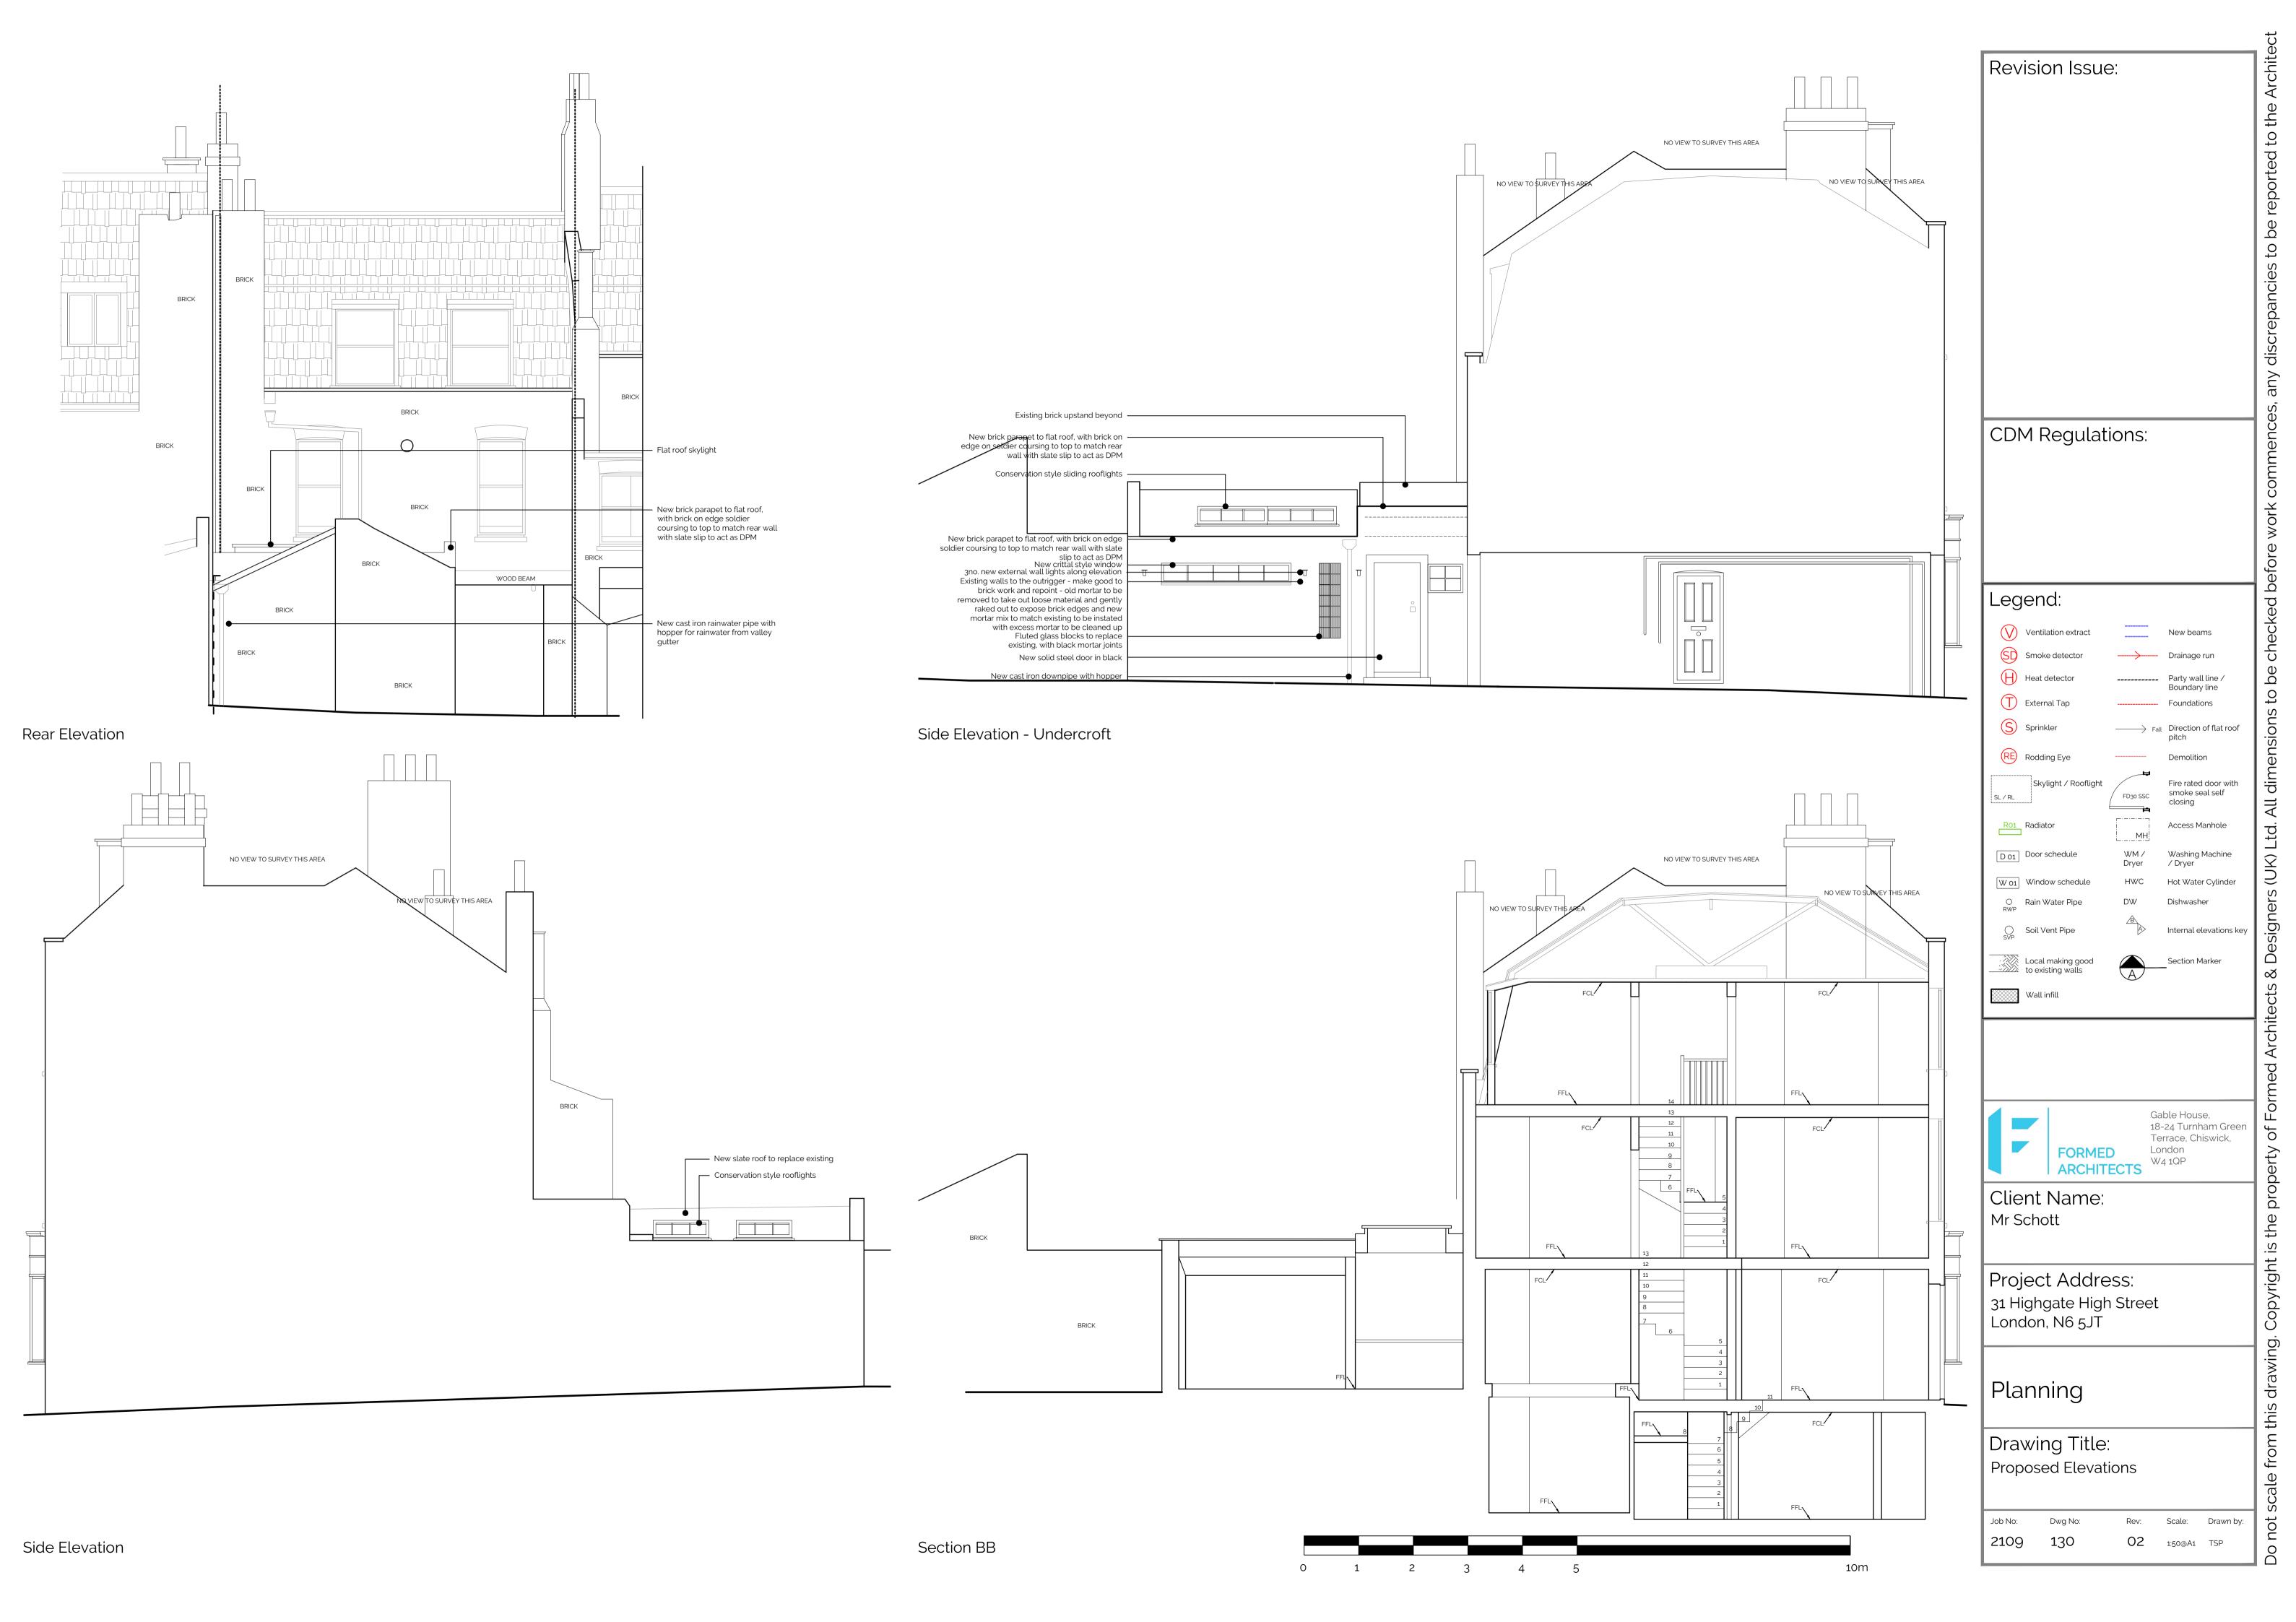
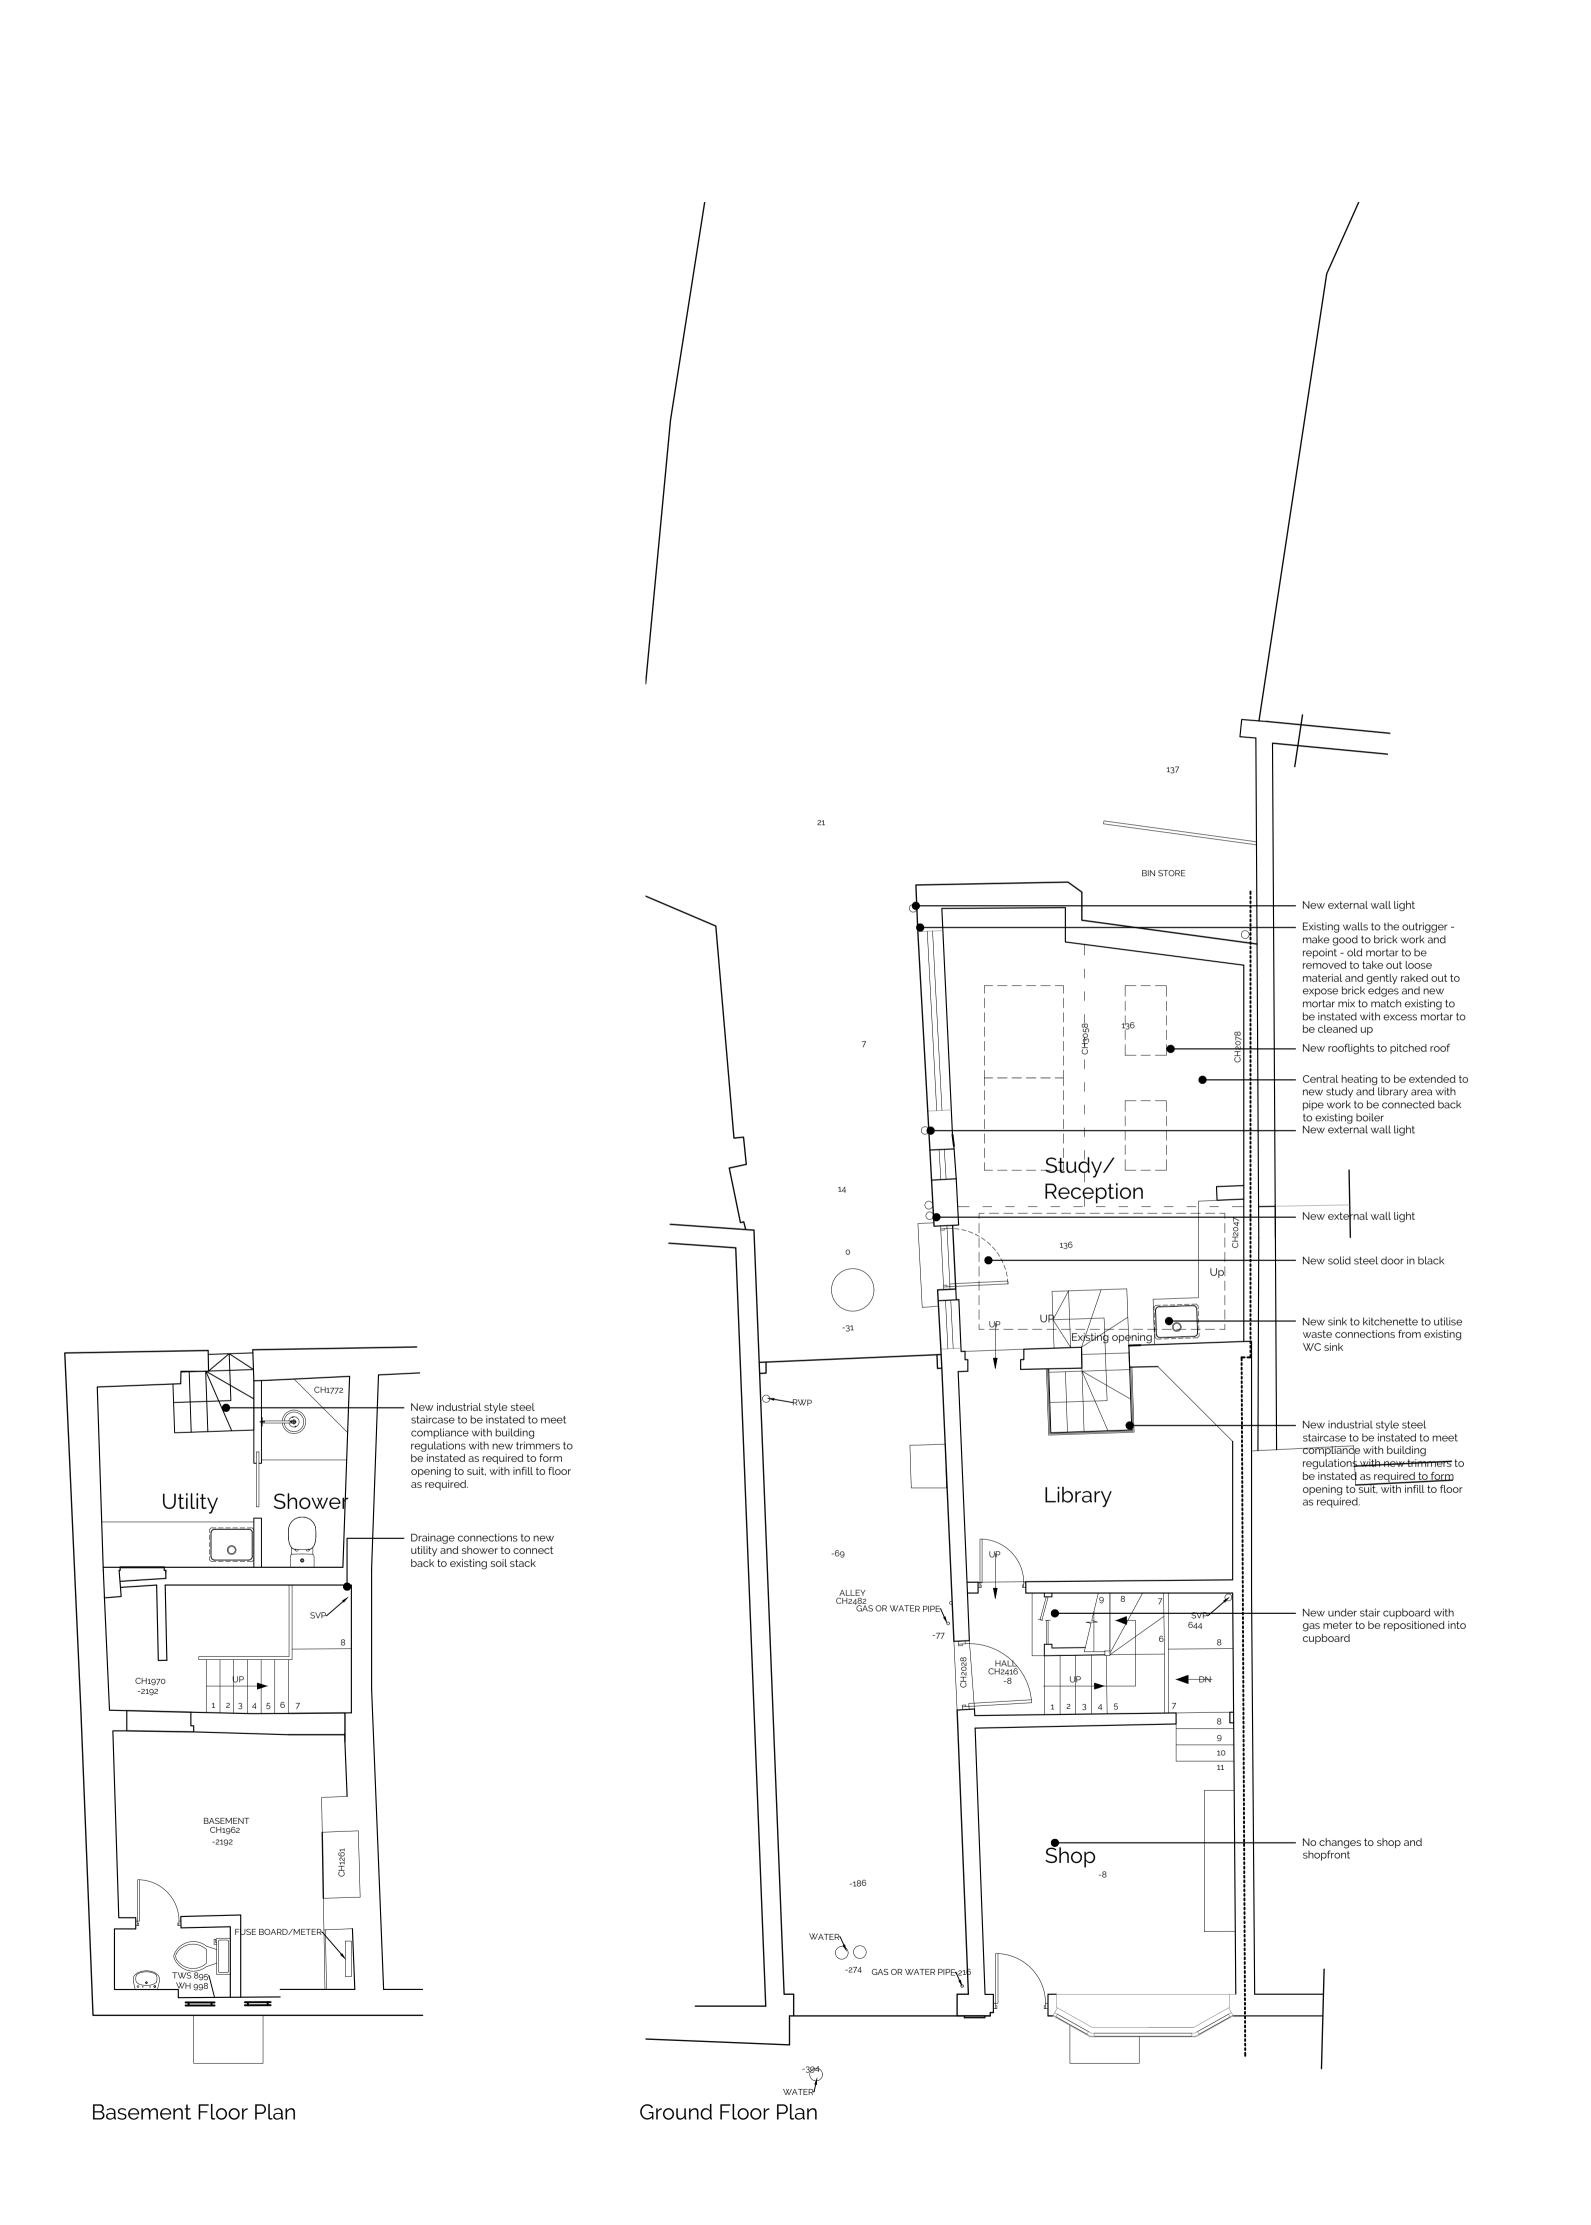
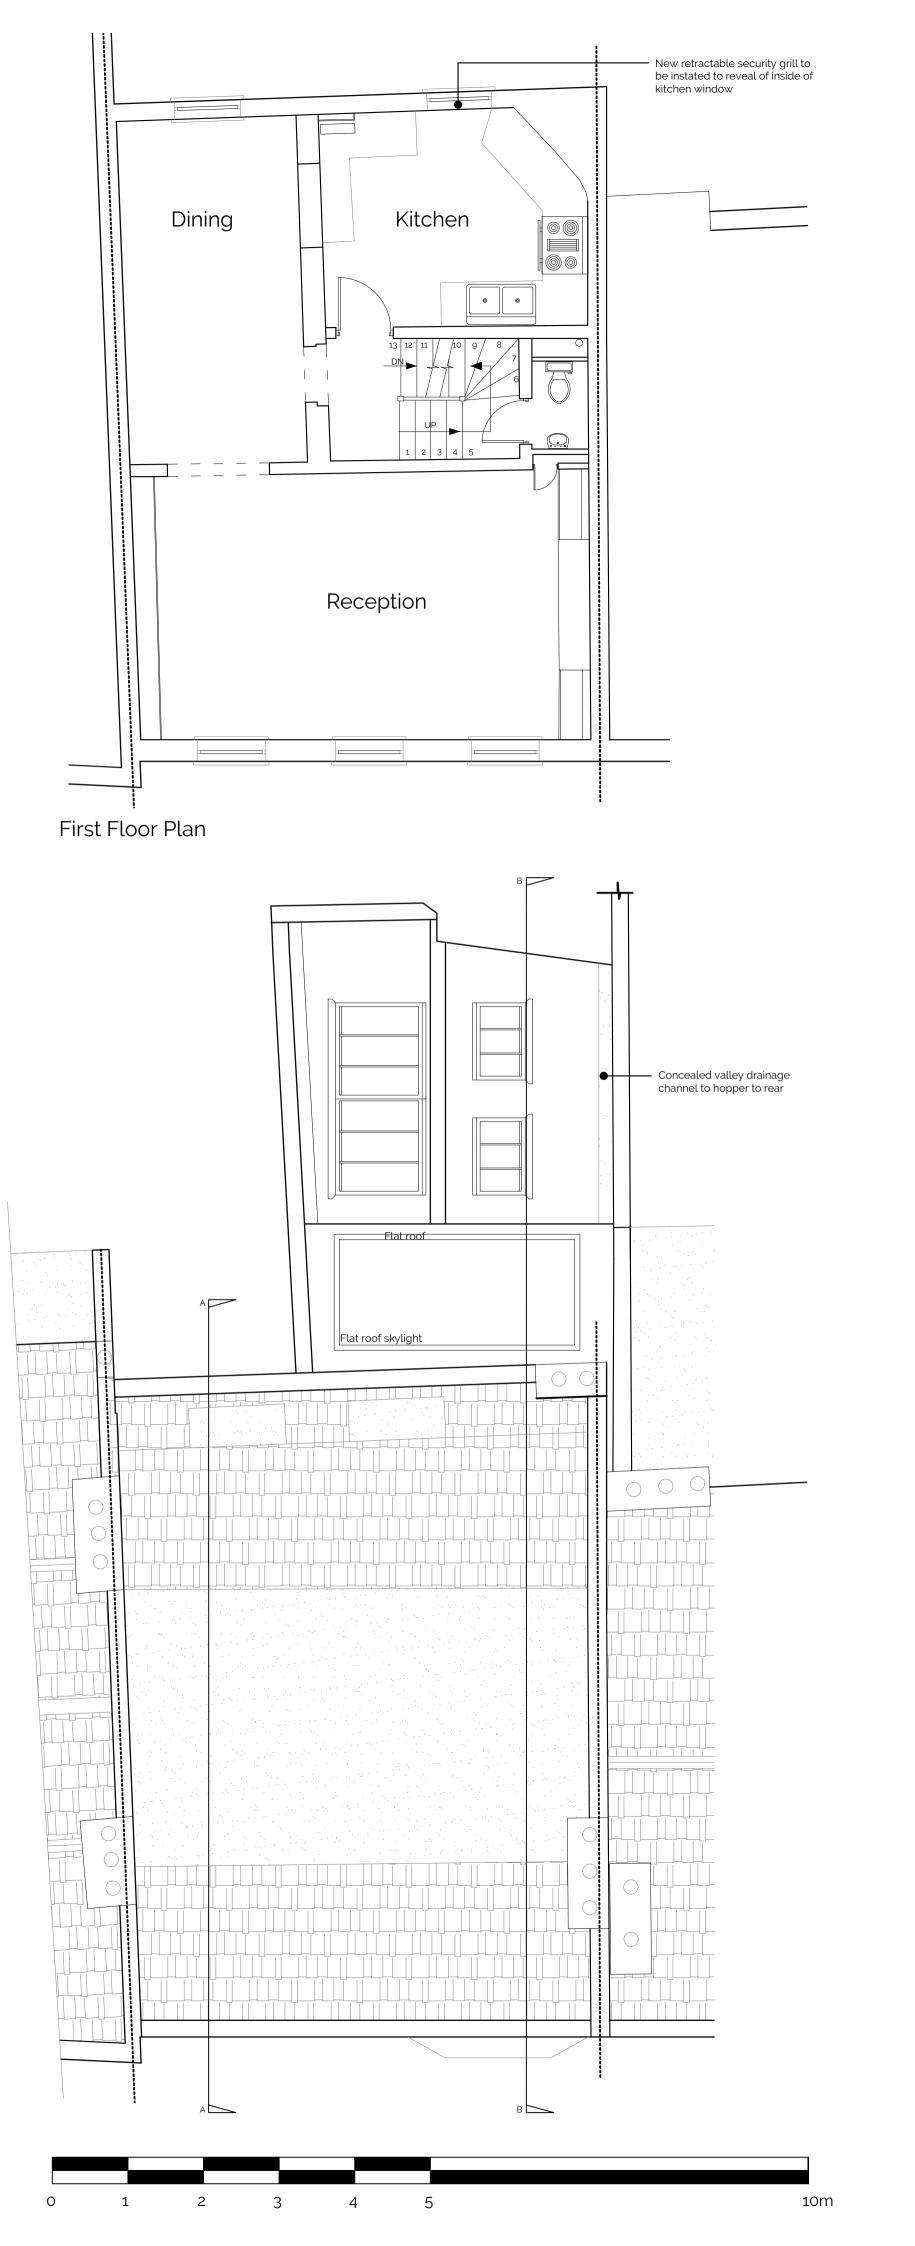
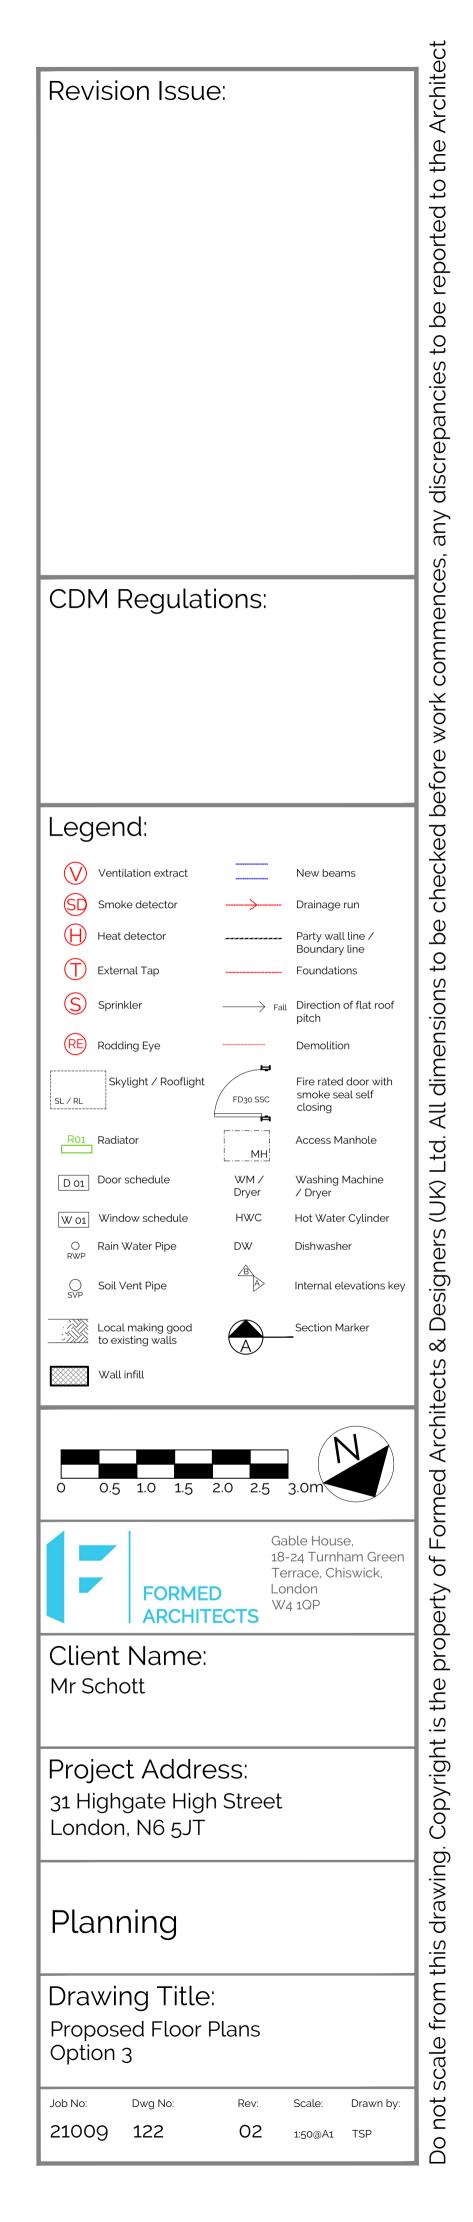
Existing staircase to be removed.

New industrial style steel staircase to be instated to meet

compliance with building regulations with new trimmers to

be instated as required to form opening to suit, with infill to floor as required.

Drainage connections to new

utility and shower to connect back to existing soil stack

Staircase is a later addition
