**111 Arlington Road
London NW1 7LE**

Photographs forming part of the listed building application

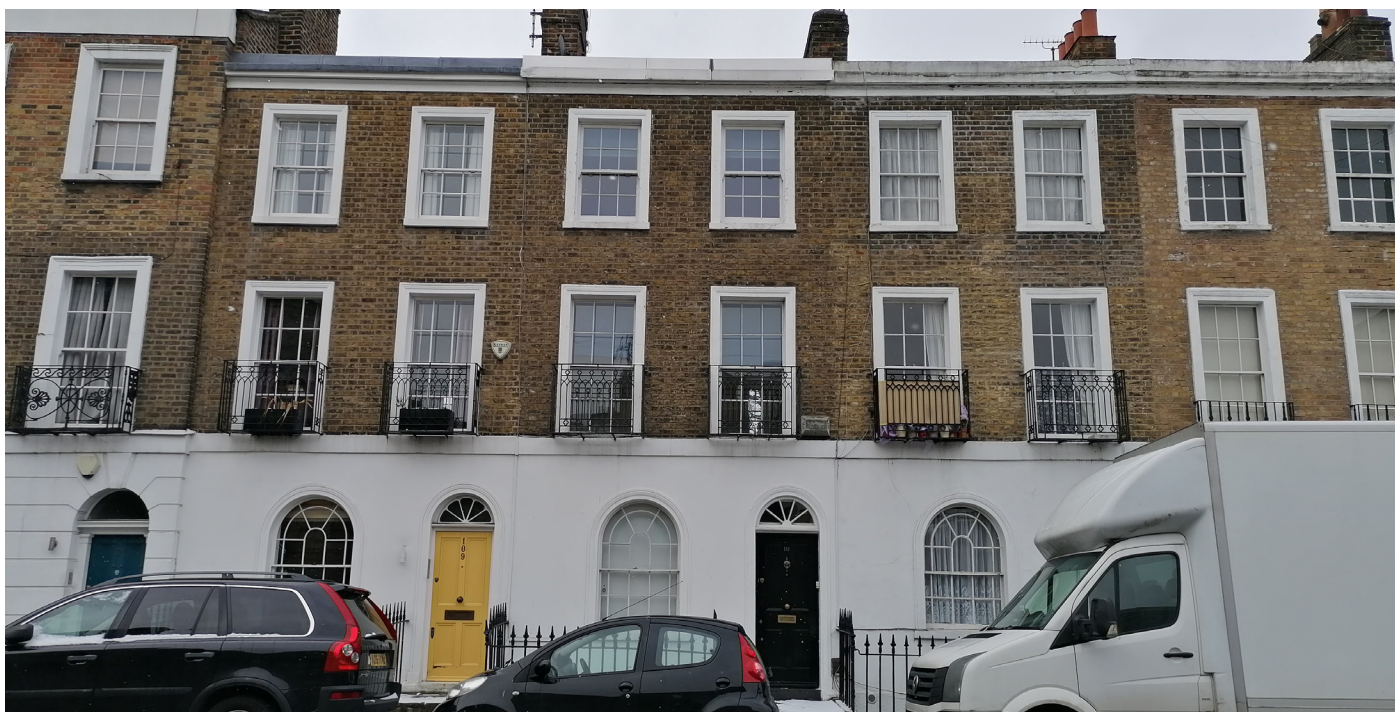
Photo 1. Front elevation of 111 Arlington Road within the street context
(centre house with black front door)

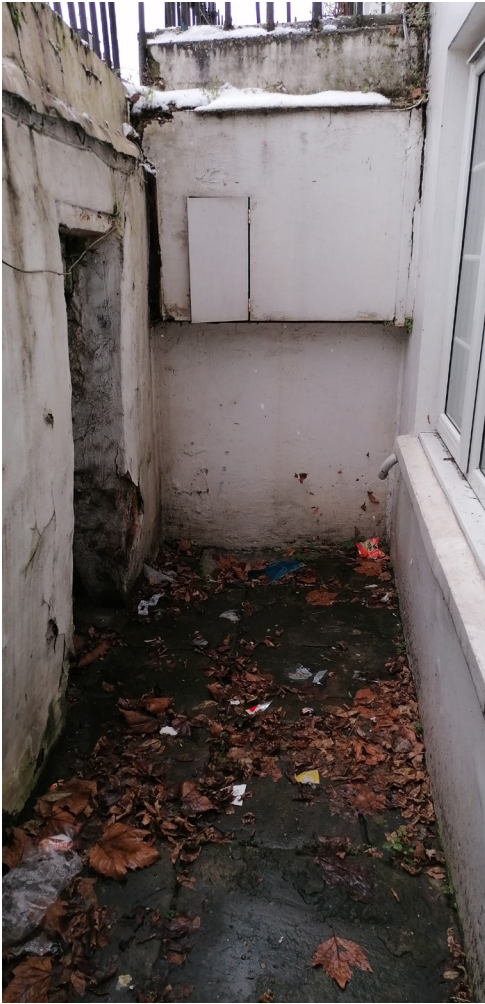
Photo 2. Existing front lightwell with one of the two doorways to the vaults visible on the LHS

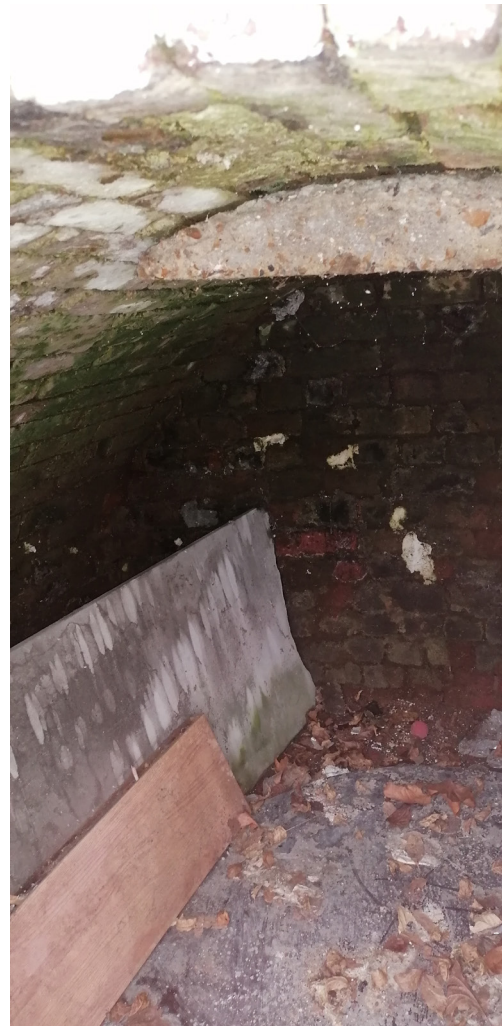
Photo 3. Detail of one of the existing vaults. The brick arch will be preserved with the installation of a reversible drained cavity membrane system.

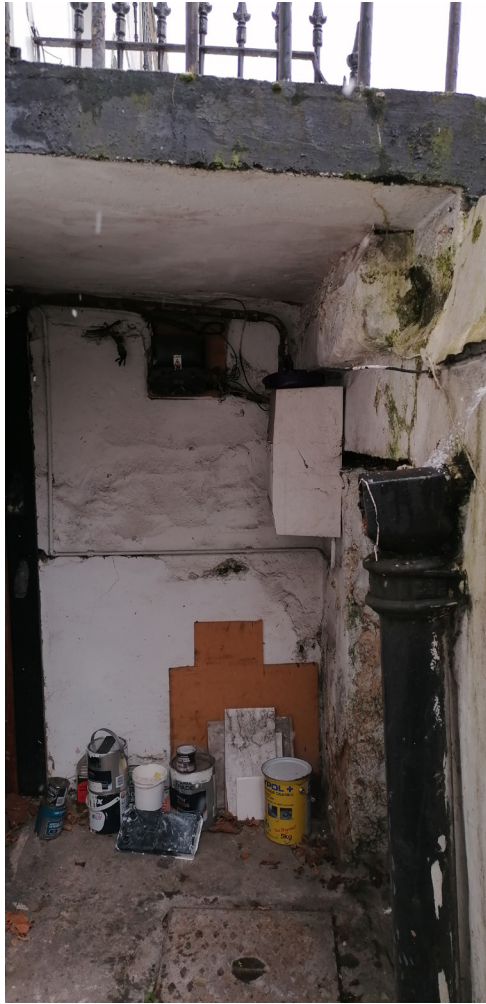
Photo 4. The proposed hardwood external door will be located in line with the entrance step above

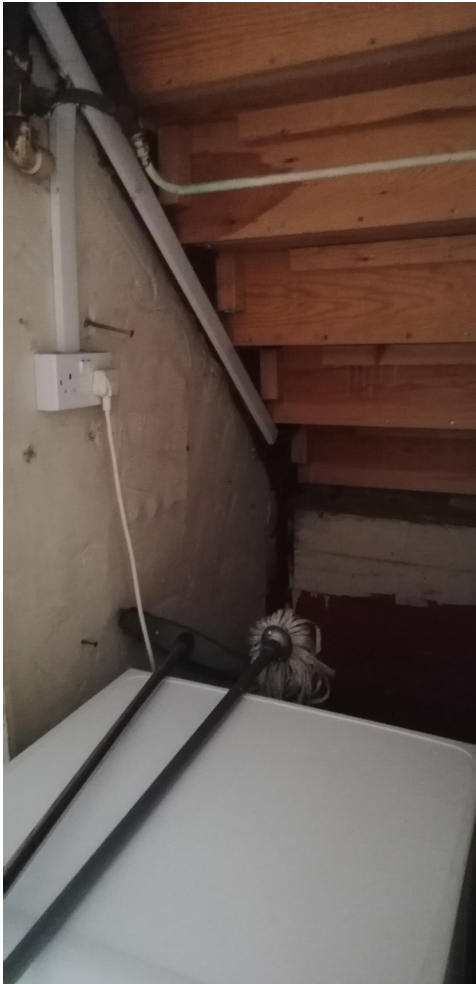
Photo 6. The existing ground to basement staircase is non-original. Most of the interior features have been lost prior to listing.

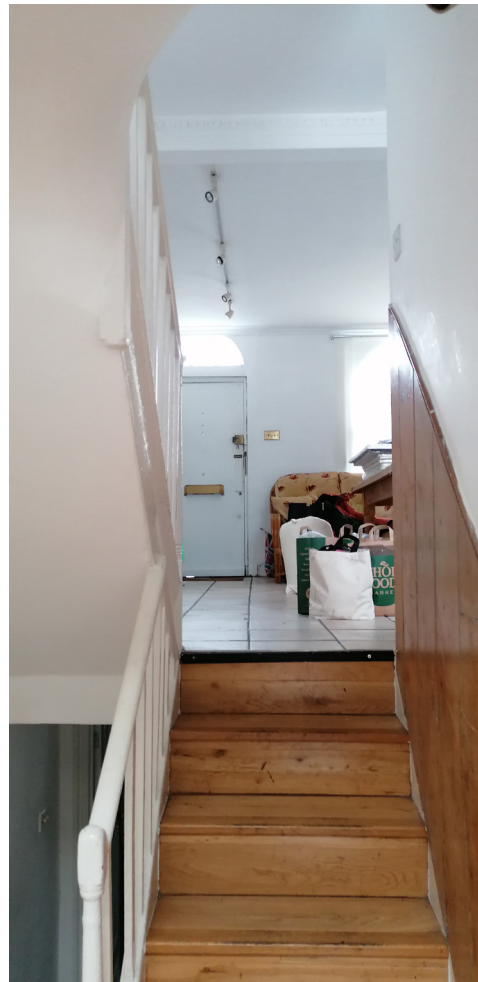
Photo 7. View looking towards the front door from the existing basement. We are seeking to reinstate the entrance hall enclosure to restore part of the historic plan form.

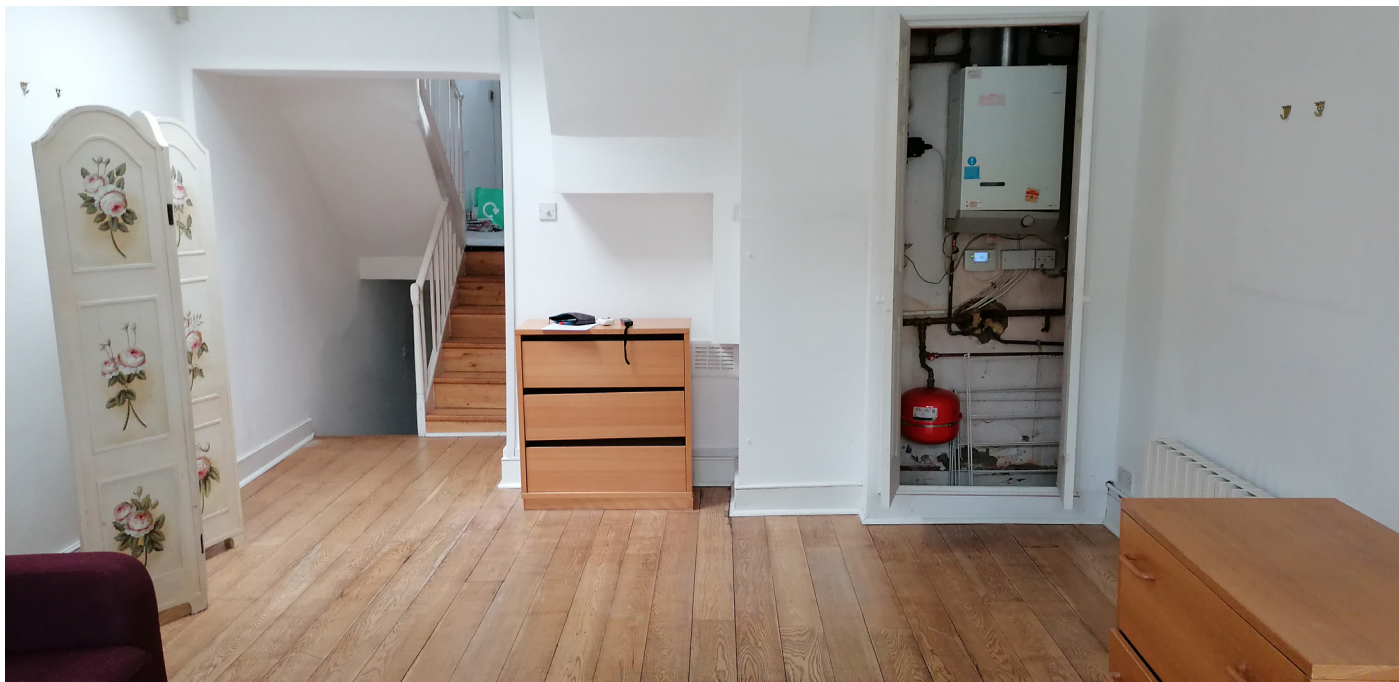
Photo 8. Looking towards the rear of the original house from the existing extension. The non-original opening is visible on the LHS. This will be retained

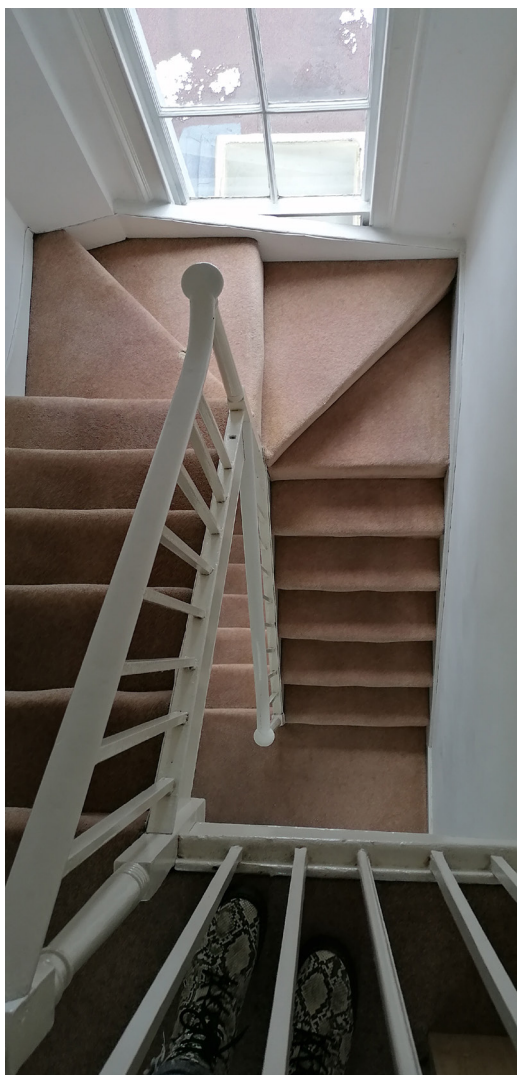
Photo 9. Looking down the staircase from the 2nd floor landing. The original handrail and balusters remain insitu.

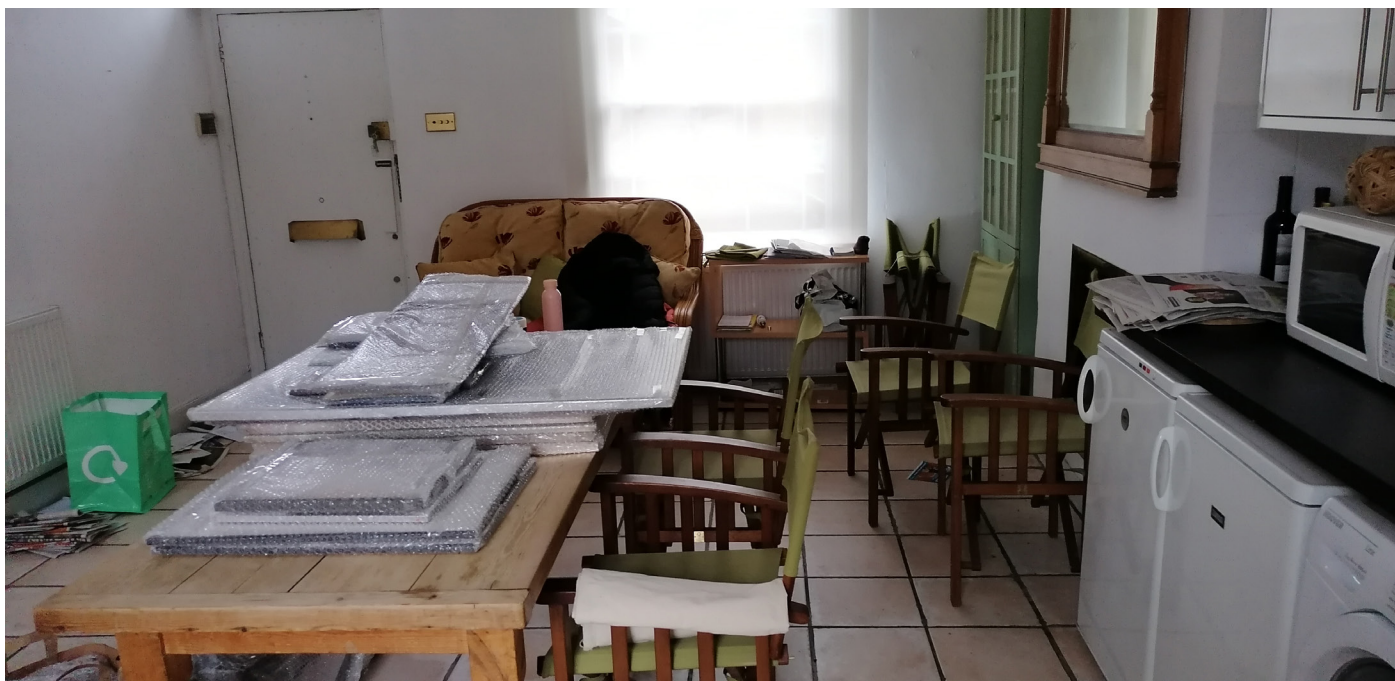
Photo 10. Ground floor front room. A period correct fireplace will be installed on the RHS. On the LHS, the internal wall will be rebuilt.

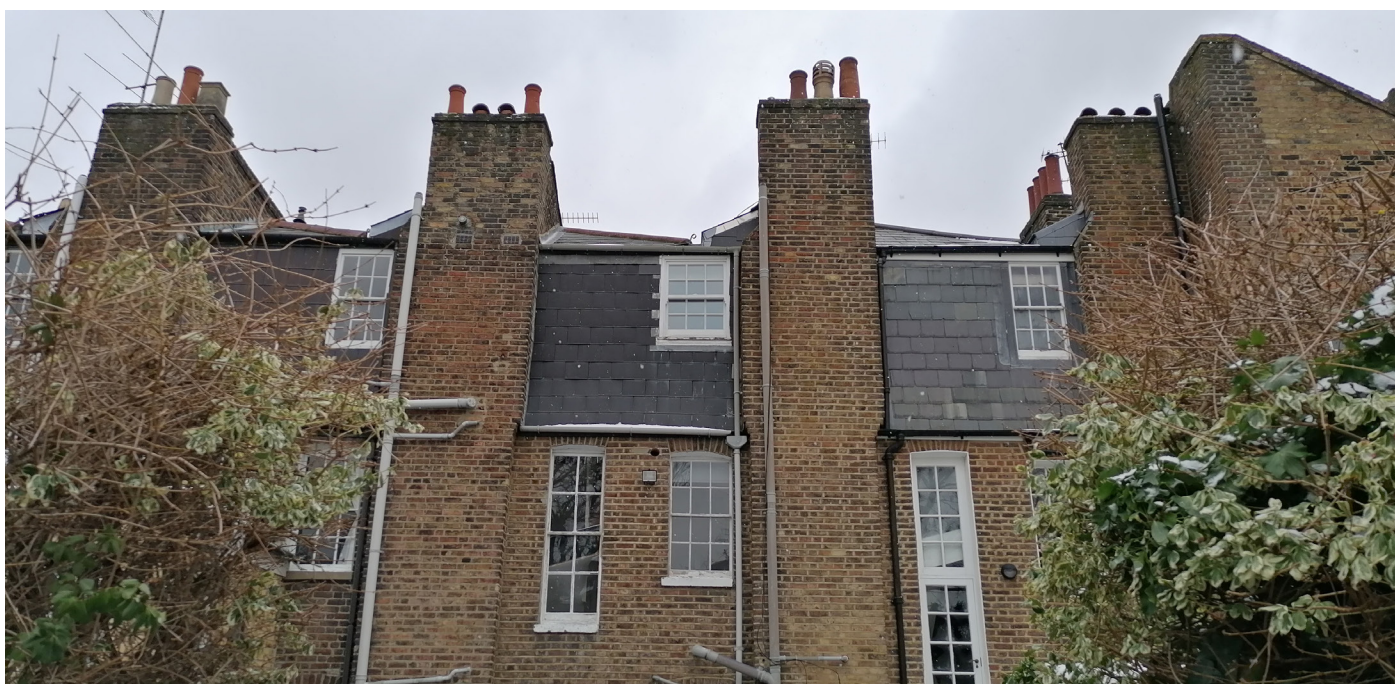
Photo 11. Rear elevation showing non-original 2nd floor sash window within slates. We aim to reinstate the original proportions of this window as still extant on the two adjacent houses.

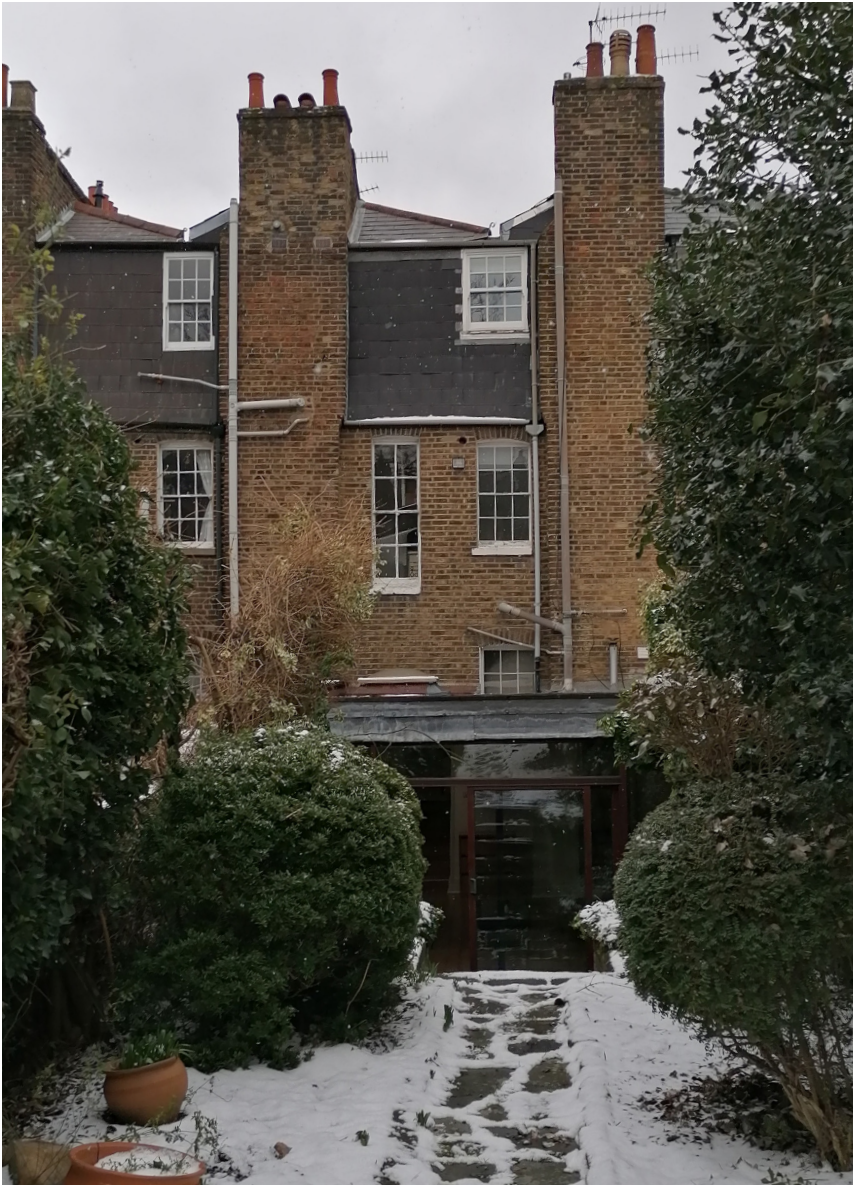
Photo 12. Rear elevation showing existing rear extension and obscured ground floor rear window.
