Arboricultural Impact Assessment Method Statement & Tree Protection Plan (to BS:5837 2012)

78A Compayne Gardens, London NW6 3RU

Ref: TH 2987

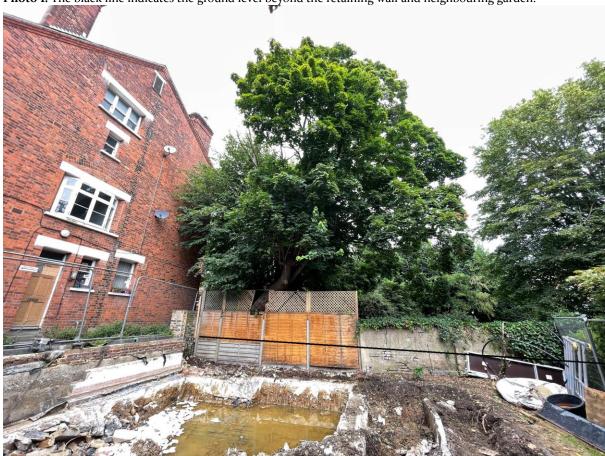
Photo 1. The black line indicates the ground level beyond the retaining wall and neighbouring garden.

9.3.1 The RPAs of Norway Maple T2 and the southern-most Lime in G3 have been amended to take into account the change in levels between this and the surrounding sites, and the existing retaining wall, neighbouring rear garden and existing concrete ring beam (see photo 1).

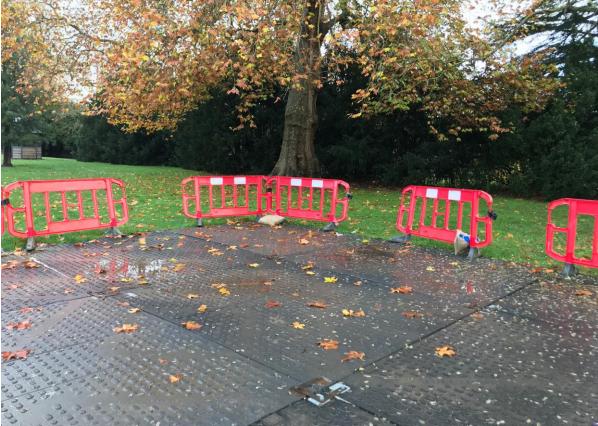
Figure 1: An example of ground protection on work areas within a RPA (BS 5837:2005).

In all cases, the objective should be to avoid compaction of the soil, which can arise from the single passage of a heavy vehicle, especially in wet conditions, so that tree root functions remain unimpaired.

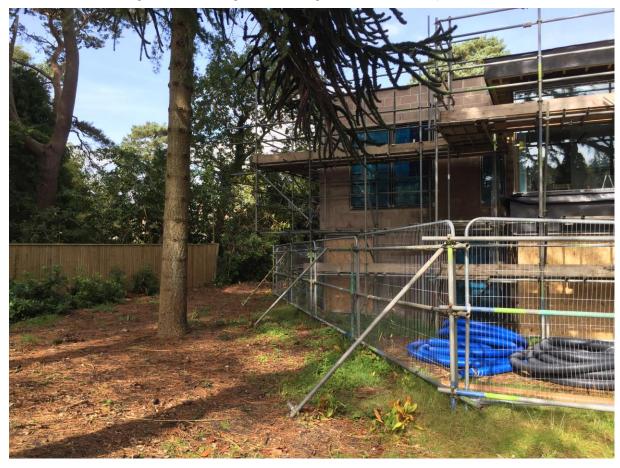
Photo 1: A worked example of the default specification for protective barrier (BS 837:2012)

The framework support (shown in Figure 2 and photo 1) is the usual method of support for 'Heras' fencing. Some variations are possible if site conditions are appropriate; i.e. support by wooden posts (75mm x 75mm x 2.75m) dug or concreted into the ground (dry mix concrete contained within a plastic bag), or if there is no pressure for access, a lighter form of netting on stakes.

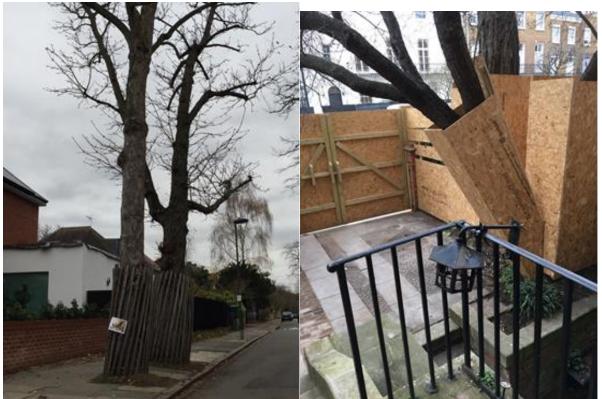
$\textbf{Photo 2:} \ \textbf{Trees protected by hessian \& chestnut pale fencing / limbs protected by wooden boxing}$

Where specified in the AMS, the tree(s) stem/s shall be boxed off with wooden ply boards or wrapped in hessian and chestnut pale fencing. This will help avoid any direct damage to tree stems from passing machinery (see photo 2).

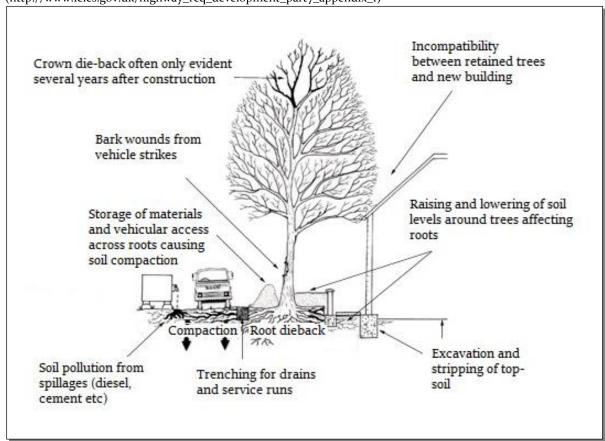
Figure 4: Common problems for trees on development sites (http://www.leics.gov.uk/highway_req_development_part7_appendix_f)
