PROJECT
Wesley Camden Methodist Church
DRAWING
Window Types 58, 59 & 60
SCALE
1:10 @A1
STATUS
Stage 5

JOB No.	PREFIX	VOLUME	LEVEL	TYPE	ROLE
1127	MWA	ZZ	ZZ	DR	A
DRAWING No.	REVISION				
04 3027	C 1

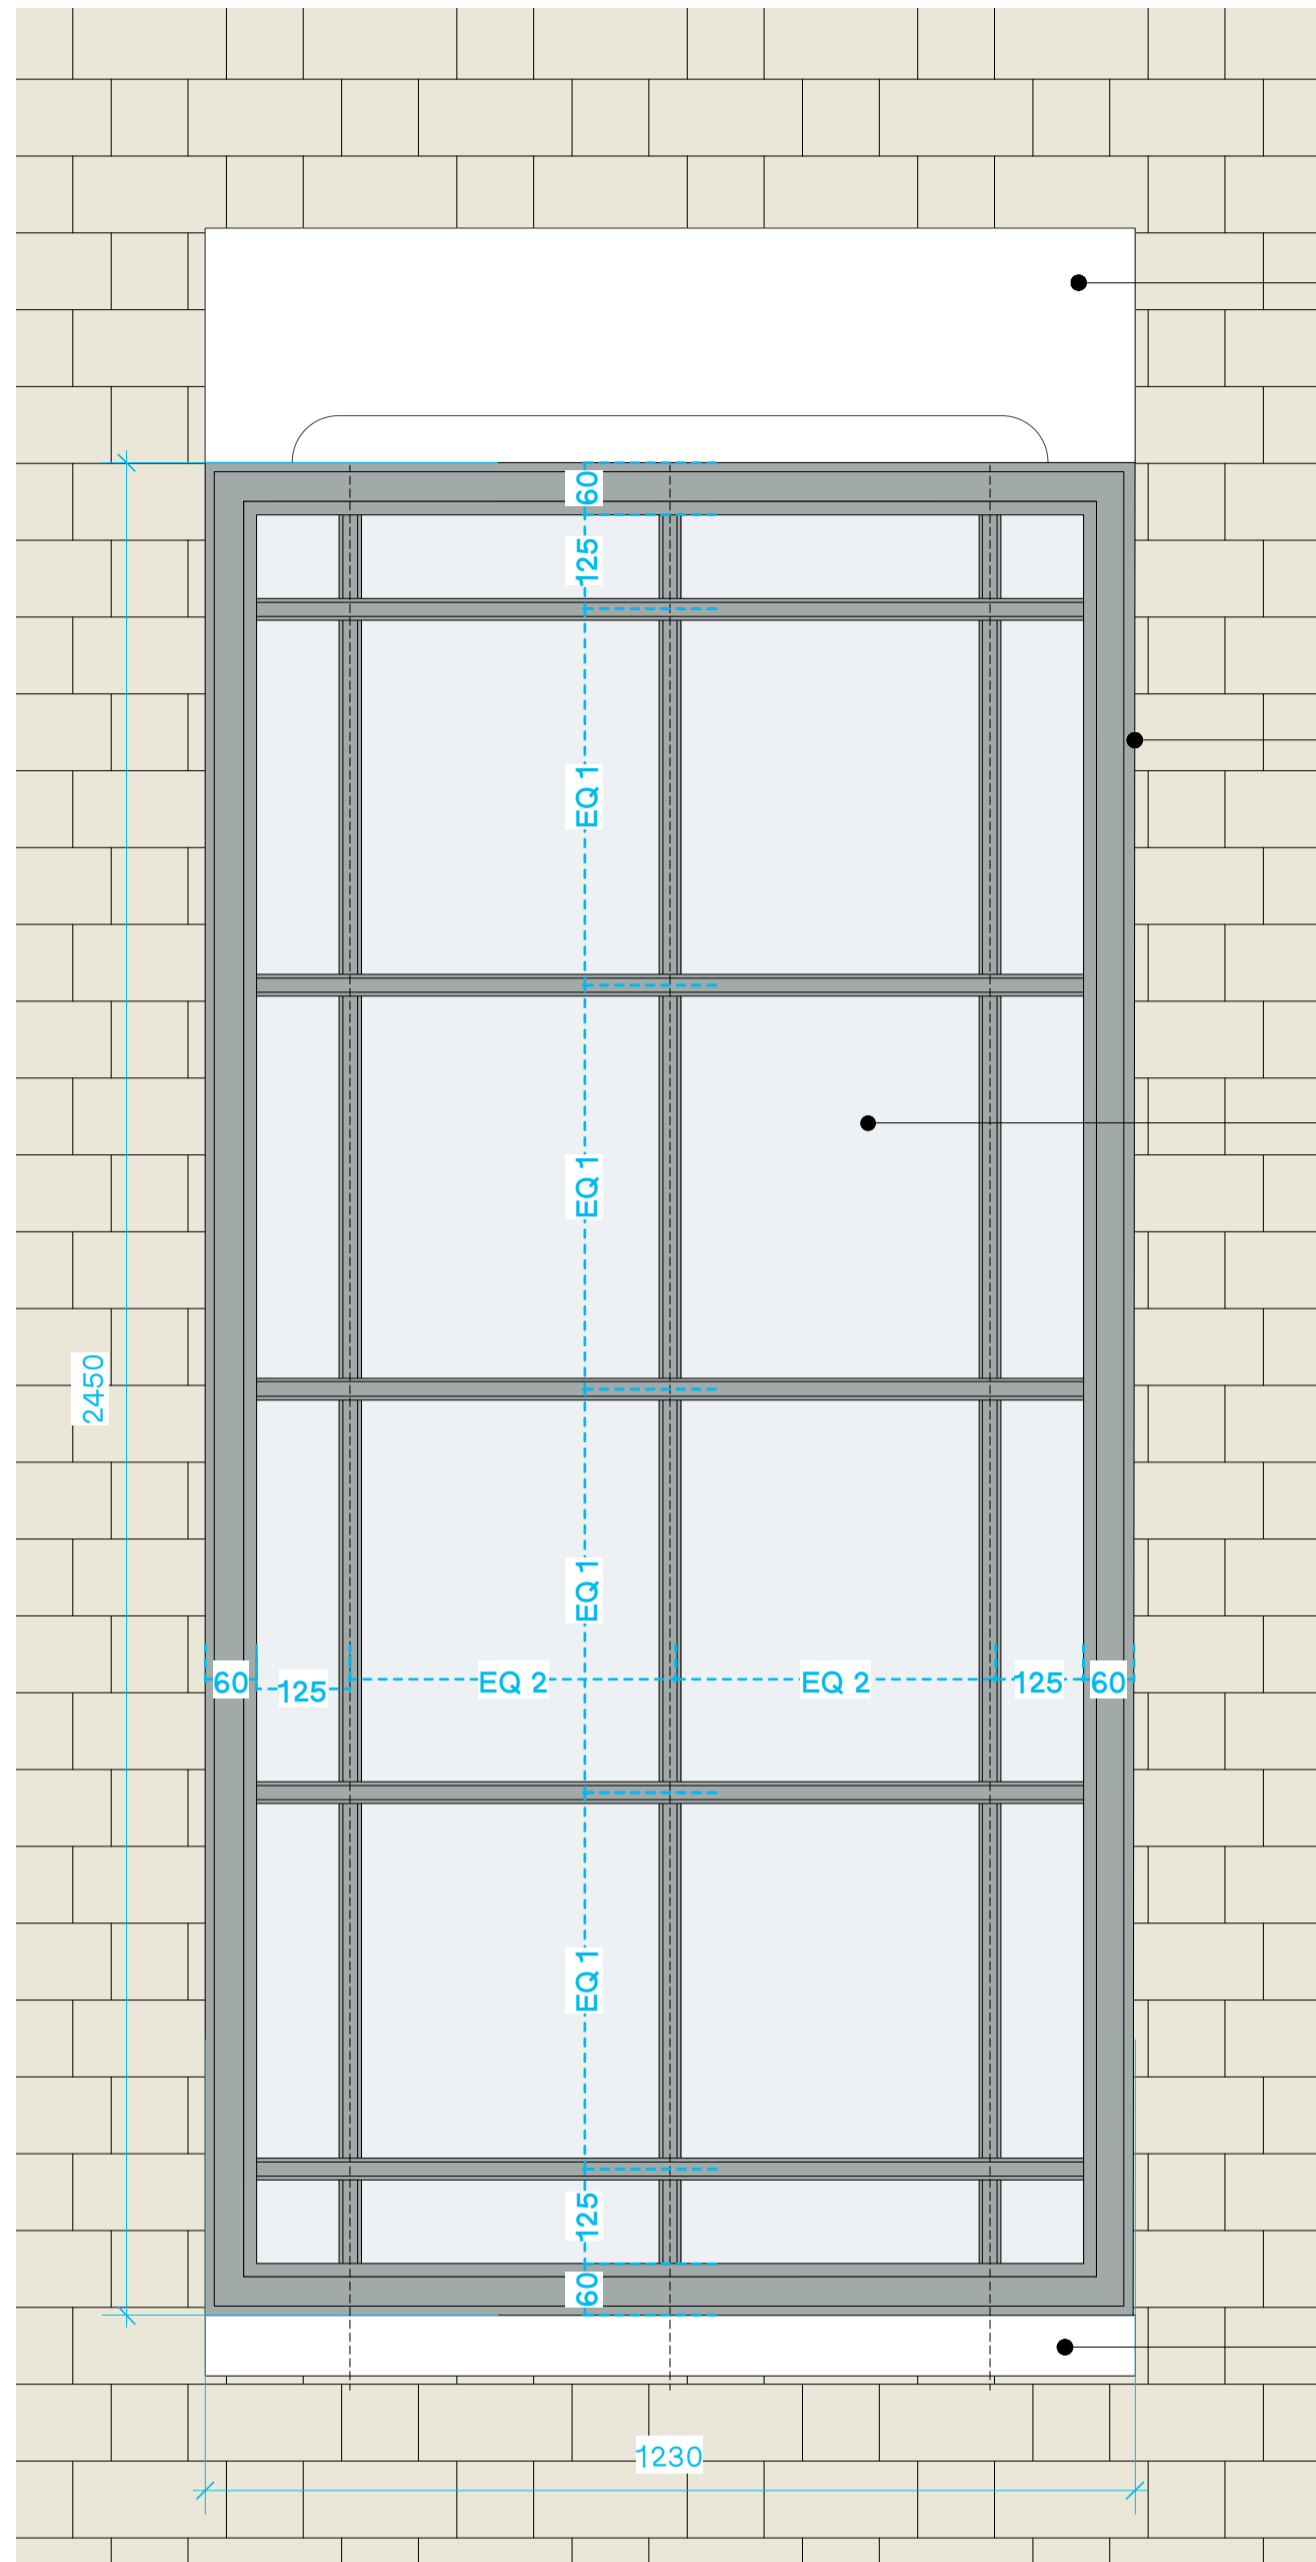
2 WT.58 Elevation
Scale: 1:10

Existing stone lintel/arch repaired where required

Existing opening in masonry

L10/310 Steel Windows (WT.51-63)
New aluminium framed steel replacement window

Existing stone cill repaired where required

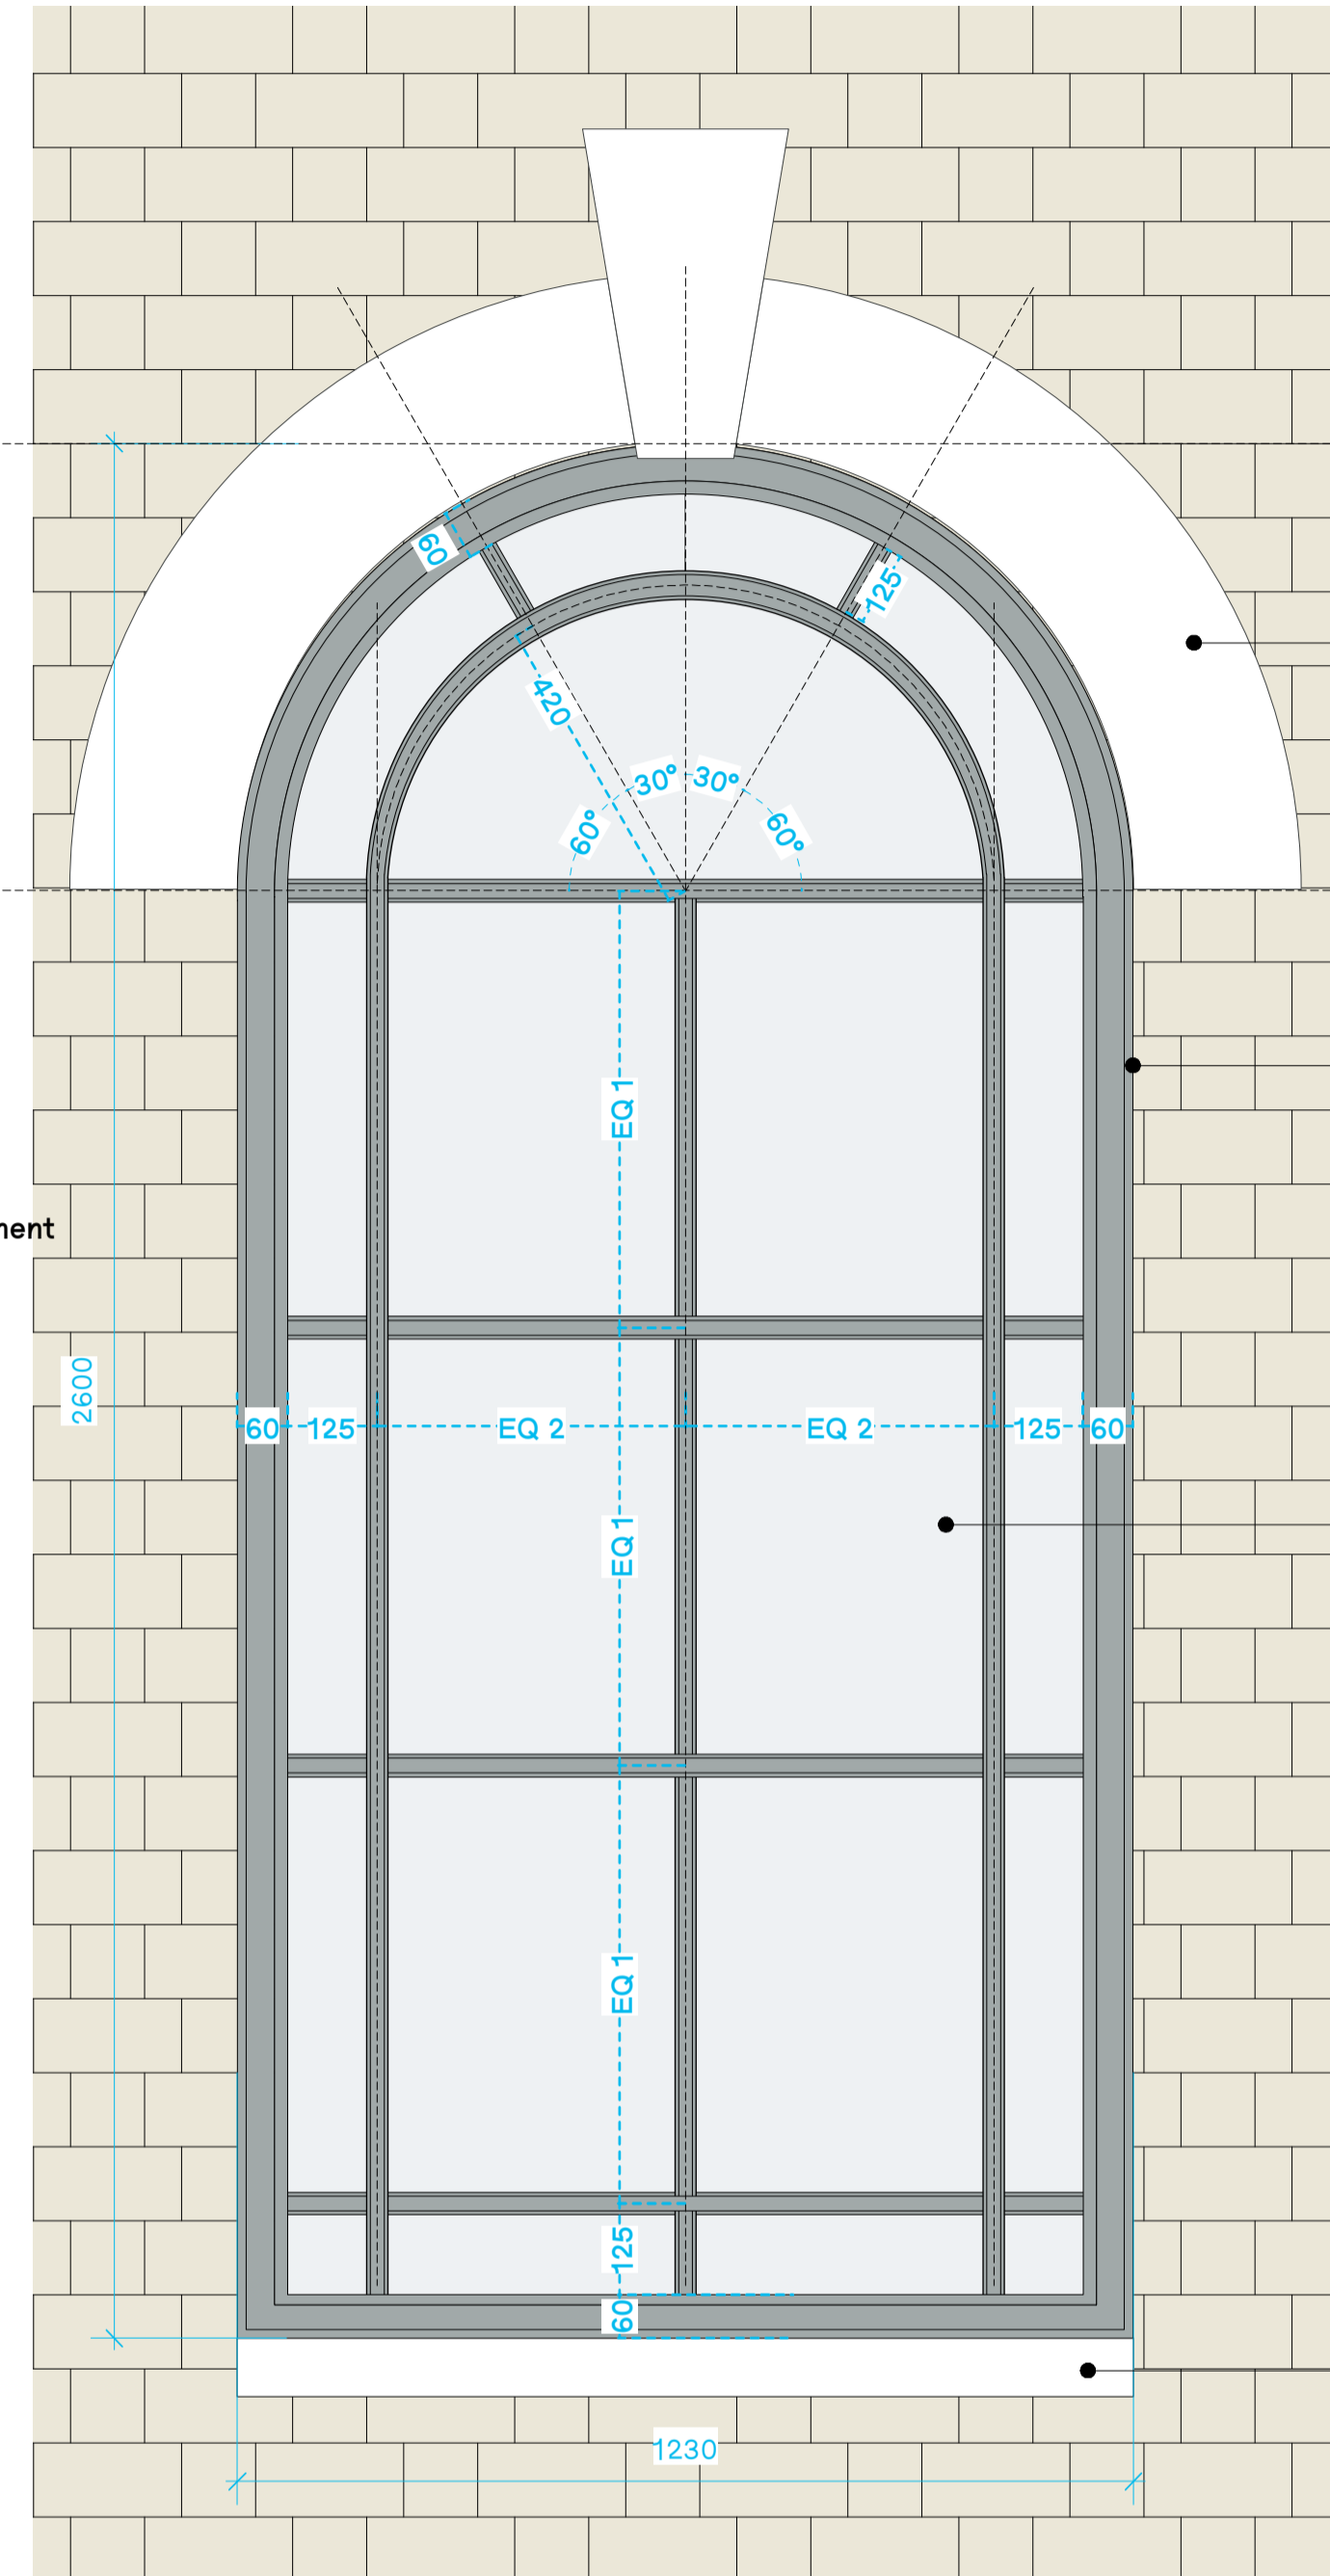
4 WT.59 Elevation
Scale: 1:10

Existing stone lintel/arch repaired where required

Existing opening in masonry

L10/310 Steel Windows (WT.51-63)
New aluminium framed steel replacement window

Existing stone cill repaired where required

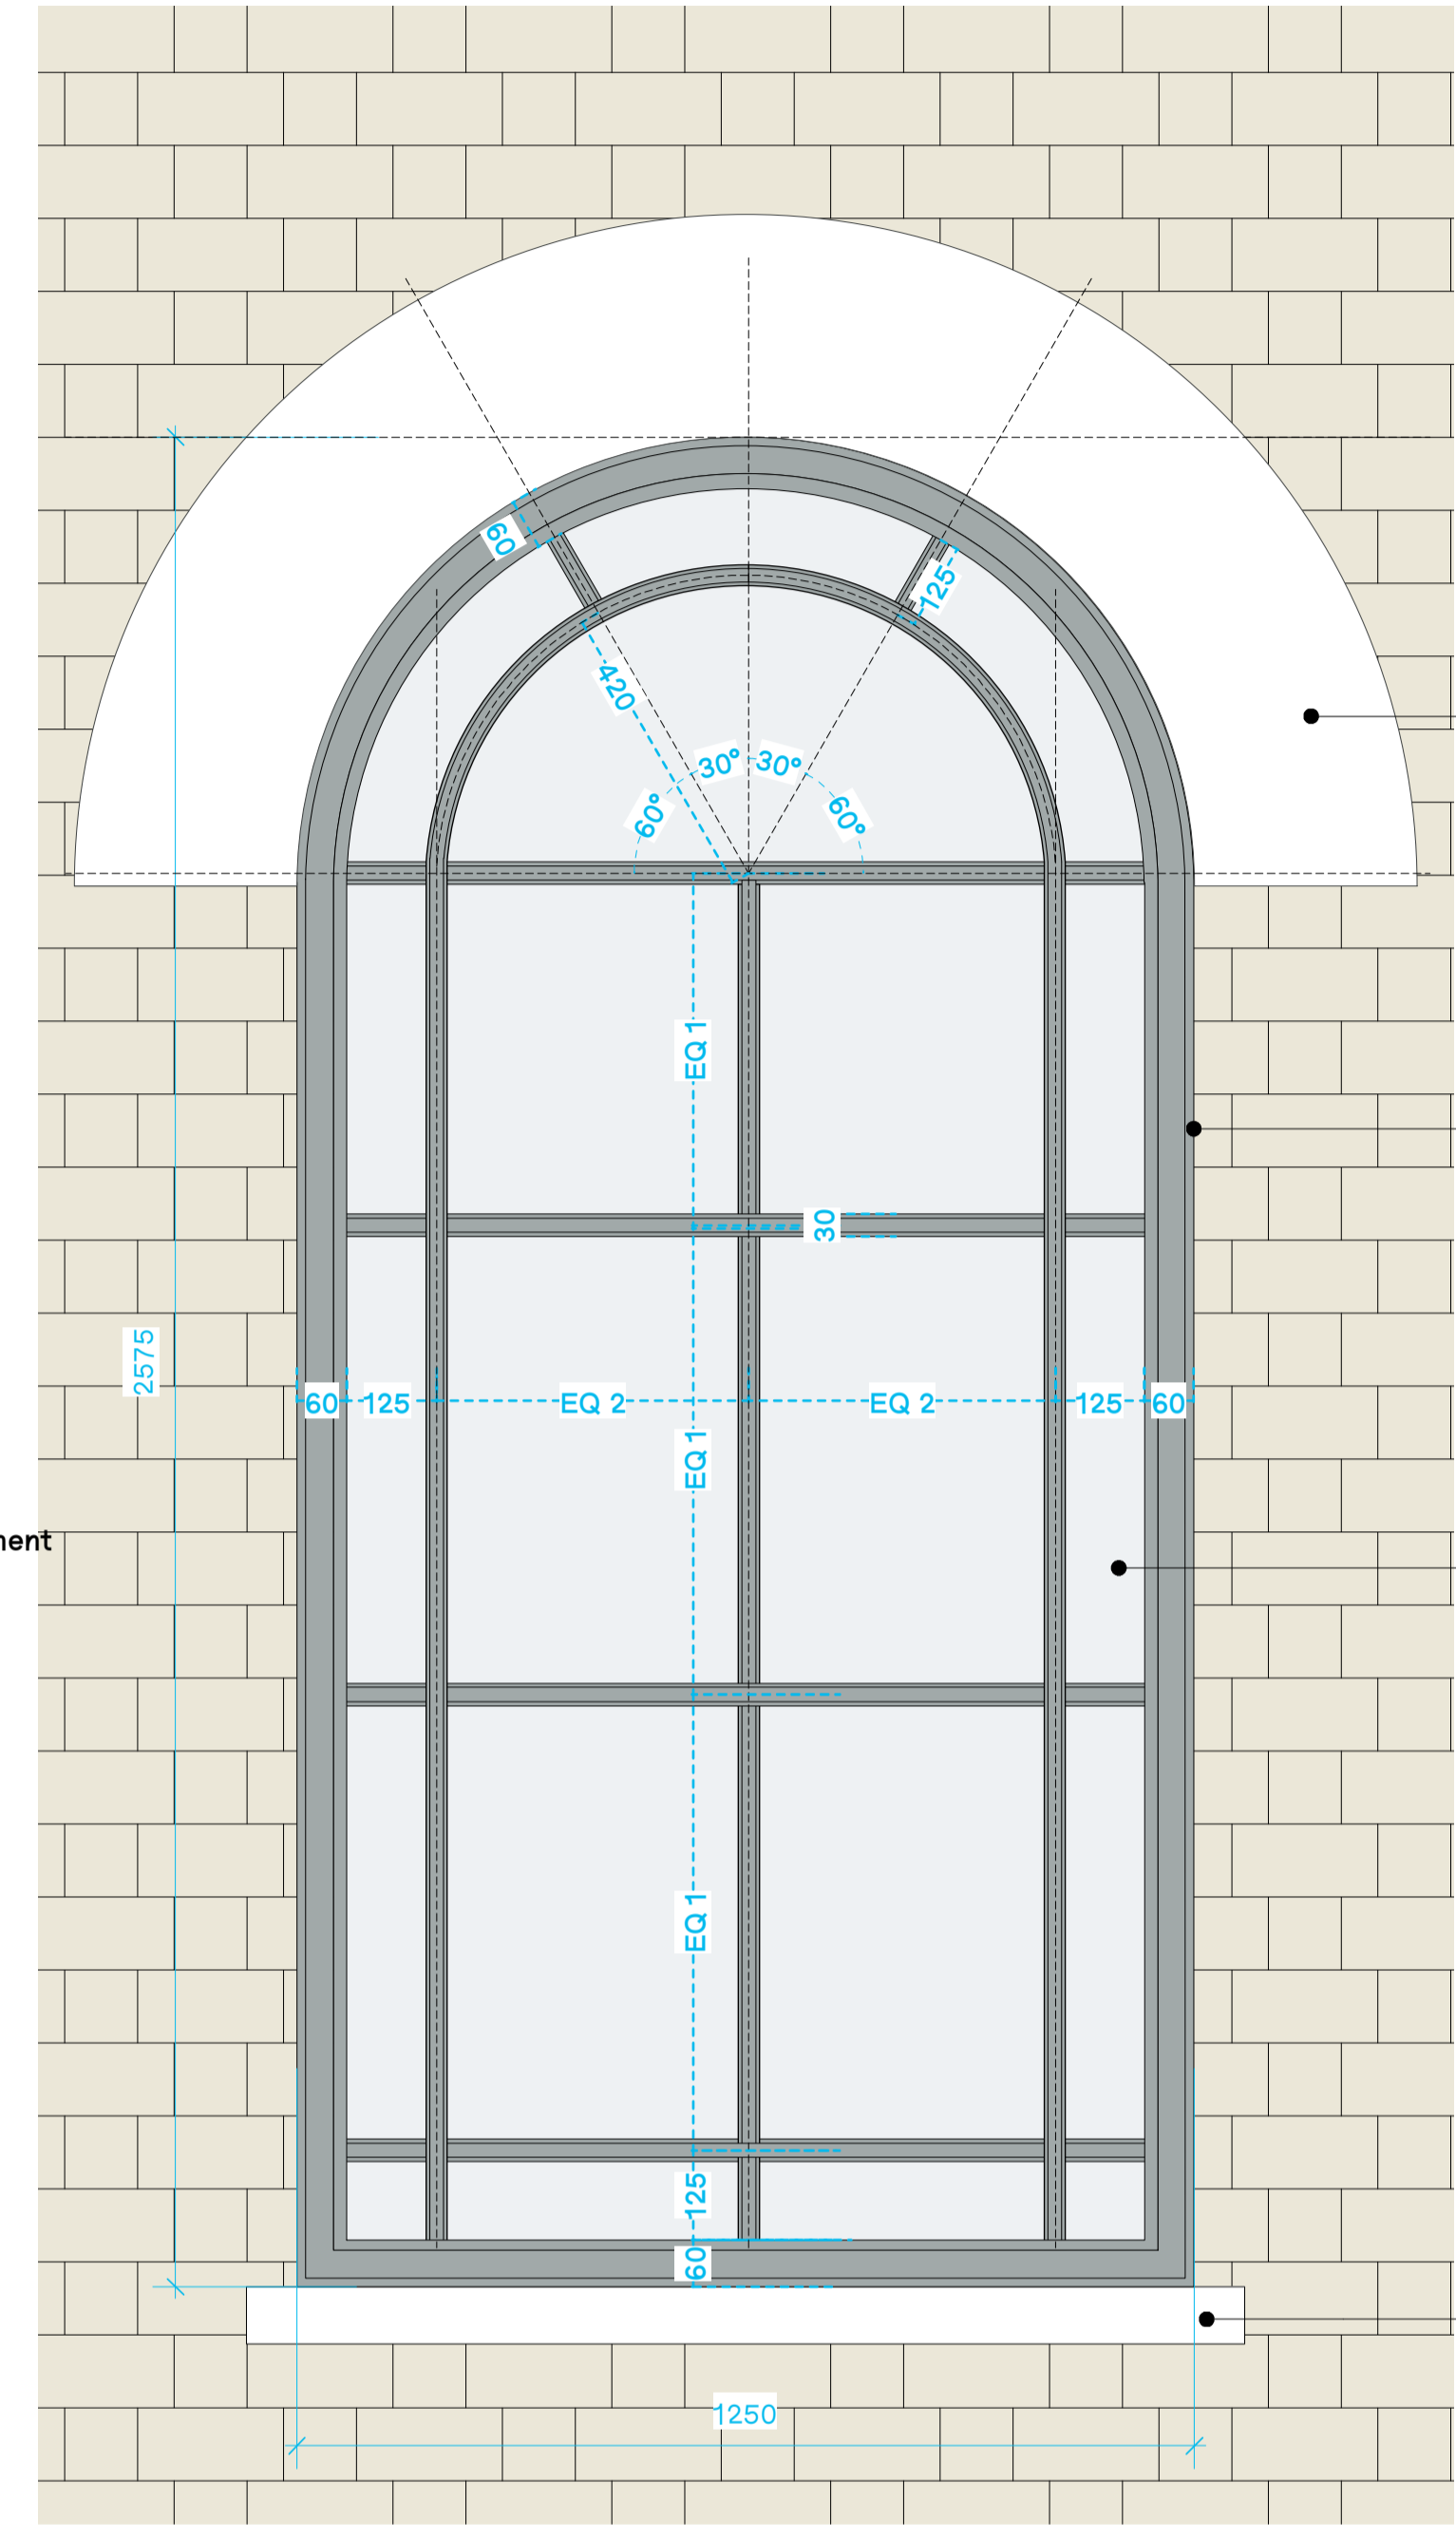
6 WT.60 Elevation
Scale: 1:10

Existing stone lintel/arch repaired where required

Existing opening in masonry

L10/310 Steel Windows (WT.51-63)
New aluminium framed steel replacement window, Technal Crown

Existing stone cill repaired where required

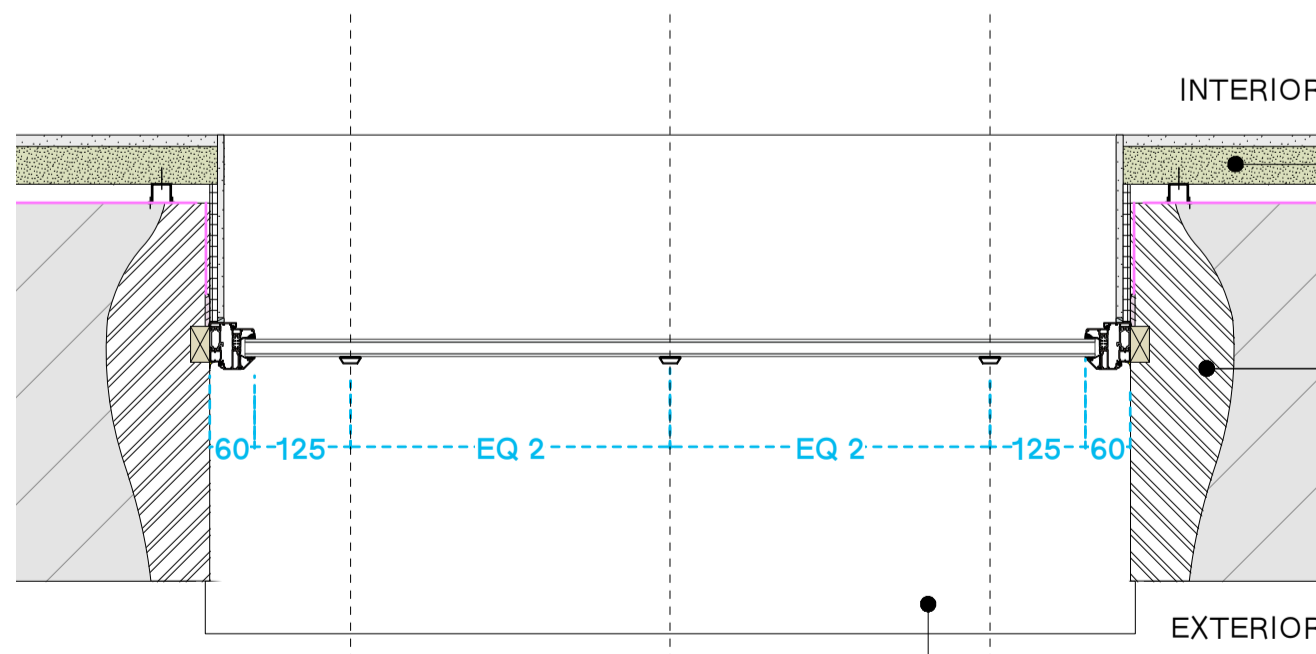
1 WT.58 Plan
Scale: 1:10

Existing stone cill repaired where required

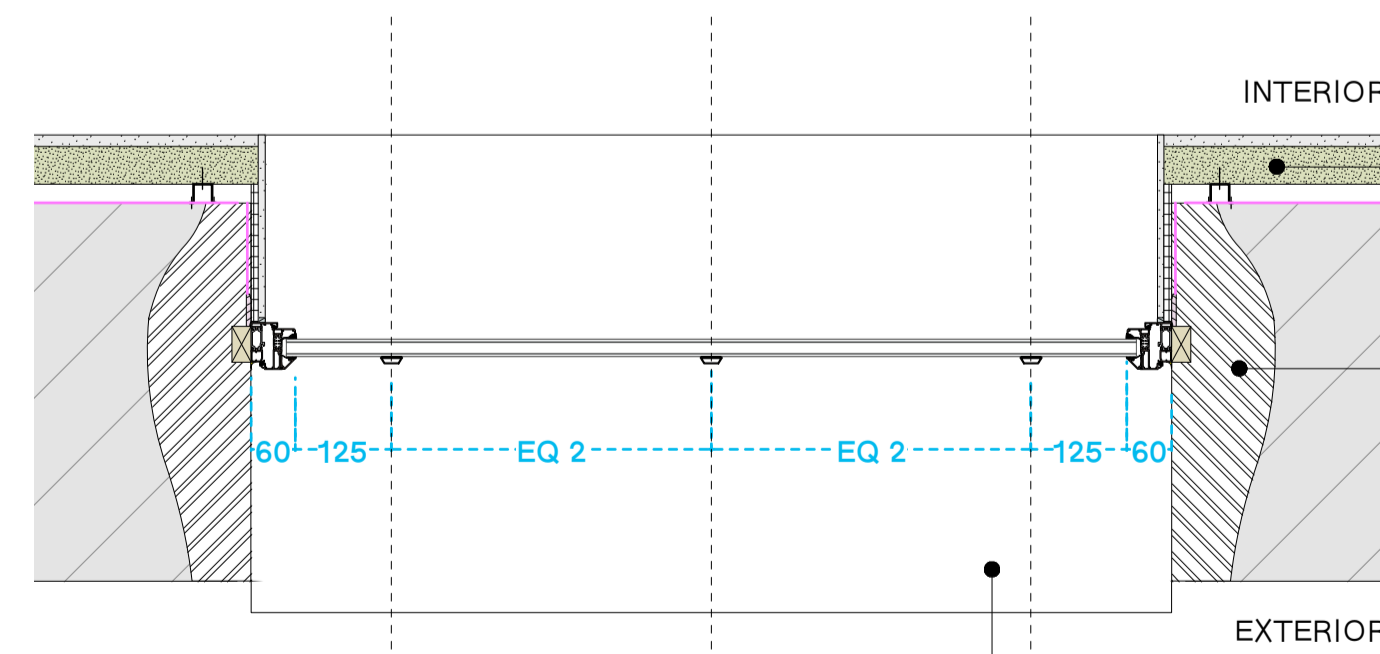
3 WT.59 Plan
Scale: 1:10

Existing stone cill repaired where required

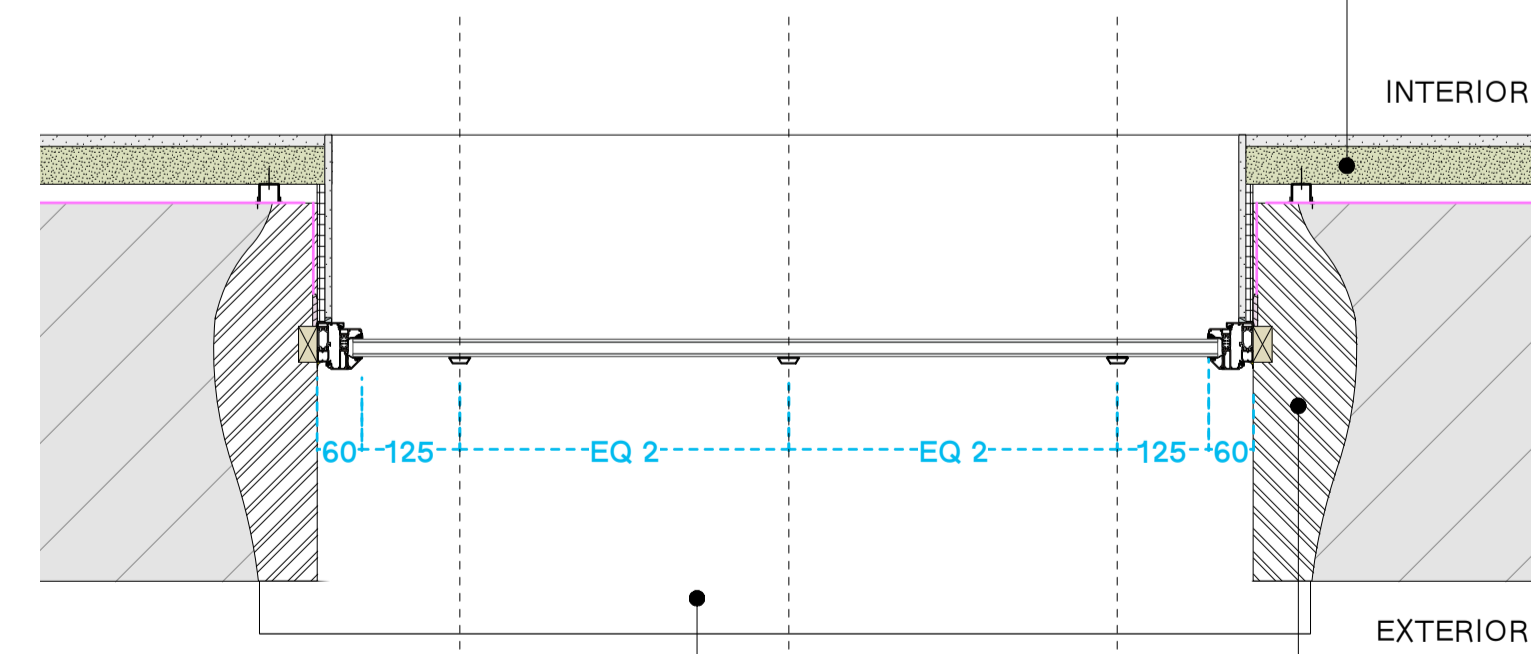
5 WT.60 Plan
Scale: 1:10

Existing stone sill repaired where required

Existing stone cill repaired where required
