## 13 Netherhall Gardens NW3 5RN

Drainage Report

13 Netherhall Gardens 2180456 Drainage Report

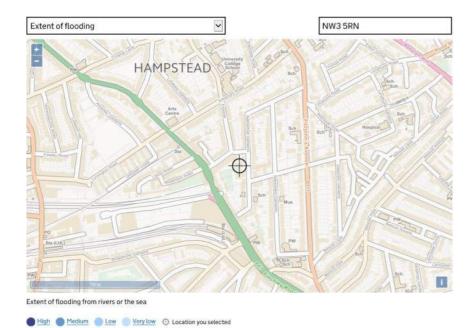
**Figure 2**: Planning flood map showing site is located within Flood Zone 1 (GOV.UK Flood Maps)

Based on data from GOV.uk flood maps, the site is located in Flood Zone 1 and is therefore considered to be at very low risk of flooding.

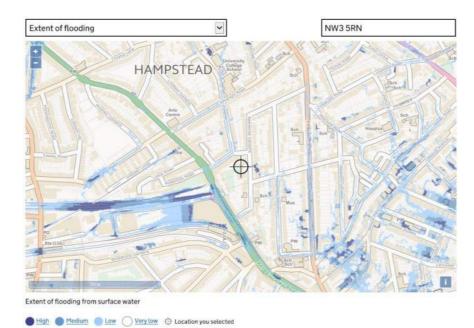
**Figure 3**: Planning flood map showing the site is at very low risk from surface water flooding (GOV.UK Flood Maps)

Based on data from GOV.UK flood maps, the site is shown to be at very low risk from surface water flooding.

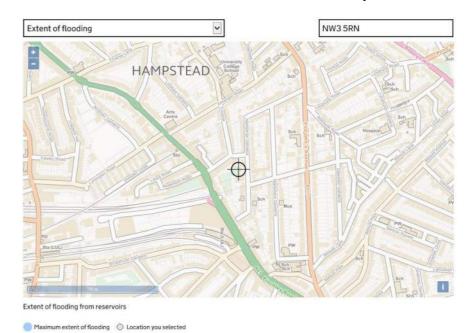
**Figure 4**: Planning flood map – Flood Risk from Reservoirs (GOV.UK Flood Maps)

Following review of the Risk of Flooding from Reservoirs map located on the GOV.UK website, the site is not located within the flooding extent associated with reservoir flooding. The risk of flooding from reservoirs is therefore considered to be very low.

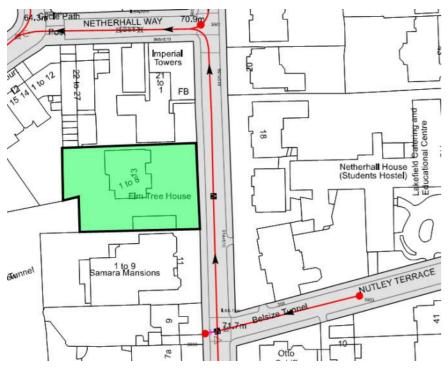
According to Thames water sewer records a 914x610 combined sewer is present within Netherhall Gardens. An extract of the Thames Water records is presented in Figure 6 and in full in **Appendix B**.

Figure 6: Thames Water Sewer Record Extract

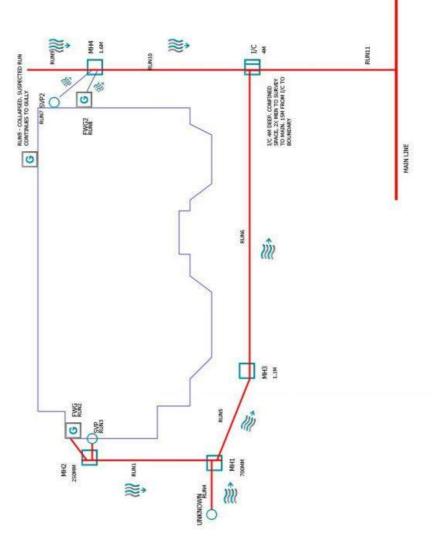
The CCTV drainage survey proved that the overall site benefits from a 150mm diameter connection to the combined sewer in Netherhall Gardens.

**Figure 7**: CCTV Drainage Survey Results Illustrating Existing Drainage Arrangement

A CCTV drainage survey was undertaken in September 2018 to prove the size, location, depth and condition of the existing site-wide private drainage and its connectivity to the Thames Water sewer.

Figure 7 illustrates the existing drainage arrangement on site.

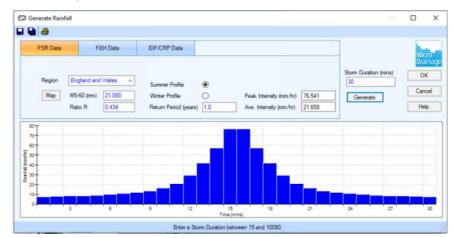
Figure 8: Rainfall intensity for the 1 in 1-year 30-minute storm event

Using the modified rational method and the following average rainfall intensities, the existing surface water discharge rate can be calculated. The results are presented in Table 2.

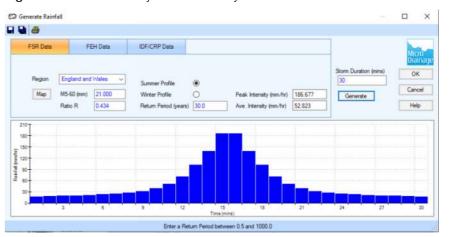
Figure 9: Rainfall intensity for the 1 in 30-year 30-minute storm event

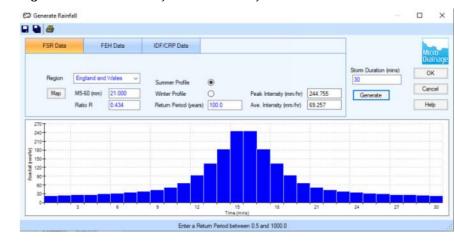
Figure 10: Rainfall intensity for the 1 in 100-year 30-minute storm event

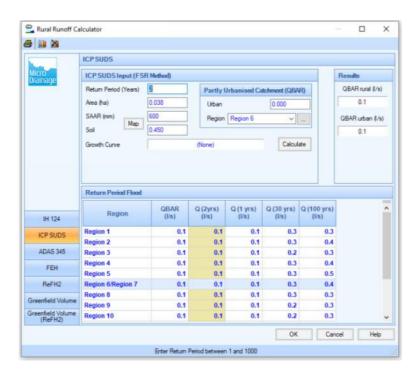
Greenfield run-off rates for the development site have been calculated using the ICP SuDS method, as indicated in Figure 11.

Figure 11: Micro Drainage ICP SuDS Greenfield Results

The resulting QBar rate is 0.11/s based on a 0.038 hectare development site. This QBar rate is prohibitively low and it would not be possible to attenuate the development to this rate given the constrained nature of the site (the existing building occupies the majority of the redevelopment site). Due to these constraints and the fact that the existing building is currently positively drained by gravity, it is proposed to incorporate SuDS in the rear lower terrace only, where new external works are proposed.

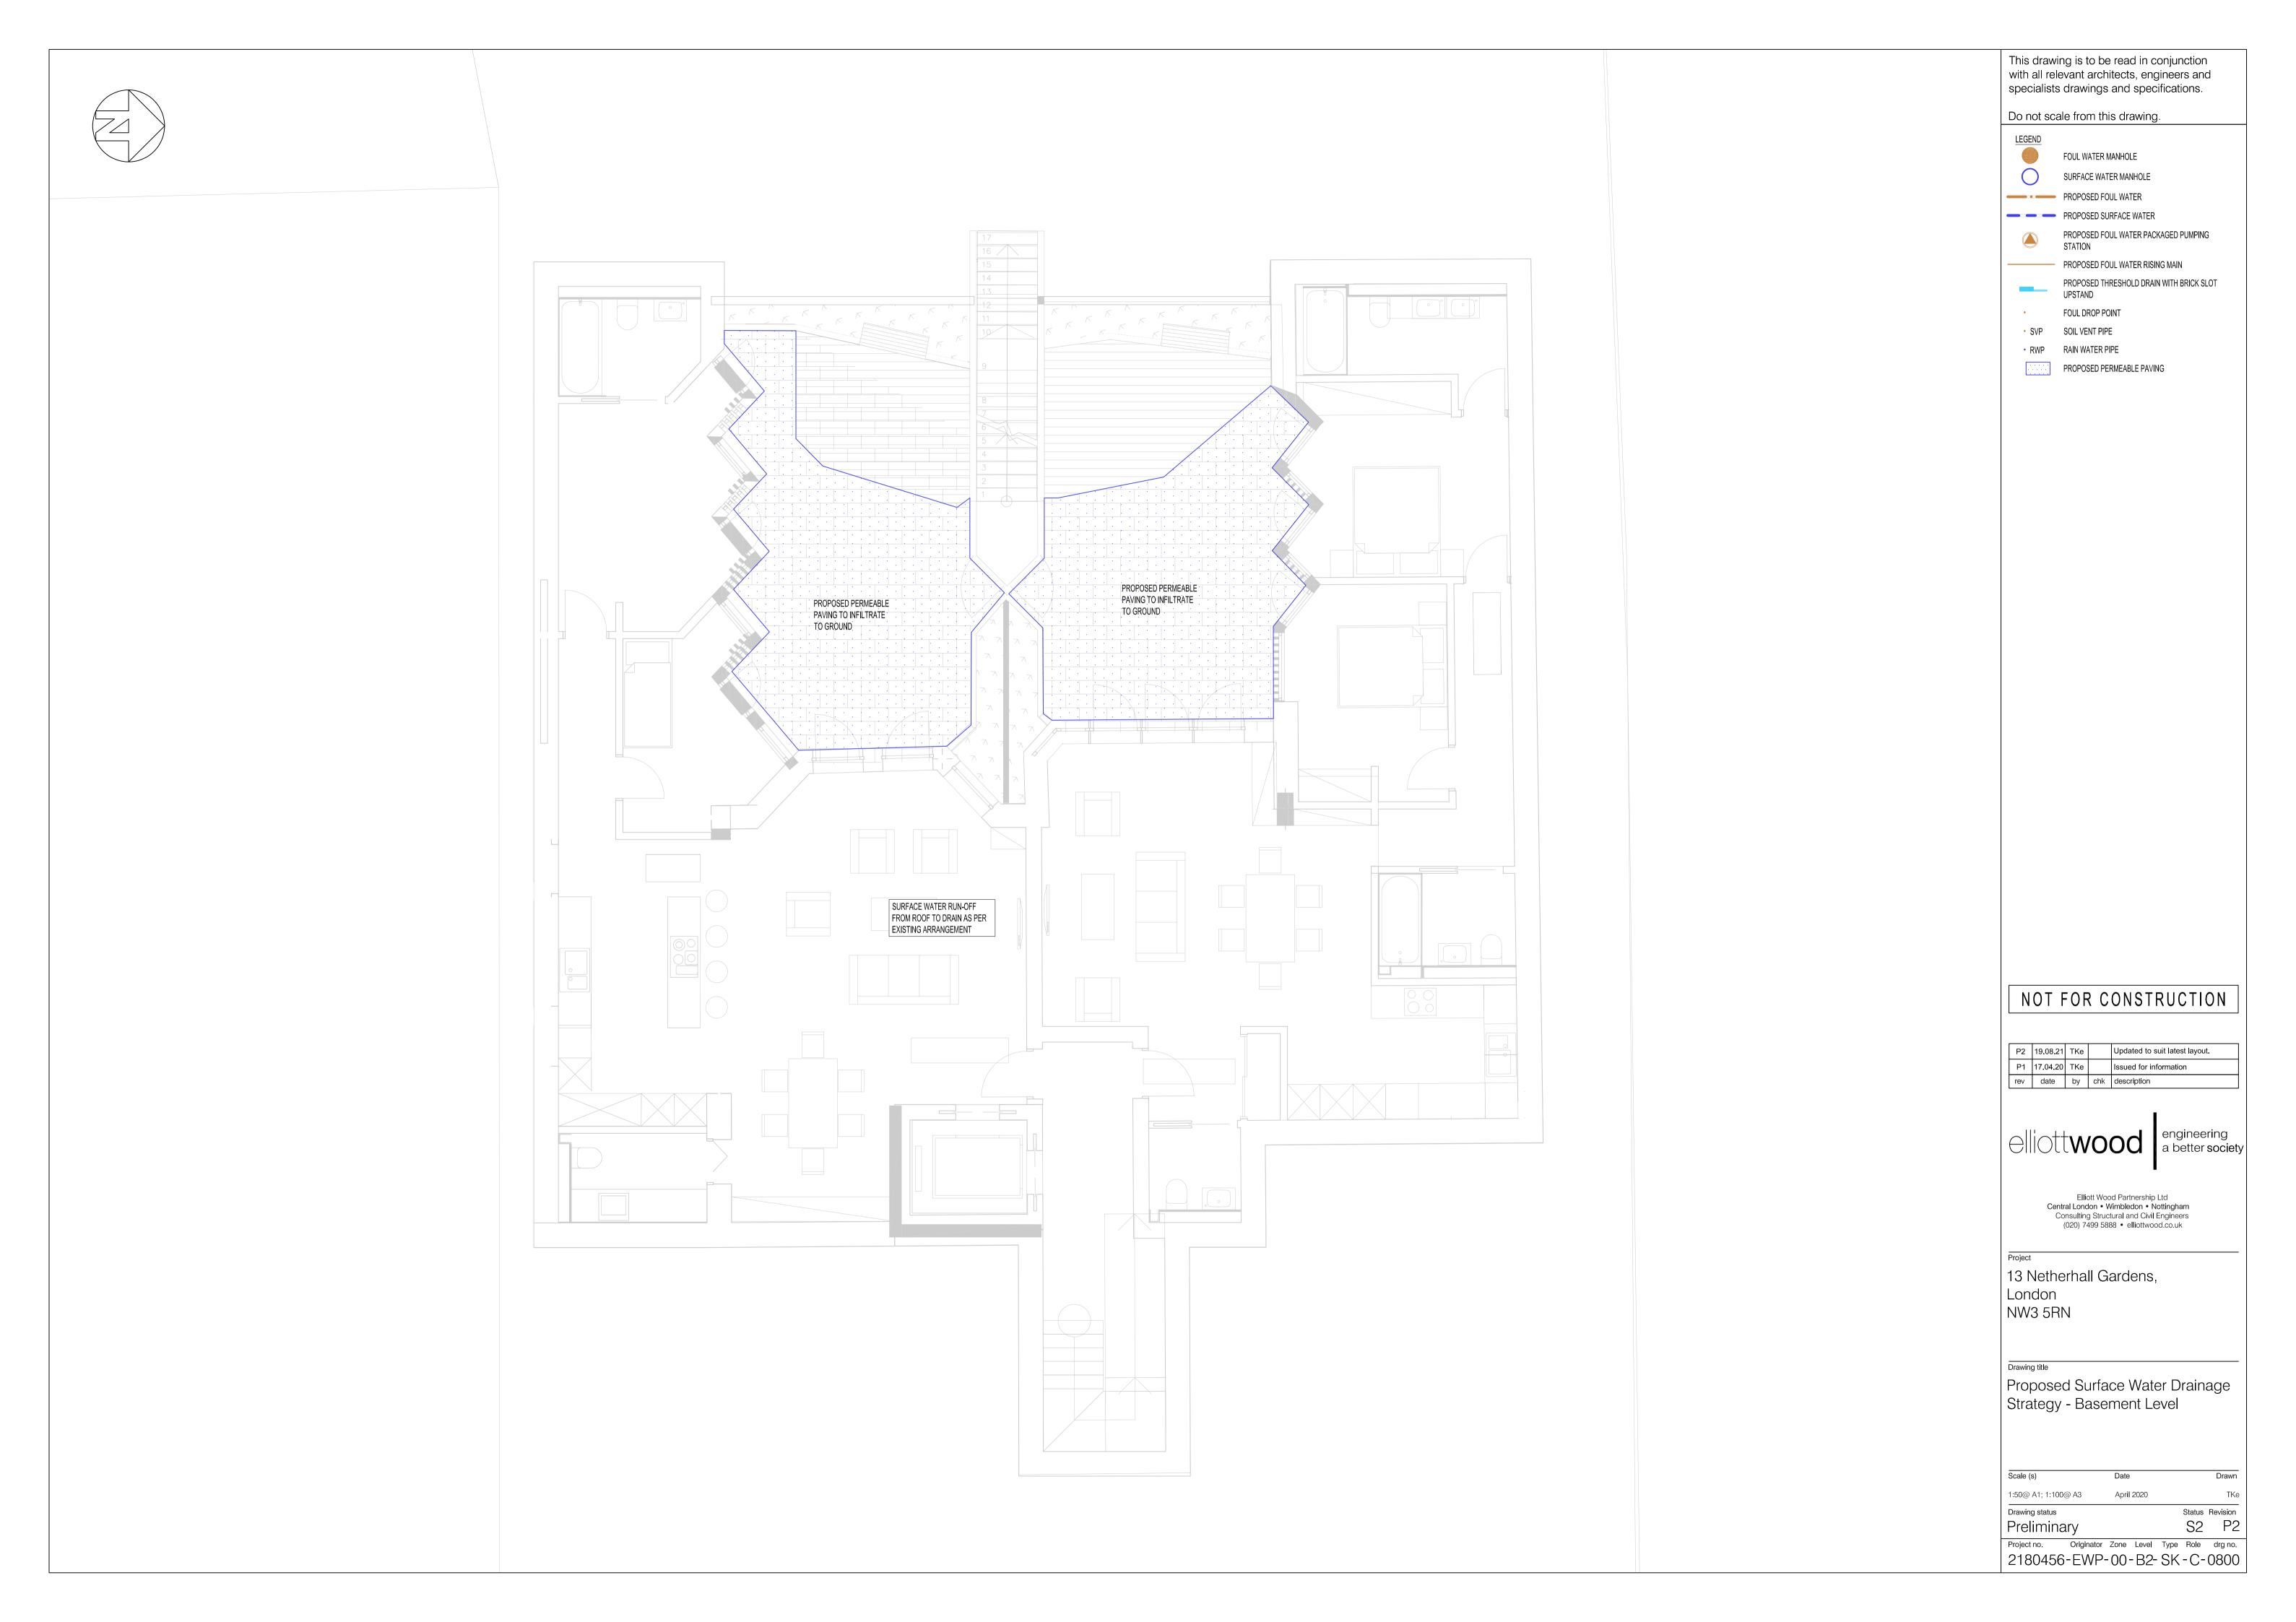
C Drainage Drawing

Drawing numbered 2180456 EWP 00 B2 SK C 0800 presented in **Appendix** C illustrates the proposed Surface Water Drainage Strategy – Basement Level.

Due to the nature of the redevelopment works and various site constraints the only feasible SuDS options are to incorporate permeable paving in the rear terrace area at Basement level.
