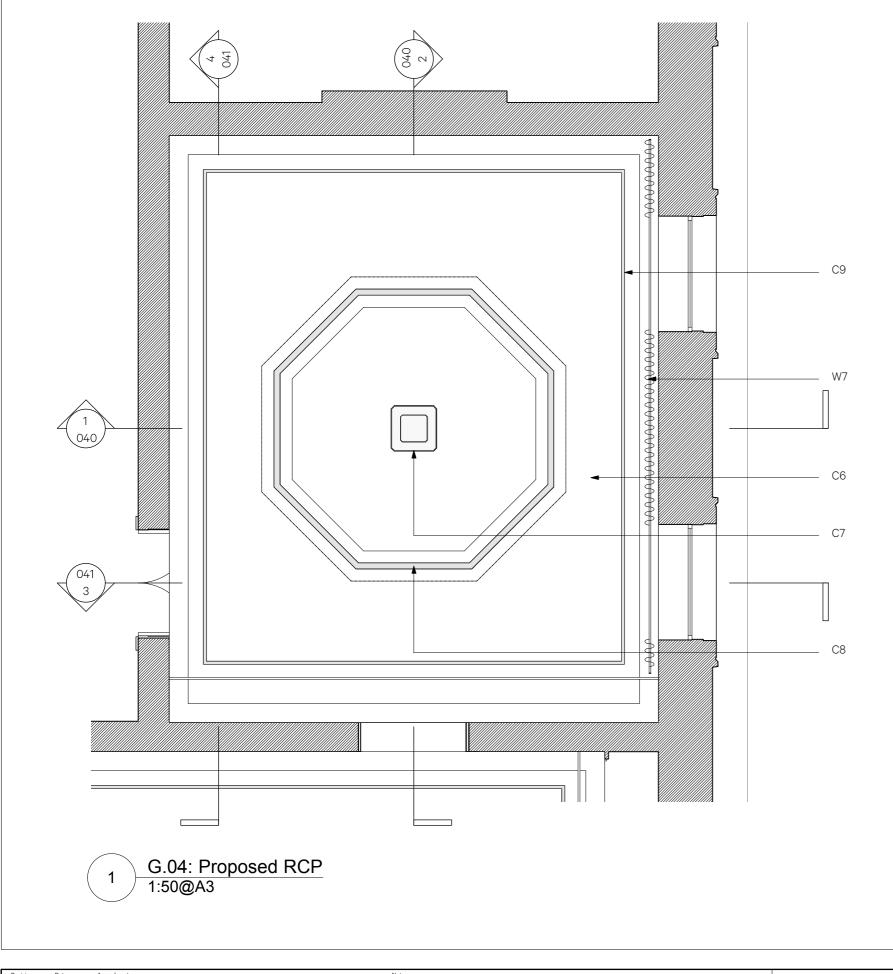
Walls

2 Existing hardwood panelling retained and protected throughout works. Refer to photographs P1-4.

W3 New penetrations to west wall (between G.04 and G.05) below existing cornice level for ventilation ductwork. Refer to photograph P4.

W4 Existing transfer grille above door to north elevation to be retained. Refer to photographs P1 & P5.

W5 Existing walls made good and redecorated. Refer to photographs PX1-4.

N6 New power and data trunking with hardwood covering to match existing hardwood panelling.

W7 New heavy curtains to south elevation.

New acoustic wall boards to provide mounting for AV screens.

Ceiling

Existing ceiling cornice retained and protected throughout the works. Existing condition to be surveyed following the removal of the existing suspended ceiling. Refer to photograph P11.

C6 New suspended plasterboard and acoustic plaster ceiling.

C7 New chandelier.

C8 New recessed track lighting.

C9 New recessed linear ventilation slot diffuser/extract.

Windows

/i2 New heavy curtains.
