1 G.04: Existing RCP
1:50@A3

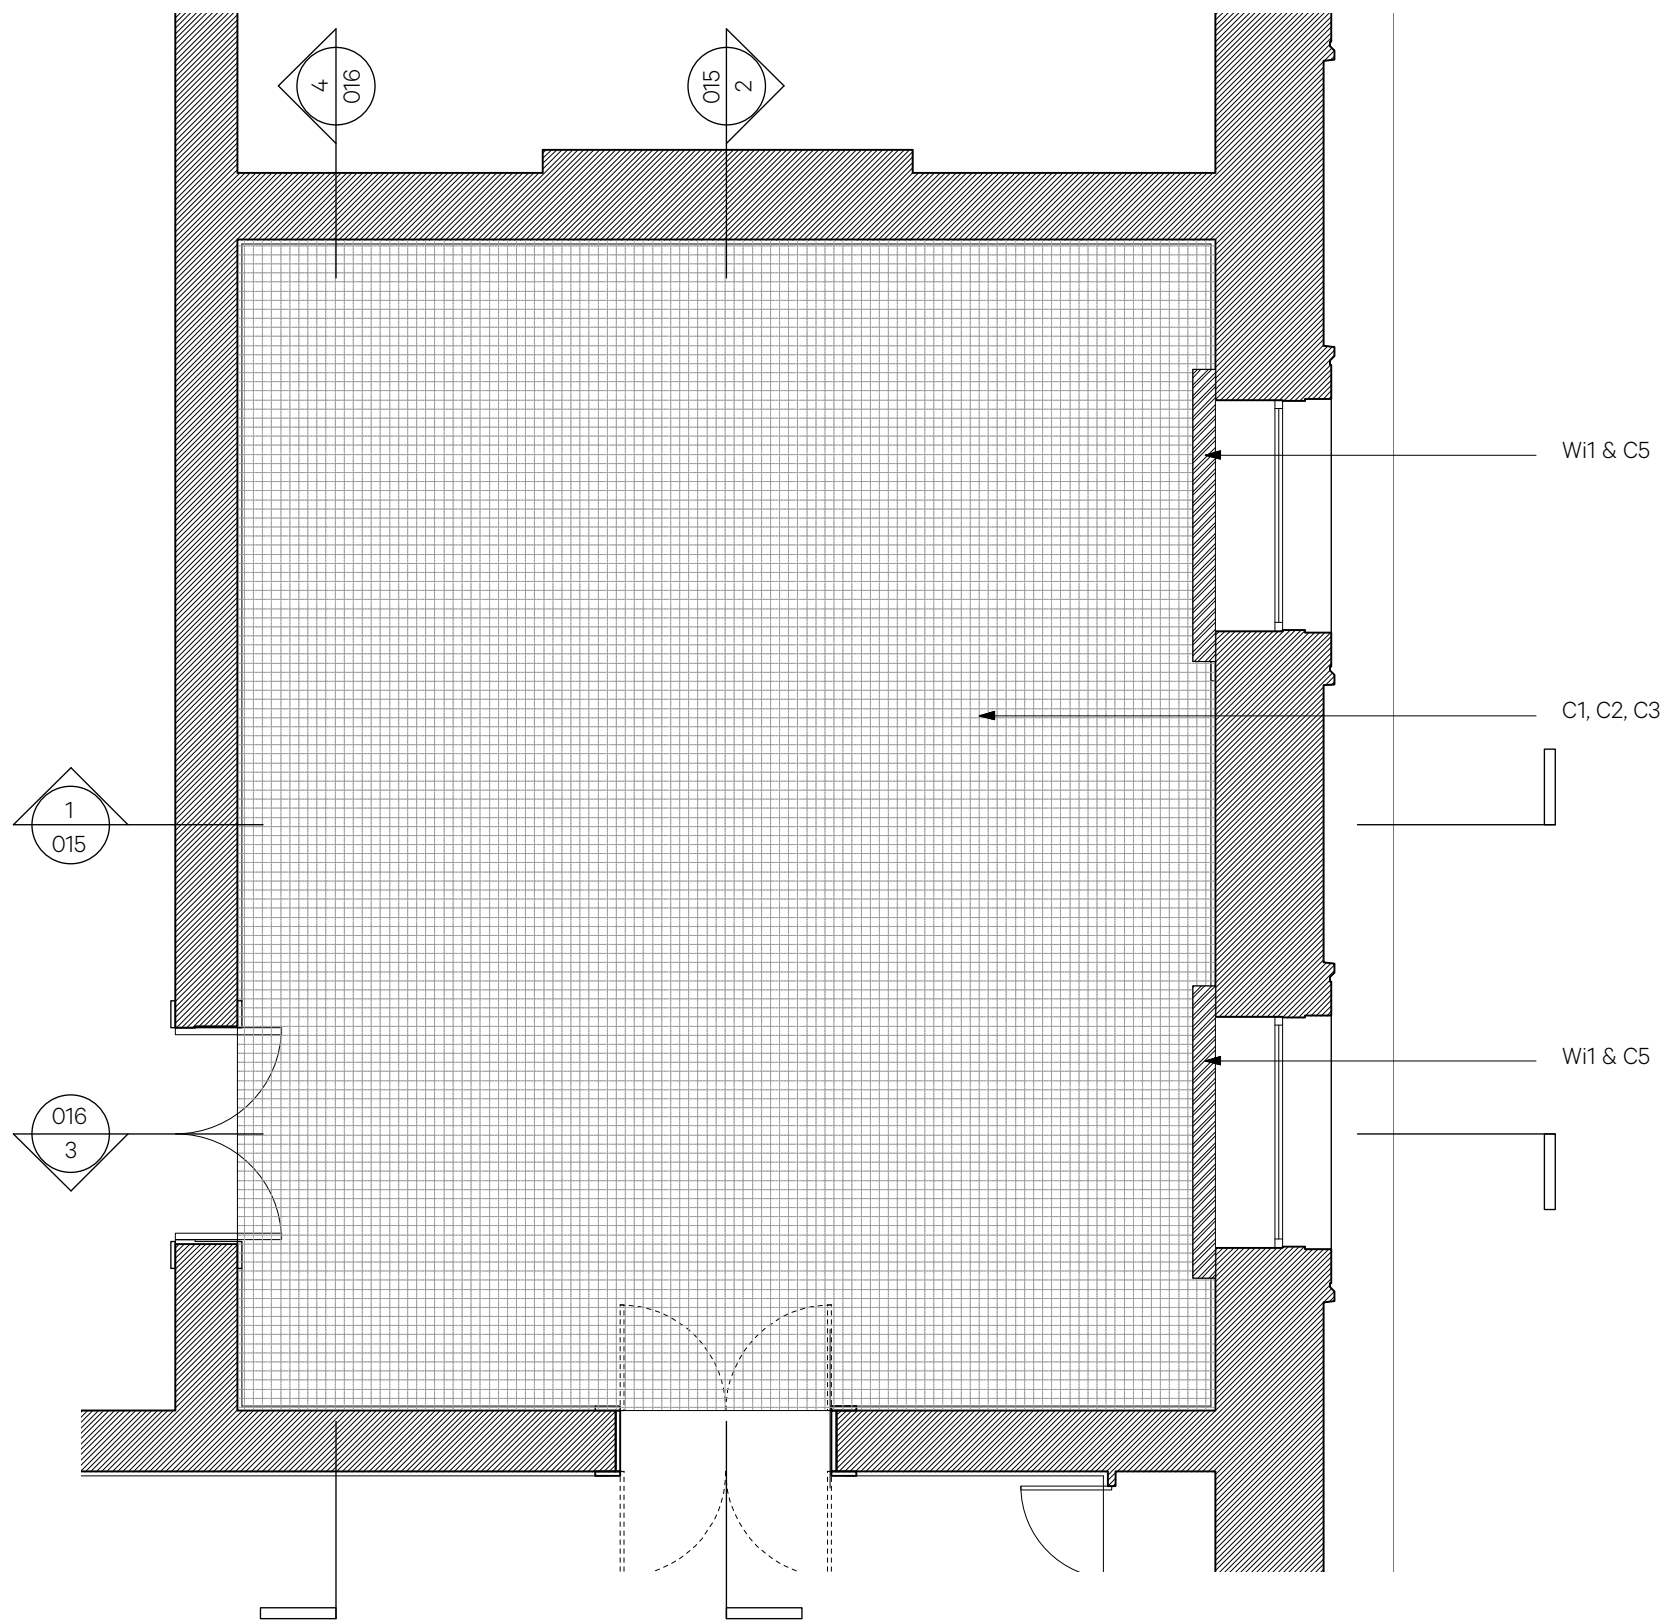
- Walls**
- W1 Existing services to be removed, including dado trunking. Refer to photographs PX1-4
 - W2 Existing hardwood panelling retained and protected throughout works. Refer to photographs P1-4.
 - W3 New penetrations to west wall (between G.04 and G.05) located below existing cornice level for ventilation ductwork. Refer to photograph P4.
 - W4 Existing transfer grille above door to north elevation to be retained. Refer to photographs P1 & P5.
 - W5 Existing walls made good and redecorated. Refer to photographs P1-4.
 - W6 New power and data trunking with hardwood covering to match existing hardwood panelling.
 - W7 New heavy curtains to south elevation.
 - W8 New acoustic wall boards to provide mounting for AV screens.

- Ceiling**
- C1 Existing suspended ceiling and fixings to be removed. Refer to photographs PX1-4.
 - C2 Existing ceiling-level services and lighting to be removed. Refer to photographs P1-4.
 - C3 Existing above-ceiling services to be generally removed, with the exception of existing water pipes serving the library above.
 - C4 Existing ceiling cornice retained and protected throughout the works. Existing condition to be surveyed following the removal of the existing suspended ceiling. Refer to photograph P11.
 - C5 Existing boxing out of window heads at ceiling level removed. Refer to photograph P6.
 - C6 New suspended ceiling.
 - C7 New chandelier.
 - C8 New recessed track lighting.
 - C9 New recessed linear ventilation slot diffuser/extract.

- Windows**
- Wi1 Existing blinds to be removed. Refer to photograph P6.
 - Wi2 New heavy curtains.
