Branch Hill House London NW3 7LS Drainage Condition Discharge

Project Number:	21021
Report Issue Date:	21 Oct 2021
Report Status:	For Planning
Prepared by:	ES/JH
Checked by:	DW

1 Introduction

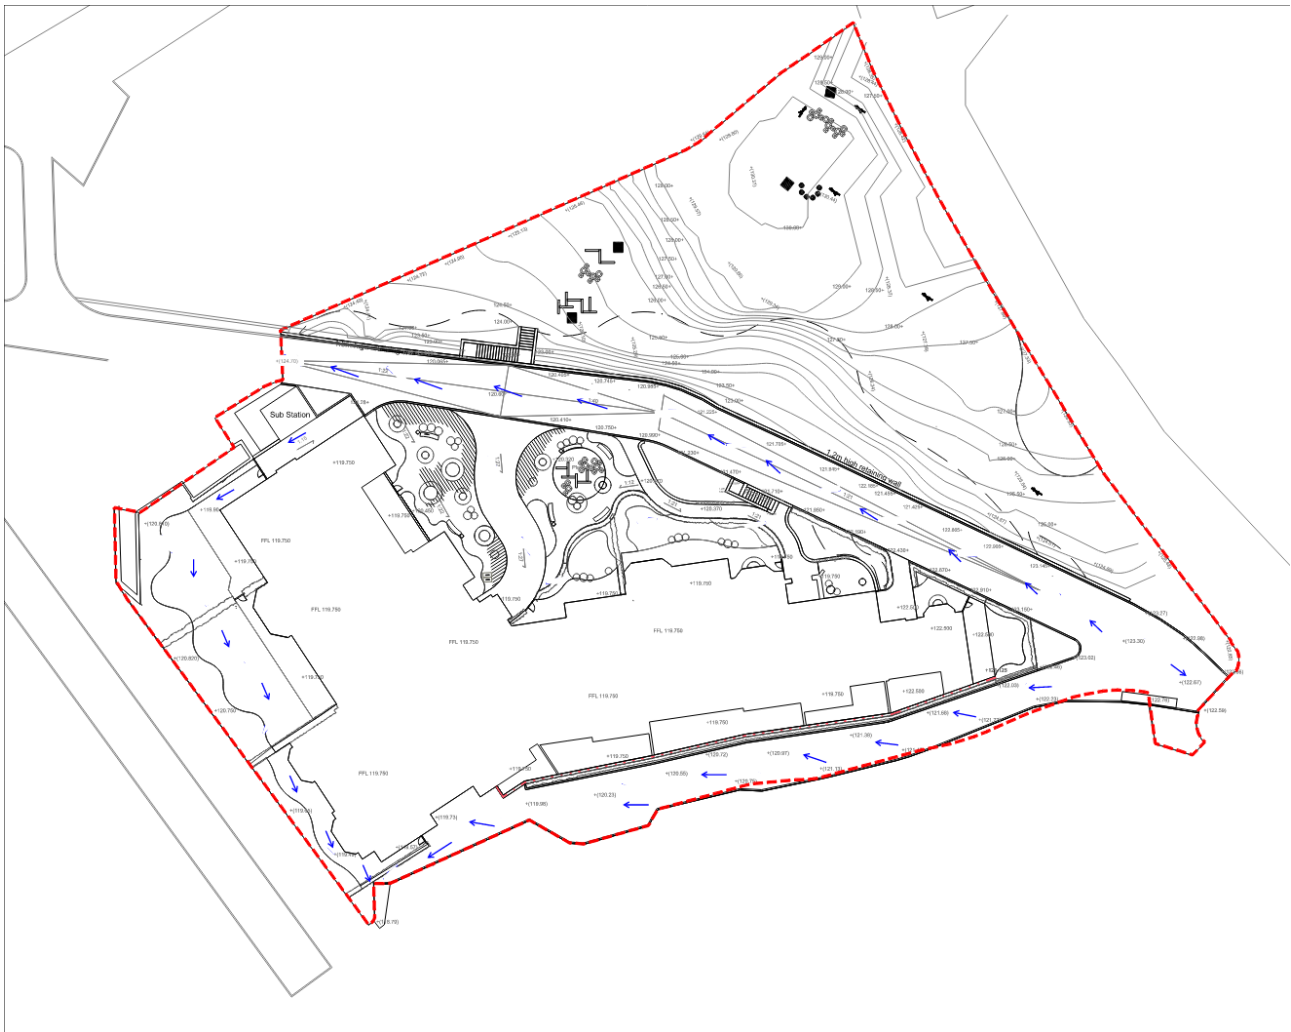
In accordance with the NPPF, this new build has been classified as ‘more vulnerable’ and is located within the Floor Zone 1. It is therefore considered suitable in accordance with Table 2 of the NPPF. Below is the flood exceedance routing plan included with the original approved plans. The overall exceedance discharge is towards the northwest of the site. There will be no damage to property due to surface water ingress during exceedance events.
