REMEDIATION STRATEGY & VERIFICATION PLAN
of a site at
27 MARESFIELD GARDENS, HAMPSTEAD
for
MR RON GOLAN

Project No 2166

Report ref: 2166-P3E-1

Issued: 18 October 2021

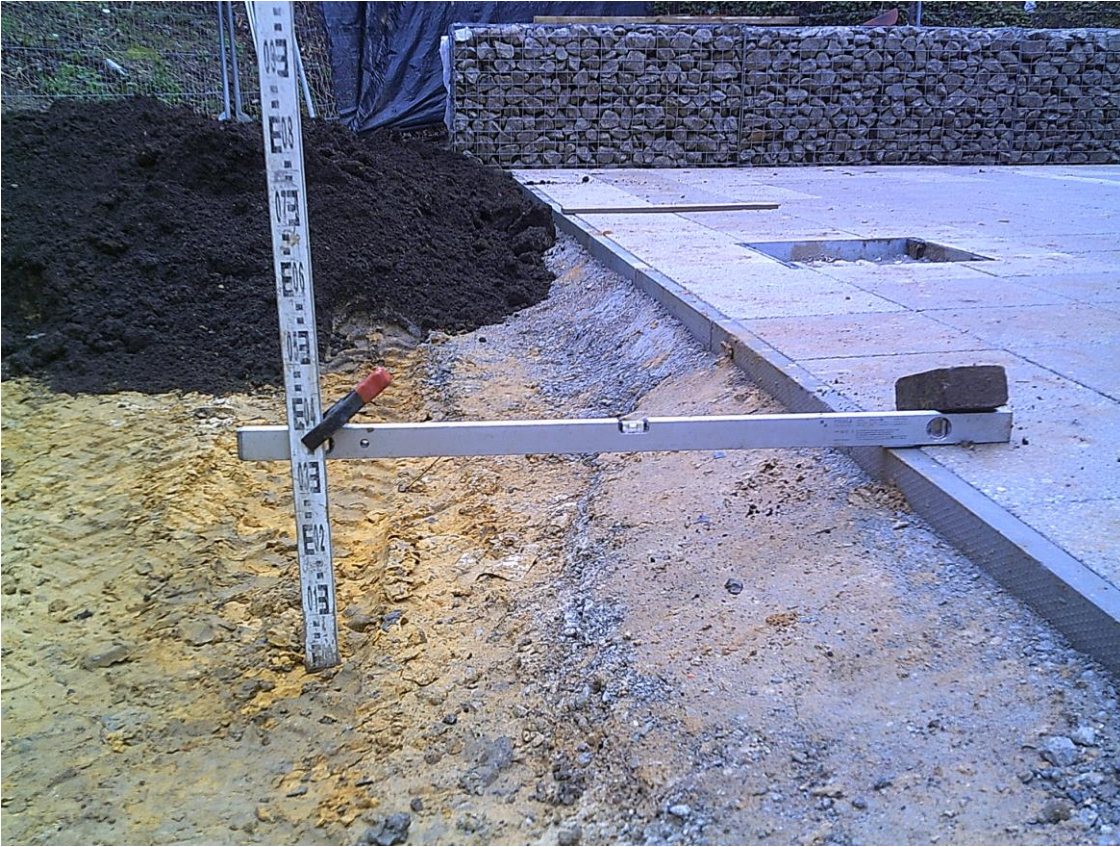
Example A: Close up, showing the depth clearly.

In order to demonstrate that the made ground within the soft landscape area has been removed to a depth of 600mm or to natural strata, photographs will be taken of the impacted area following removal of made ground. A plan showing the locations of the photographs will be prepared.

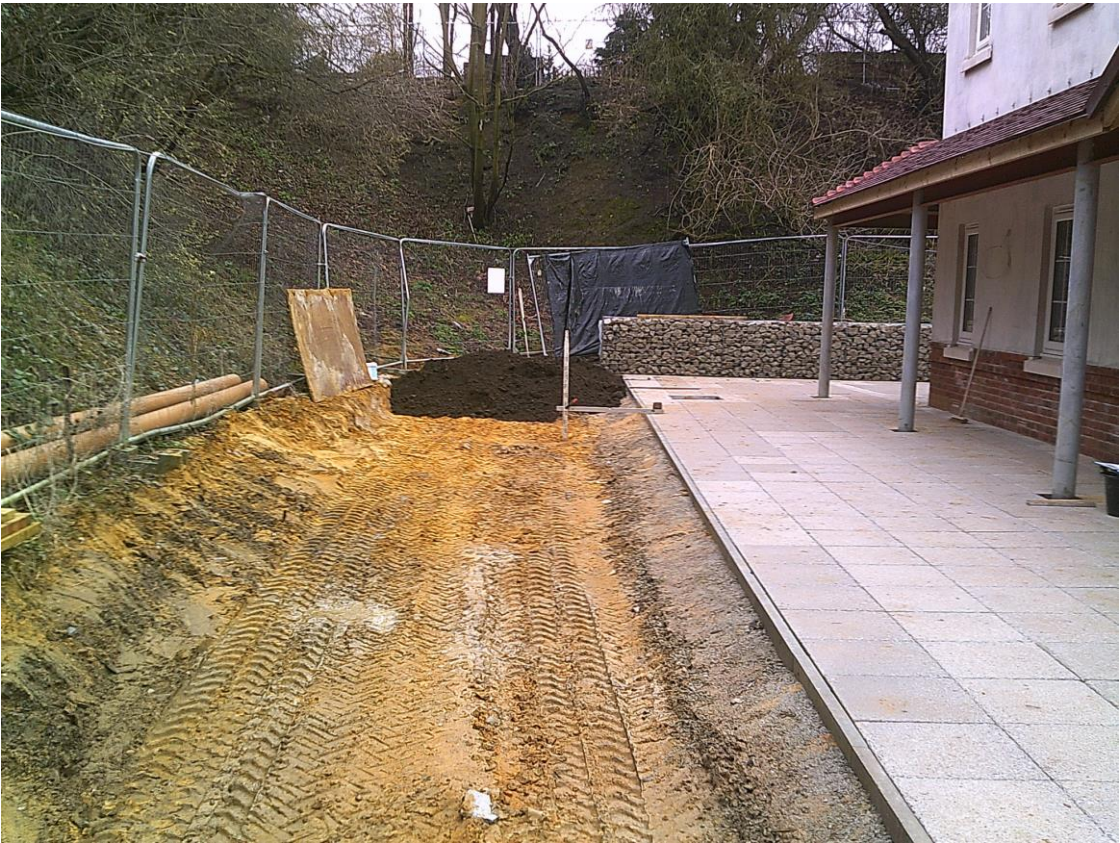
Example A: Showing the location of the close up

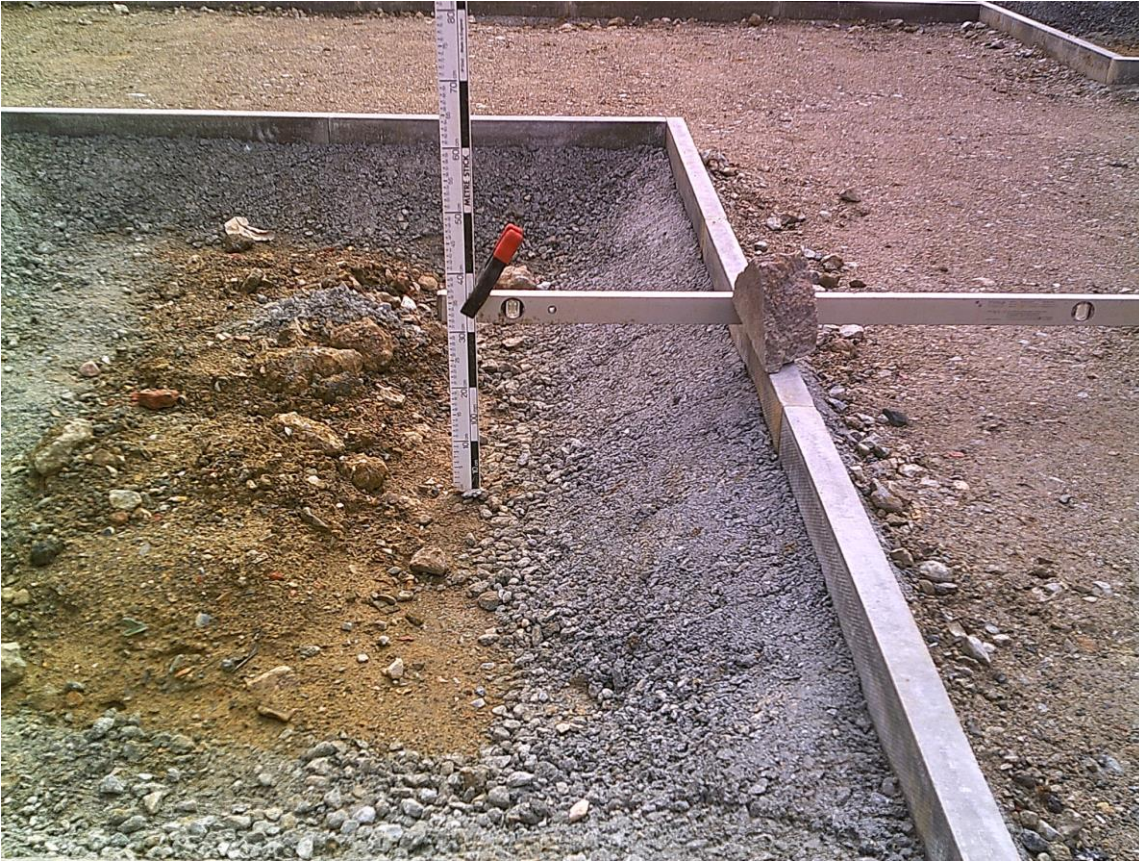
Example B: Close up, showing the depth clearly

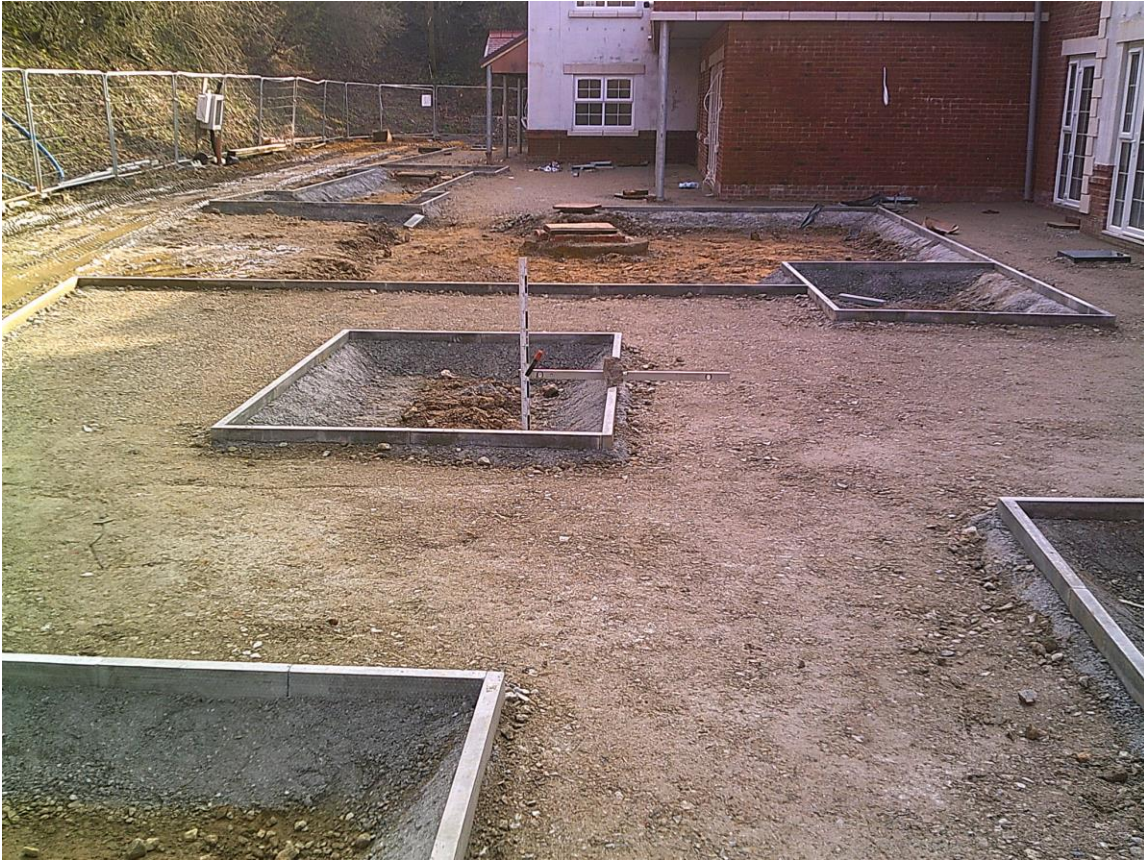
Example B: Showing the location of the close up
